Rail Accident Investigation Branch

# Rail Accident Report

**Derailement of a passenger train at Carmont,  
Aberdeenshire  
12 August 2020**

Report 02/2022  
March 2022

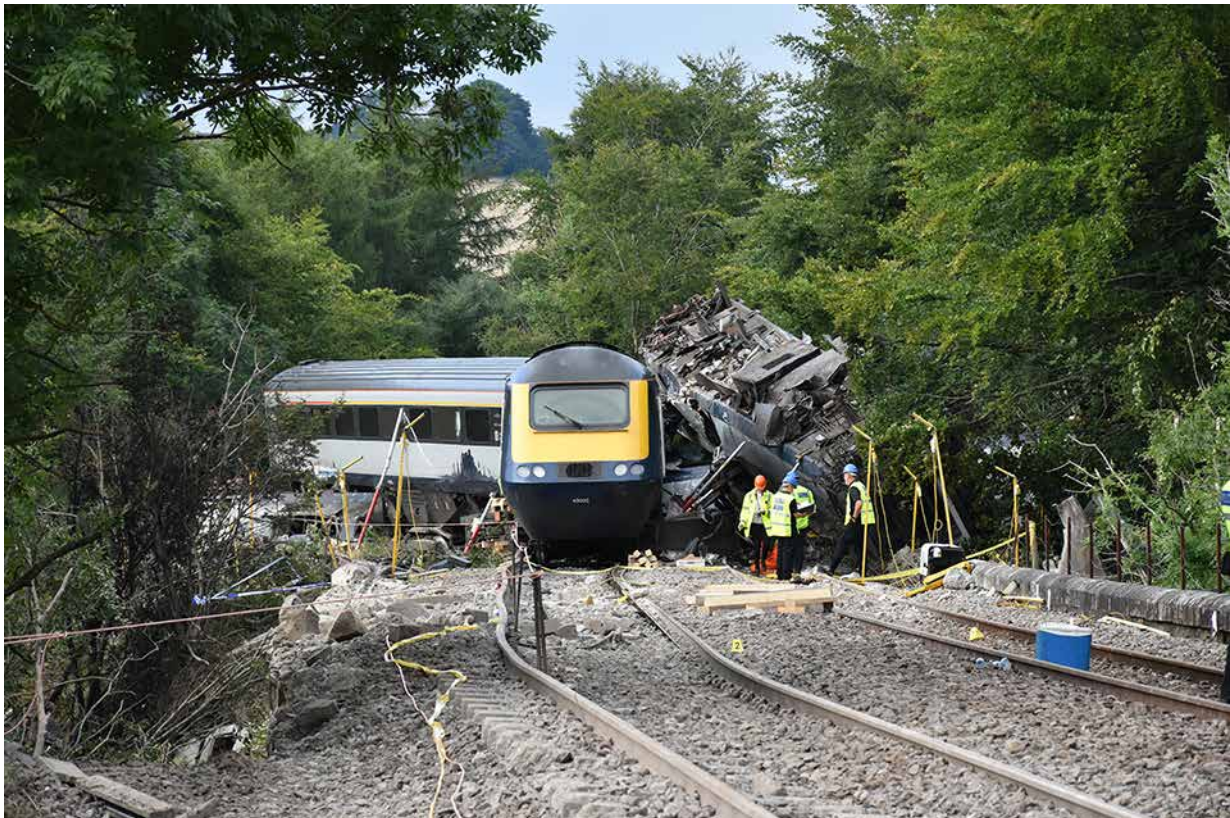
*The aftermath of the accident (image taken on 13 August 2020)*

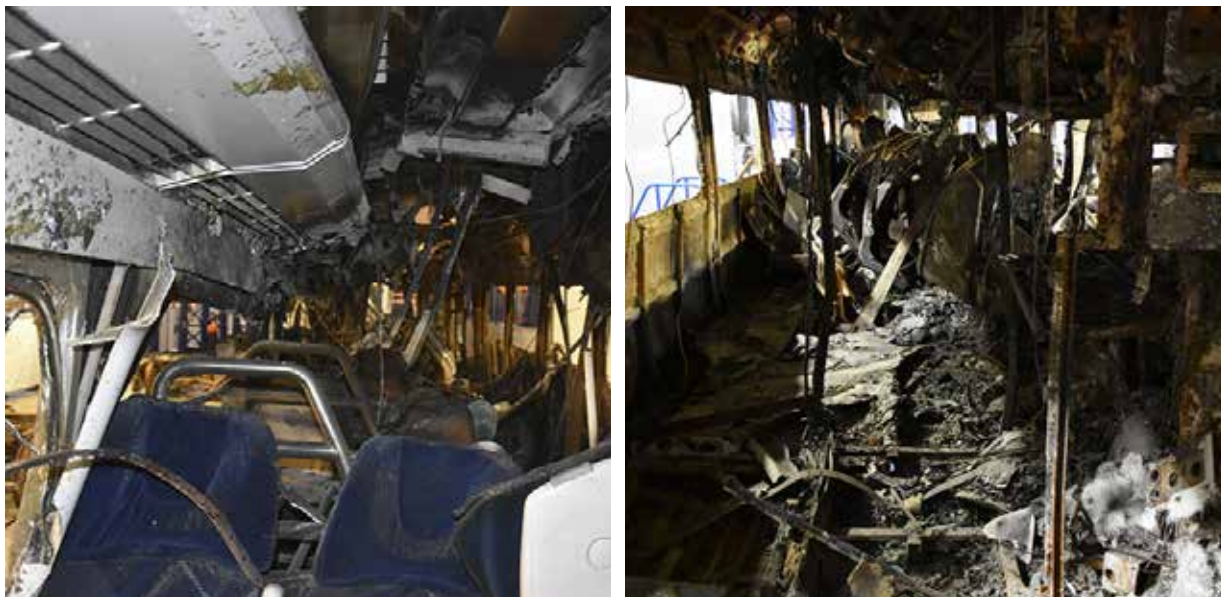
*Fire damage in the third coach*

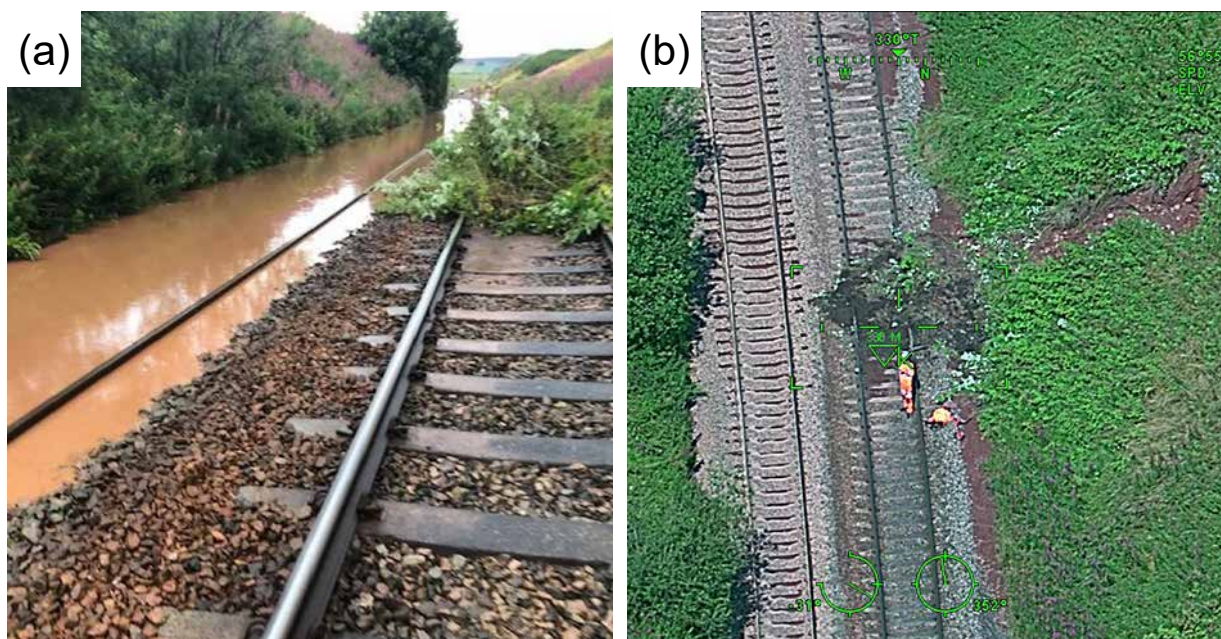
Figure 15: Landslip blocking the up line 1.6 km (1 mile) south of Carmont signal box near Ironies Bridge (a) at around 08:50 hrs on 12 August 2020 when the down line was also flooded, and (b) at around 11:00 hrs on 12 August 2020 after flooding had receded (Network Rail)

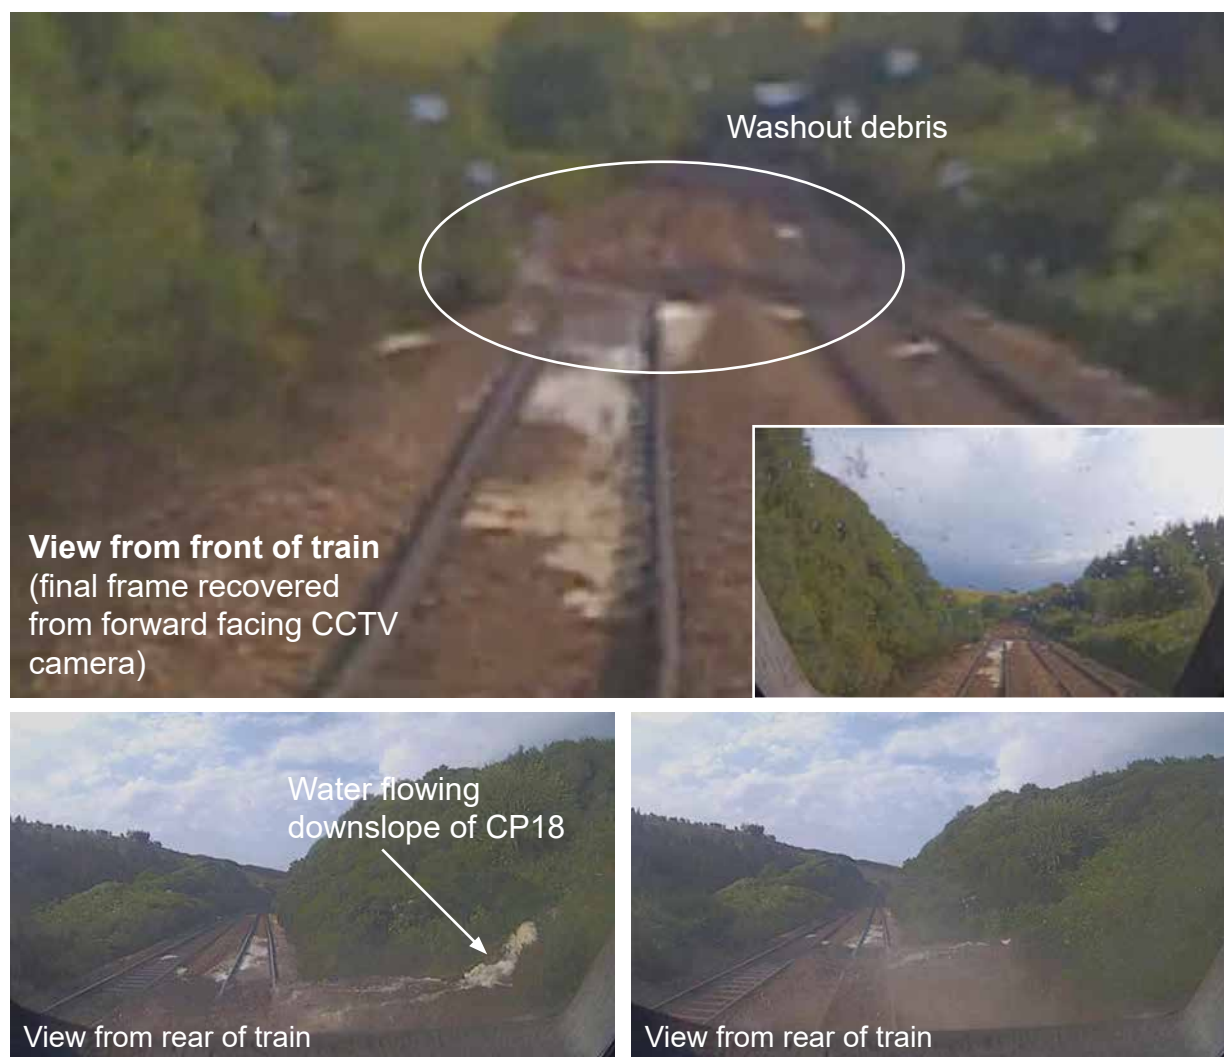
Figure 21: CCTV images from train 1T08 showing the washout (ScotRail)

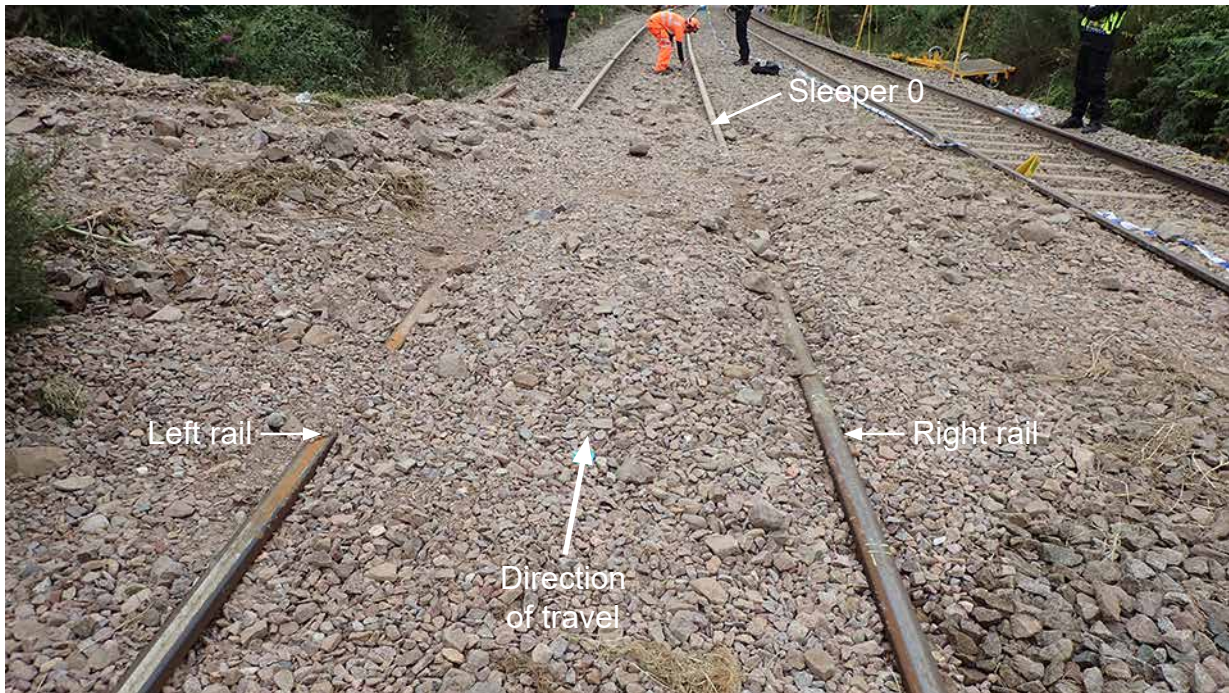
Figure 22: Washout debris covering the track and point of derailment at sleeper 0. Grooves cut by the wheels of train 1T08 through the debris are visible

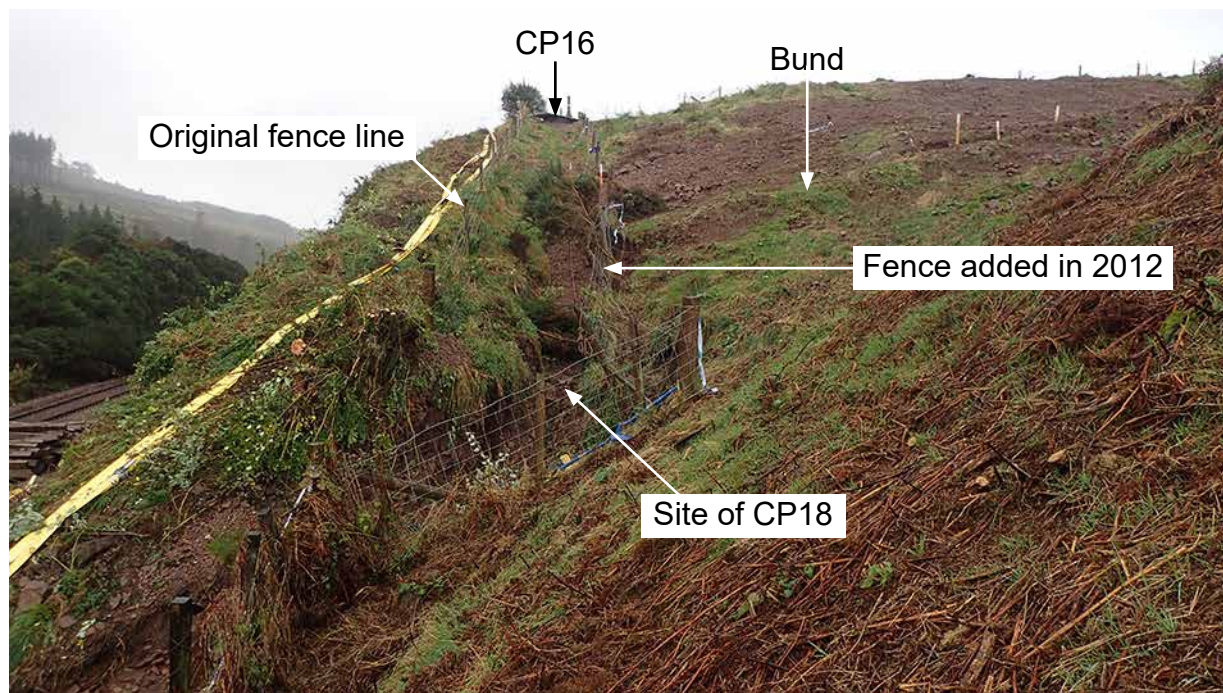
Figure 36: Funnel area post-accident after clearance of vegetation and removal of CP18

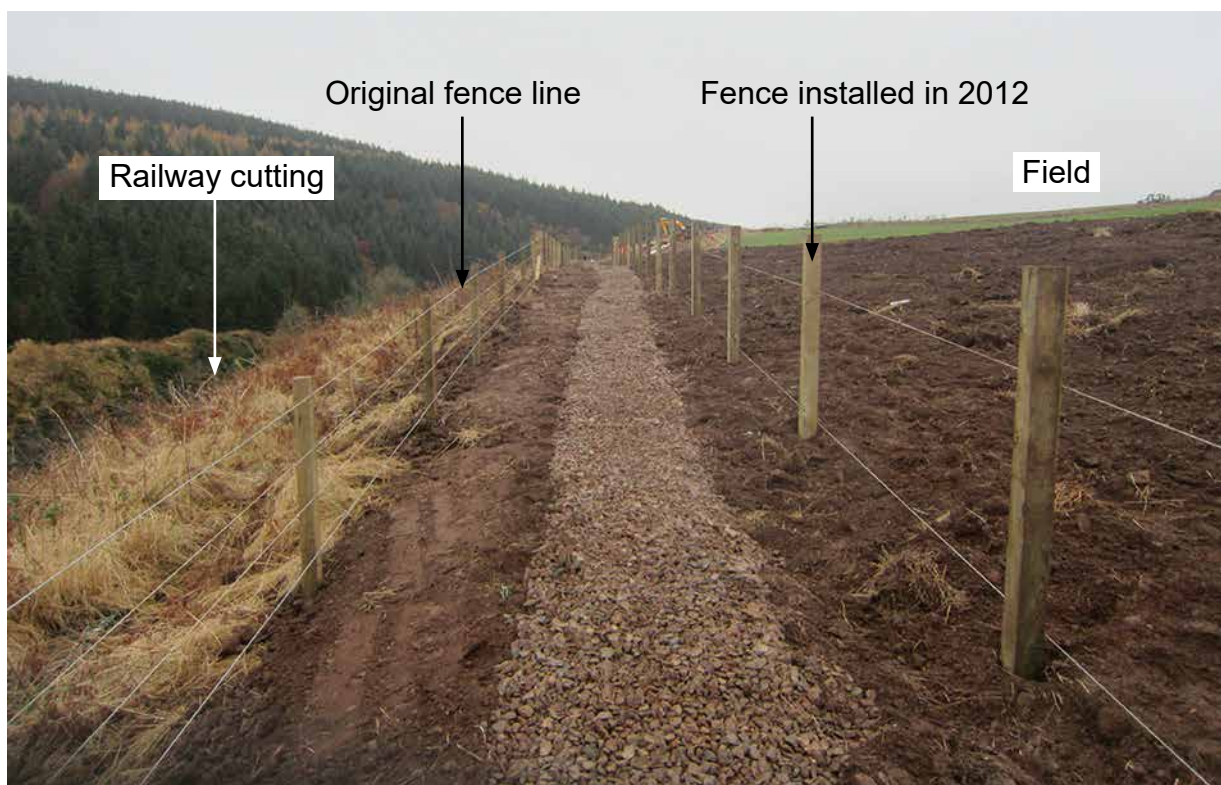
Figure 45: Drain shortly after completion in late 2012 showing section between CP11 and CP16 looking south (Network Rail)

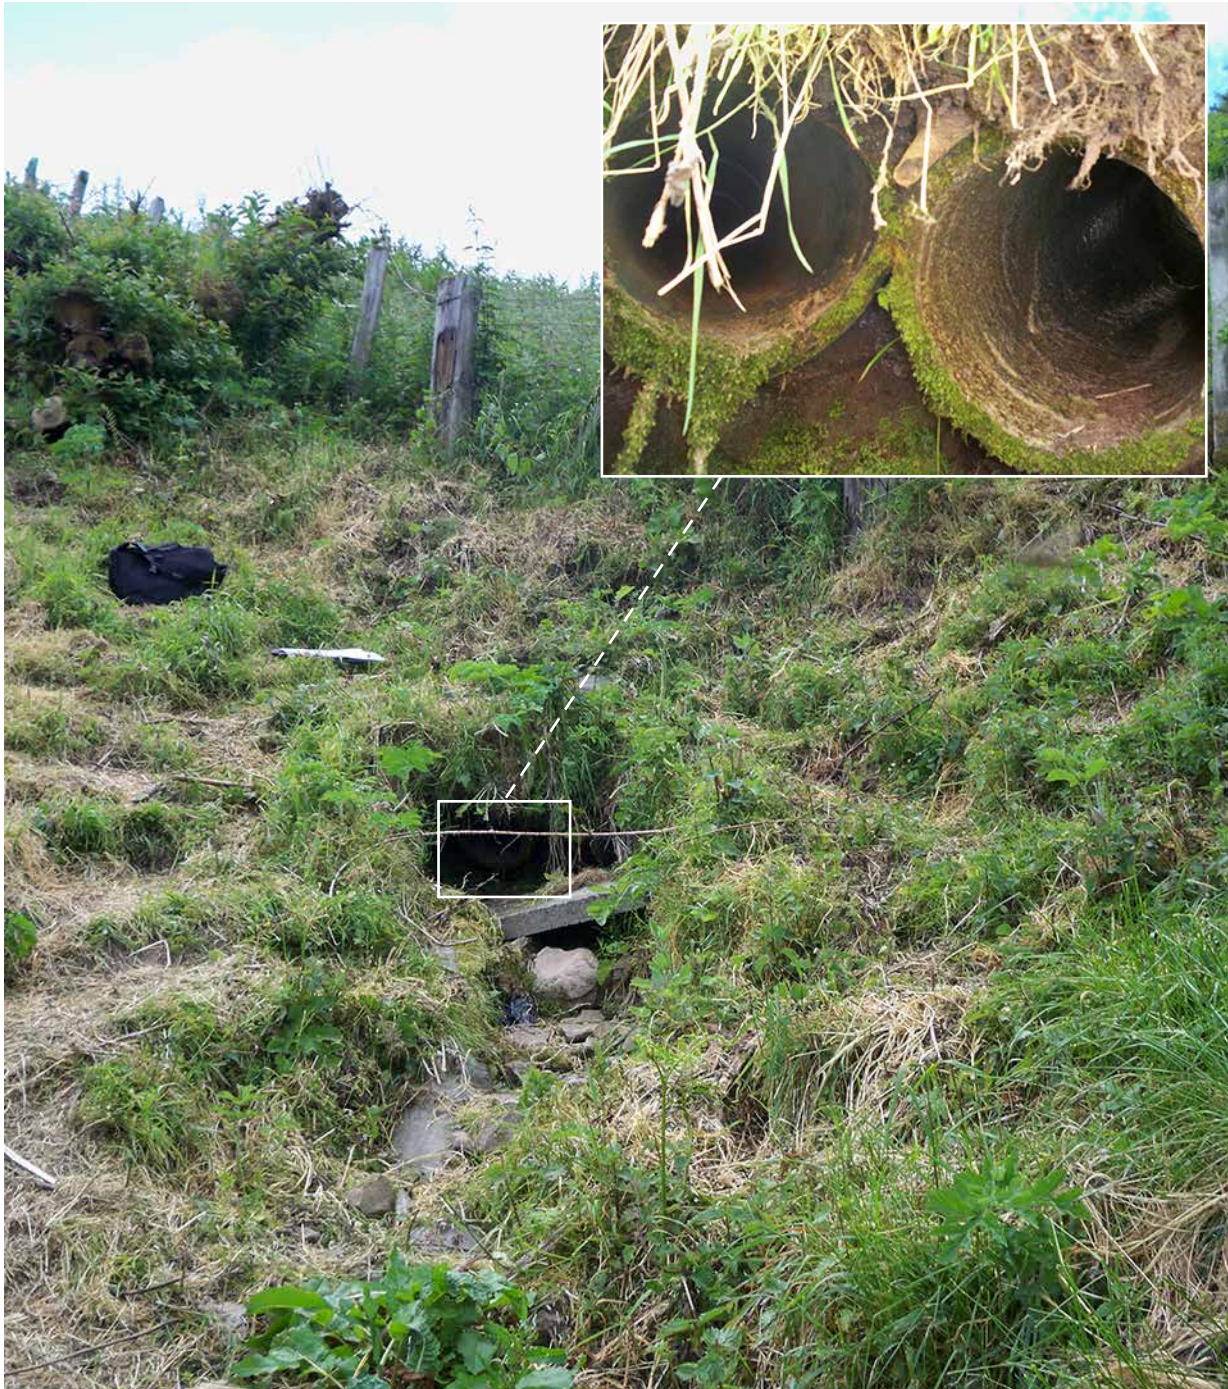
Figure 48: Pipes entering channel in pre-2010 drainage system at as-designed position of CP18 (Arup, June 2010). Inferred that left-hand pipe is from historic crest drain and right-hand pipe from pre-2010 drainage ditch as shown on figure 32

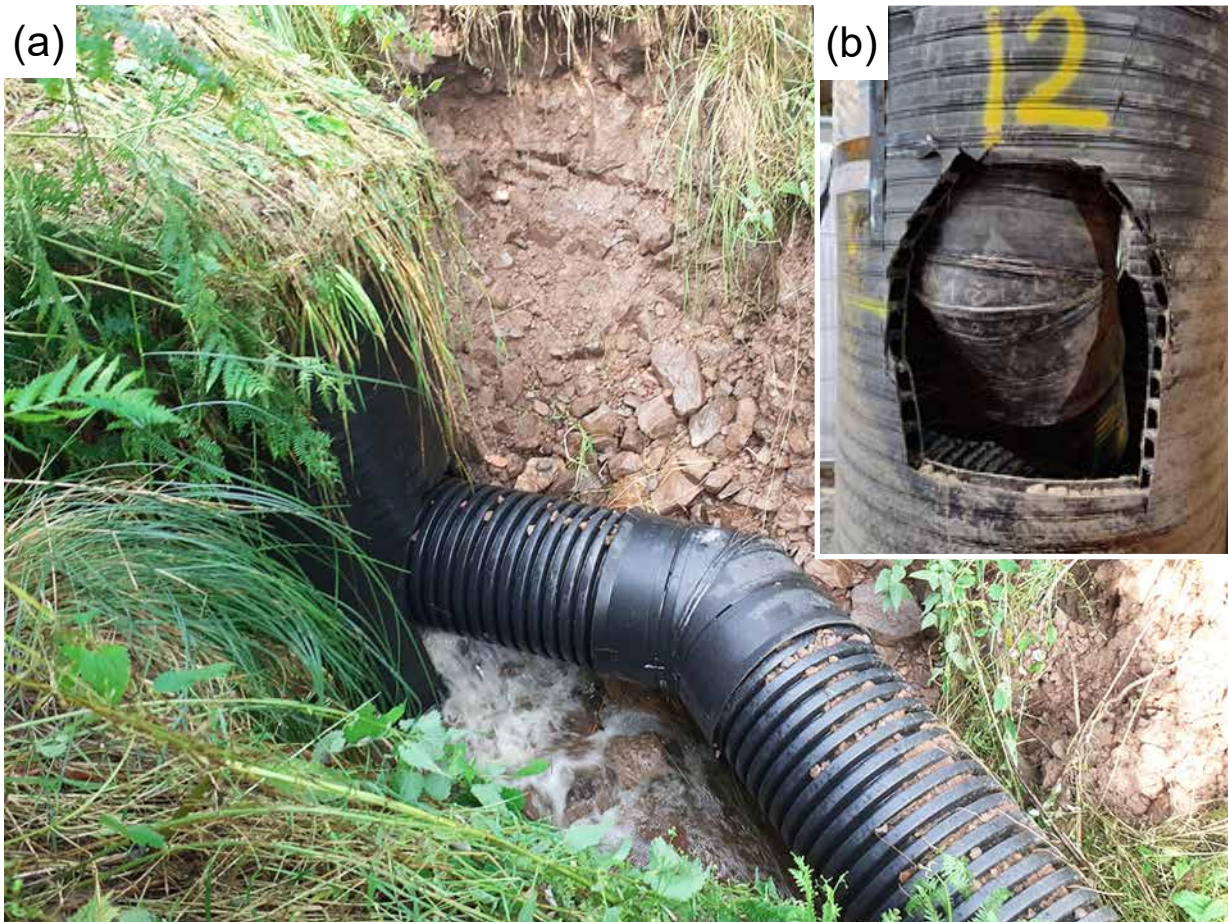
150 At CP18, the enlarged hole on the downslope side of the catchpit was significantly bigger than required to accommodate the drainage pipe. AECOM's analysis concluded that, until surface water flow caused washout of the gravel, escape of water through the gap between the pipe and the enlarged hole would have been constrained by gravel restricting the amount of outflow and by the damming effect of the locally dug fill (figure 30). This would have led to a build-up of water in the gravel sufficient to force the escaping water to re-enter the pipe through the pipe perforations, with no water escaping to the surface. This would not have caused a washout, although it had the potential to trigger a washout if surface water flows over the drain were just less than needed to cause a washout. The washout upslope of CP18 demonstrates that surface flows were sufficient to cause a washout without the assistance of water escaping from around the drainage pipe.

Figure 51: Downstream face of CP18 showing enlarged hole (a) on 12 August 2020, and (b) after removal (Note: a loose section of pipe has been subsequently placed inside the catchpit)

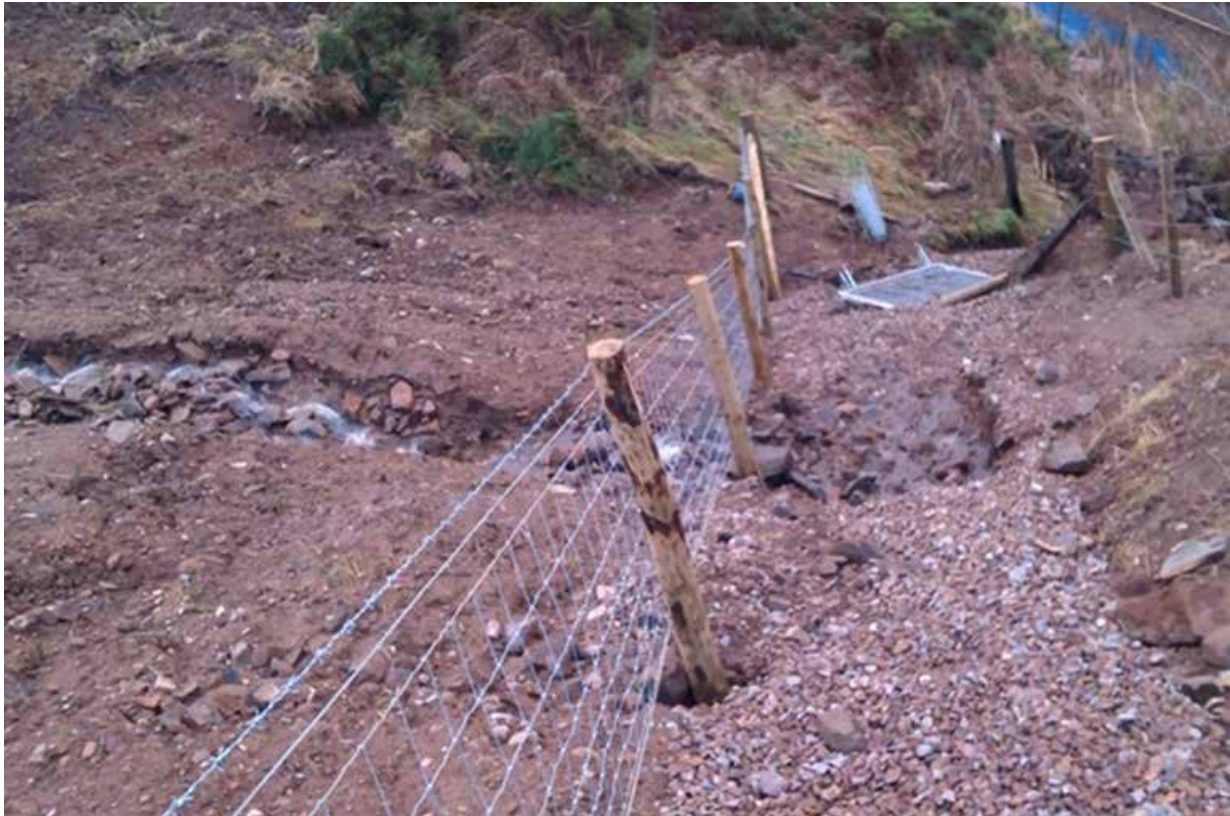
- S21 In December 2012, shortly after the drain was completed, but before the associated fencing work was finished, the landowner visited the sloping section of drain following a period of heavy rain. During this visit, he took a photograph of the steeply sloping section of drain upslope of catchpit 18 showing water flowing from a side channel and slight erosion to the gravel surface of the 2011/12 drain. The landowner stated that he passed this photograph to Carillion or Network Rail. No evidence has been found relating to receipt of the image or action being taken in response to it. It is likely that this erosion was visible when Network Rail and Carillion staff inspected the site in March 2013.

- S22 It is very unlikely that the slight erosion of the gravel surface would have been immediately recognised as a precursor to a sudden washout affecting railway safety. However, this was clear evidence of a problem requiring action such as repair, monitoring and/or reference to the drain designer. This was a missed opportunity to recognise the effect of the bund on water flows.

Figure 52: Surface of drain looking towards CP18 and railway in December 2012, before completion of the fencing (landowner)

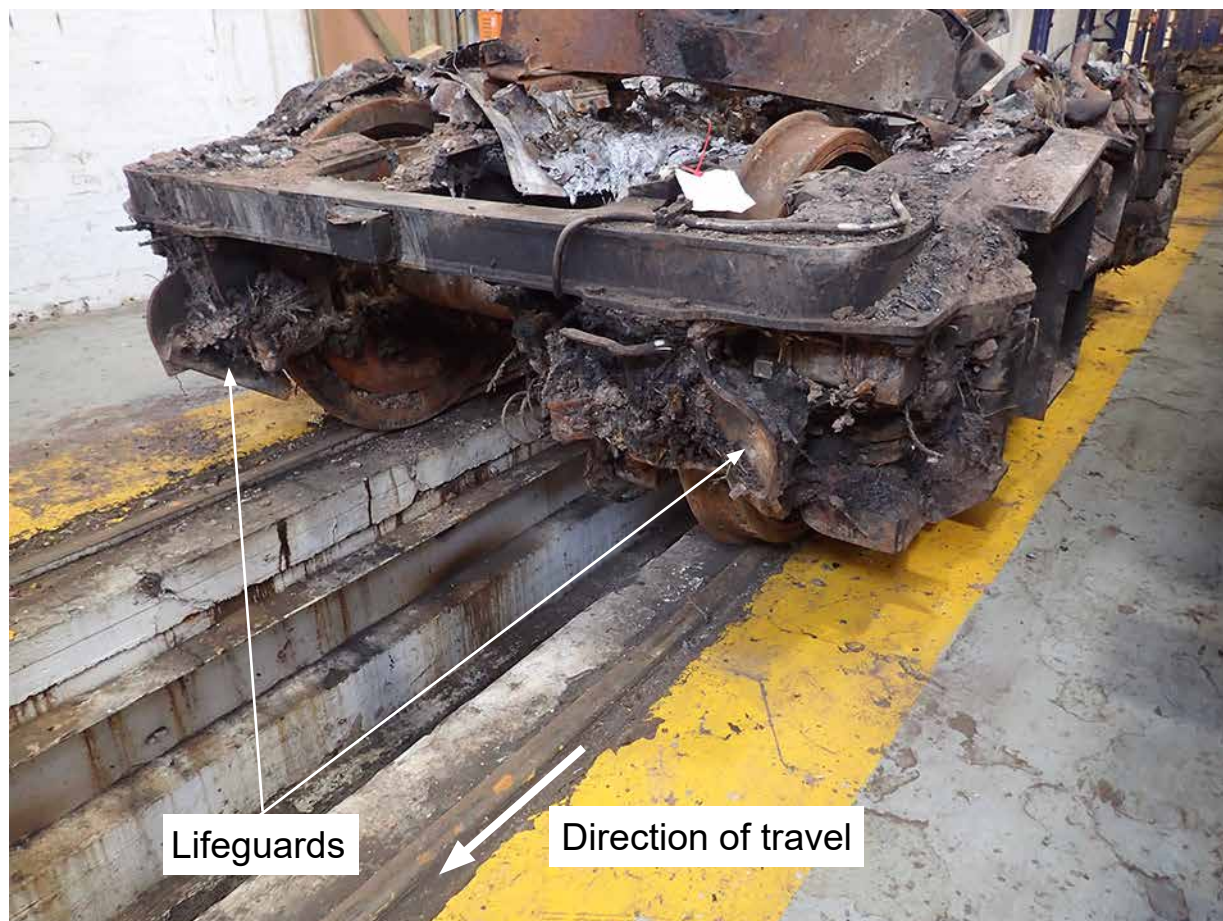
Figure 60: Damaged lifeguards on the leading bogie of the leading power car

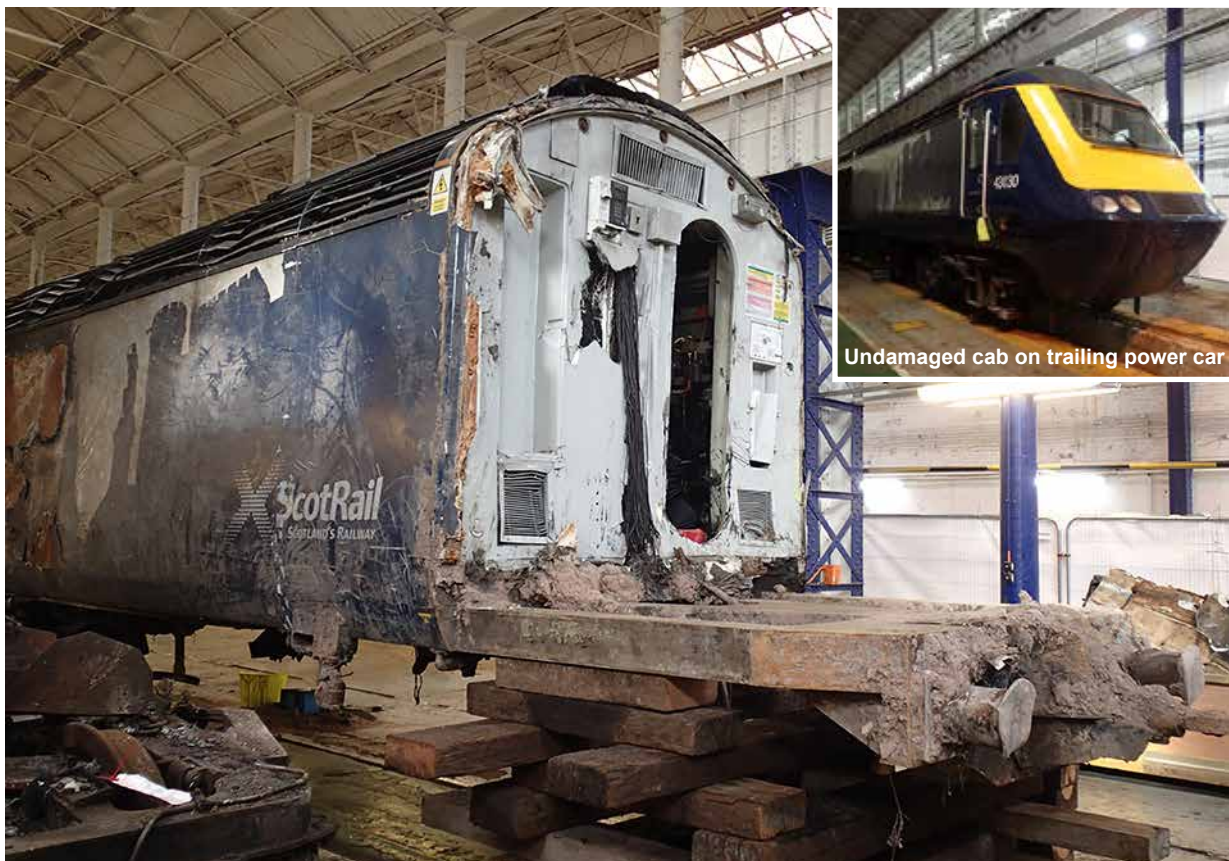
Figure 72: Front of leading power car (cab became detached during accident)

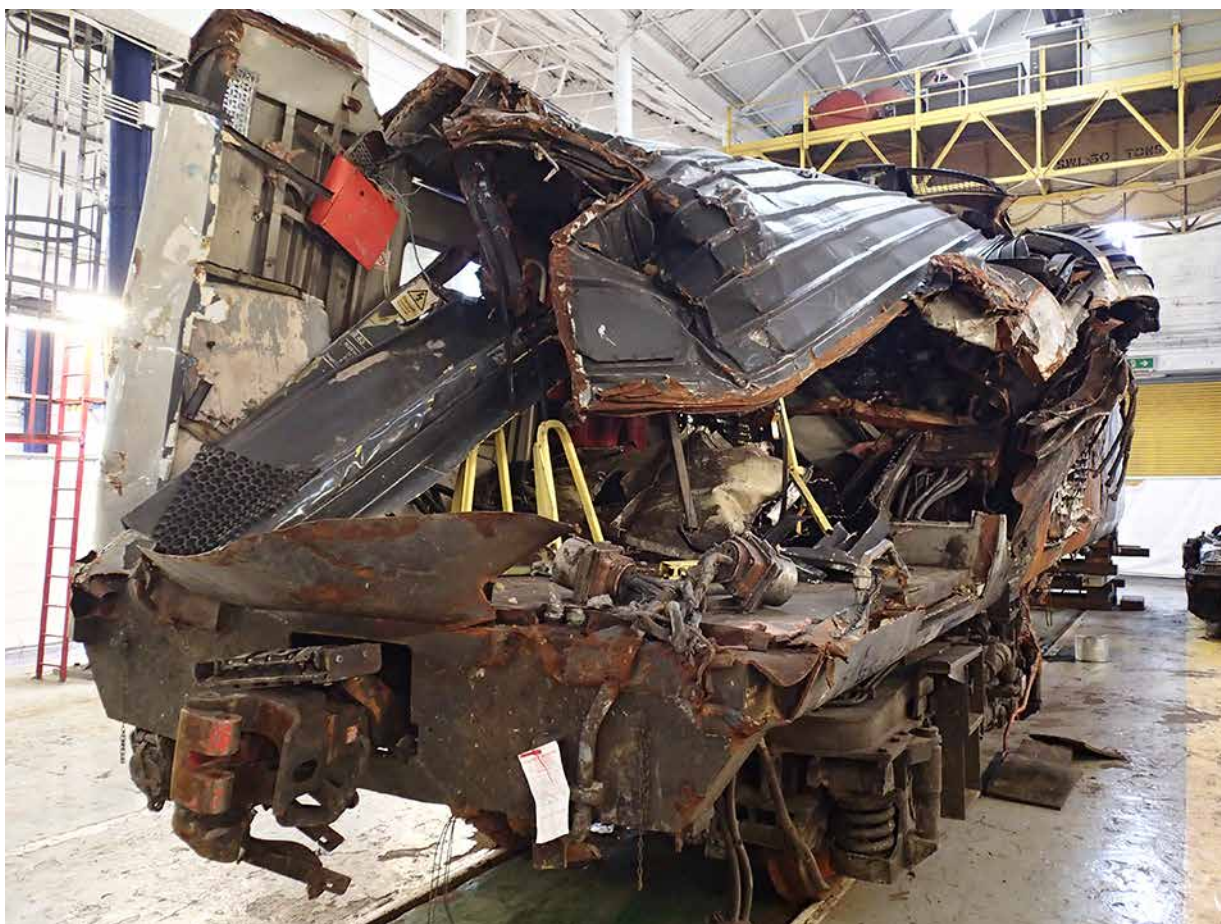
Figure 73: Damage to rear of leading power car

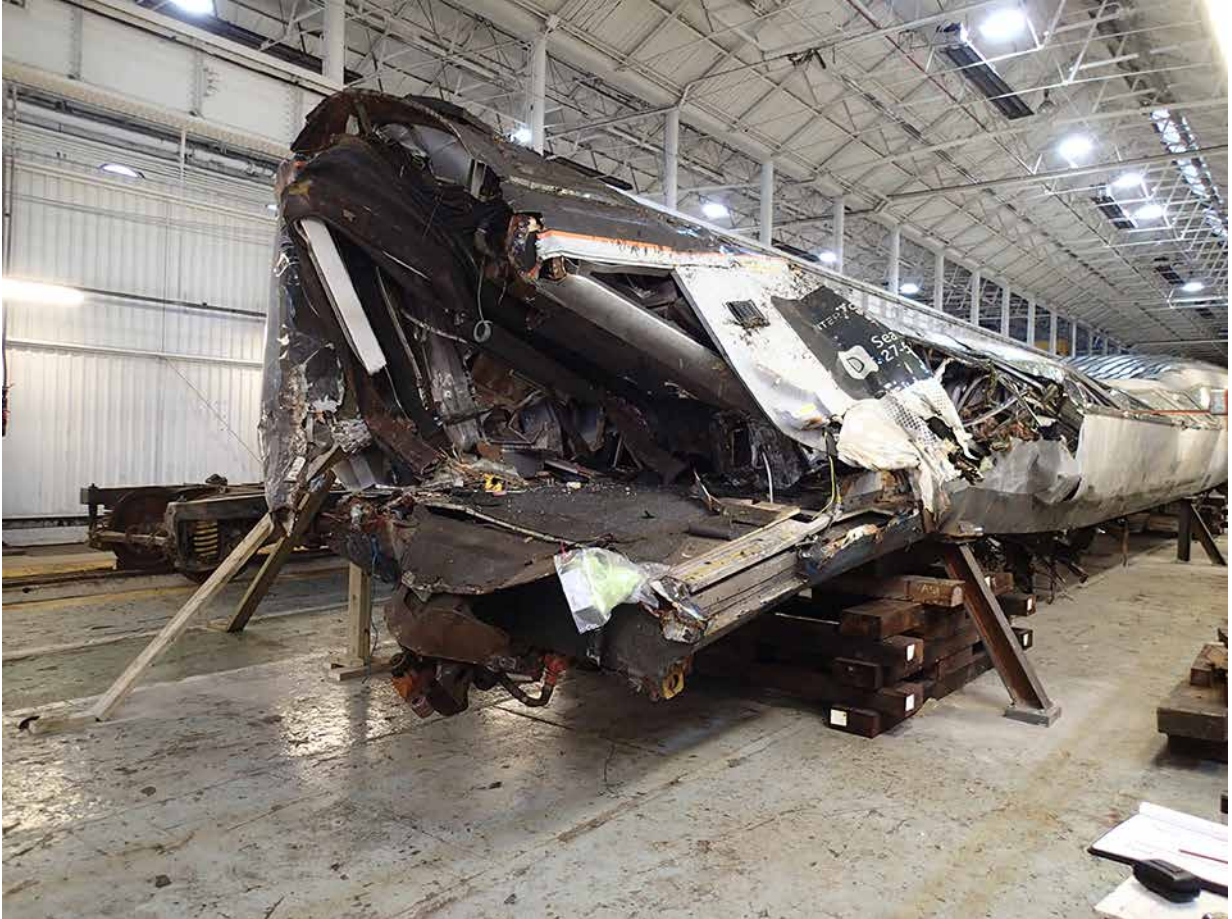
Figure 74: Damage to leading end of coach D

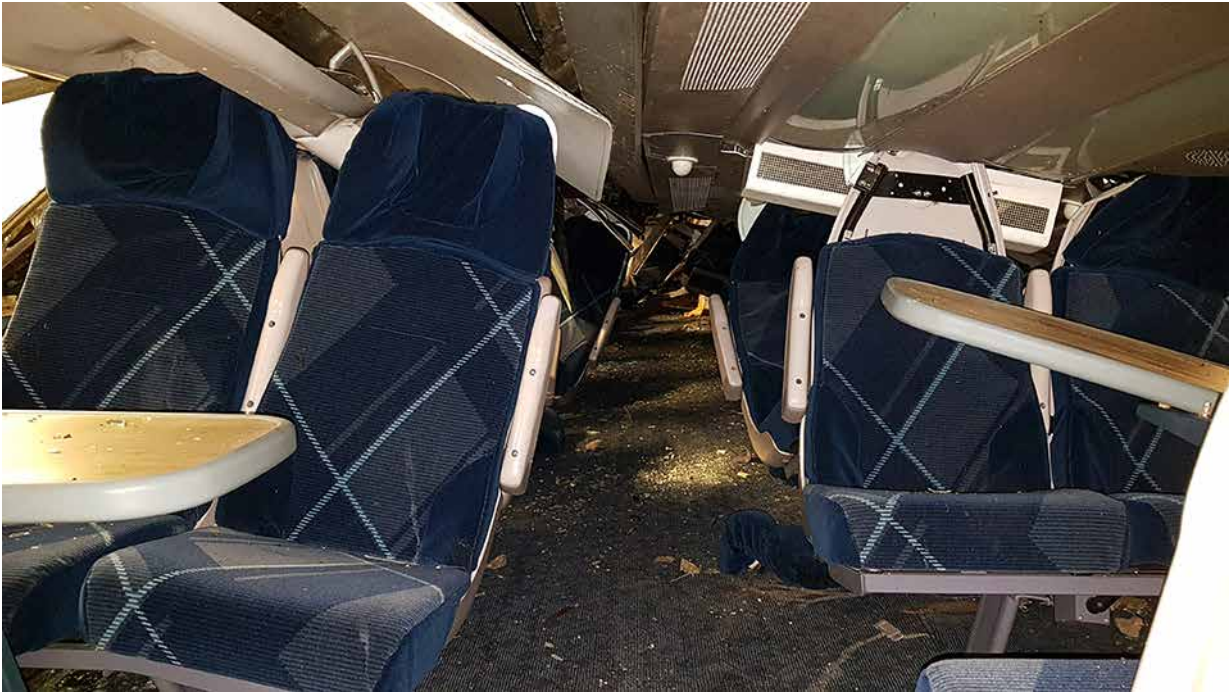
Figure 75: Interior damage at leading end of coach D

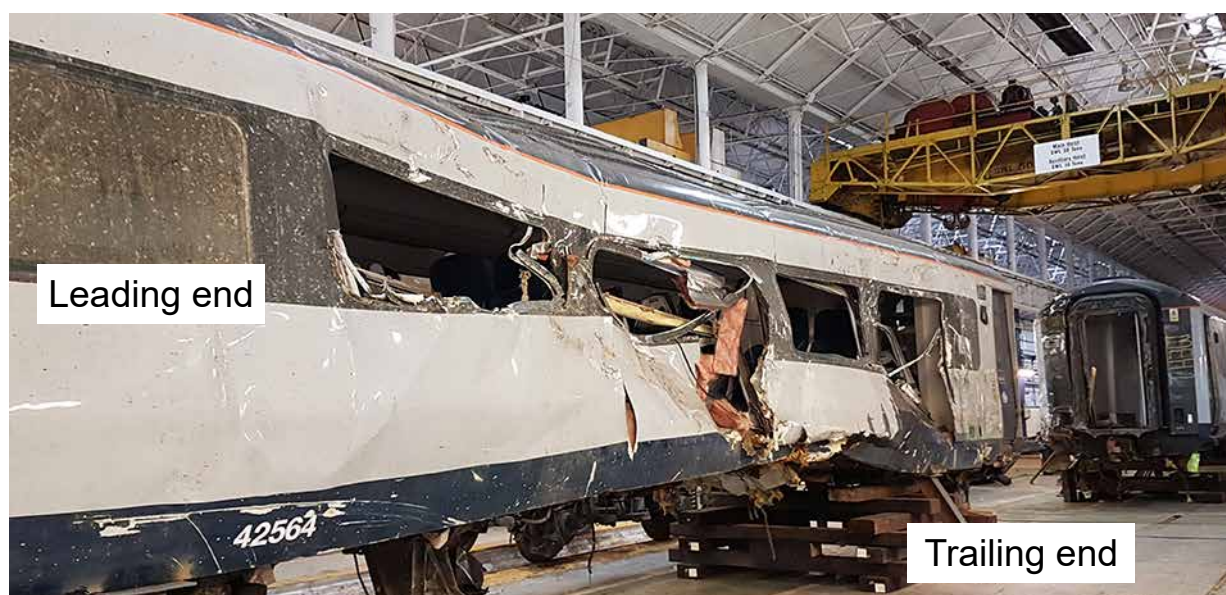
Figure 77: Penetration damage at trailing end of coach C (left side)

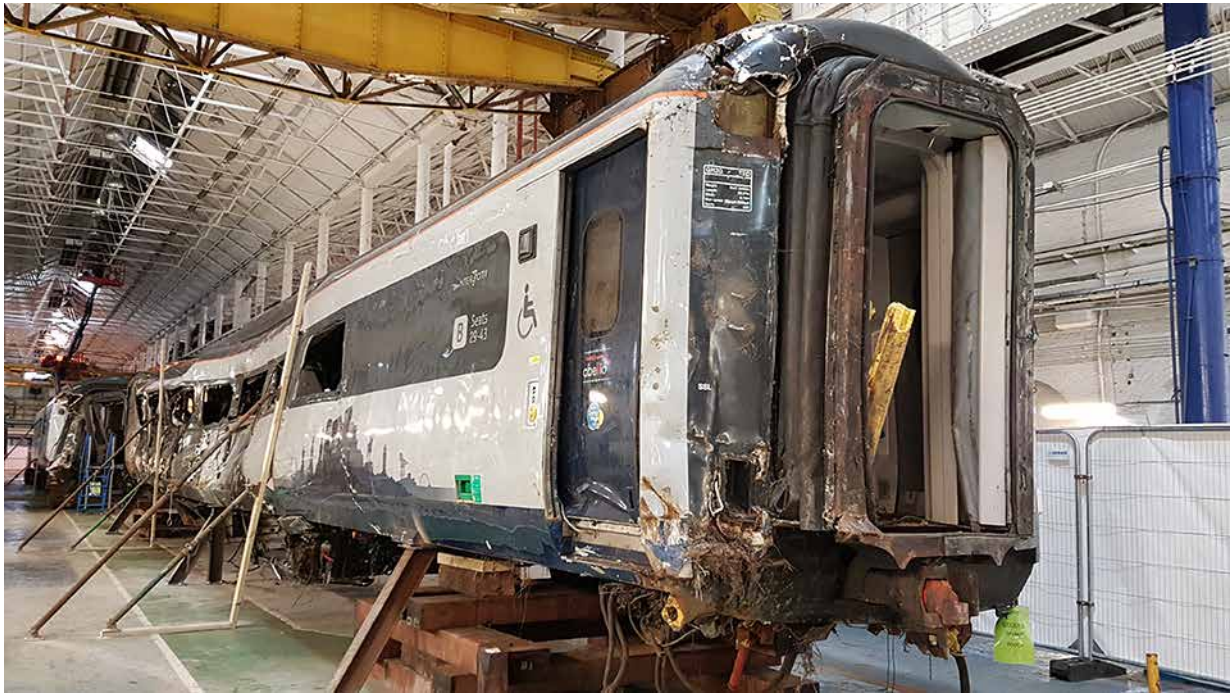
Figure 78: Damage to leading end and right side of coach B

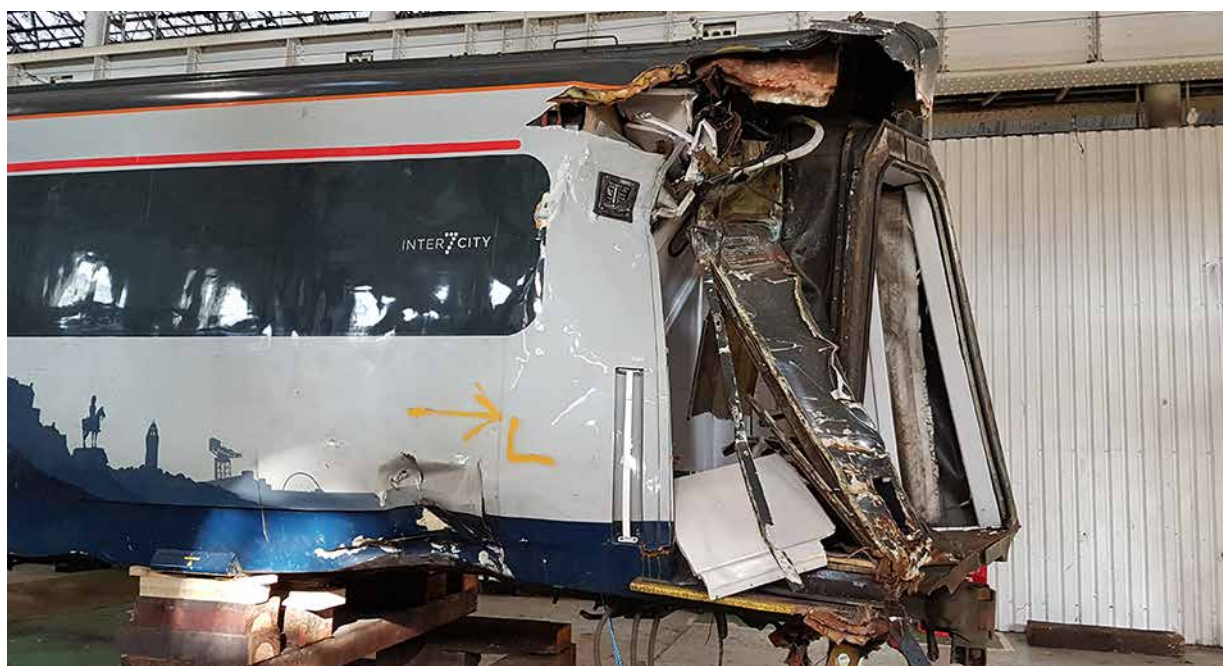
Figure 79: Damage to leading end of coach A

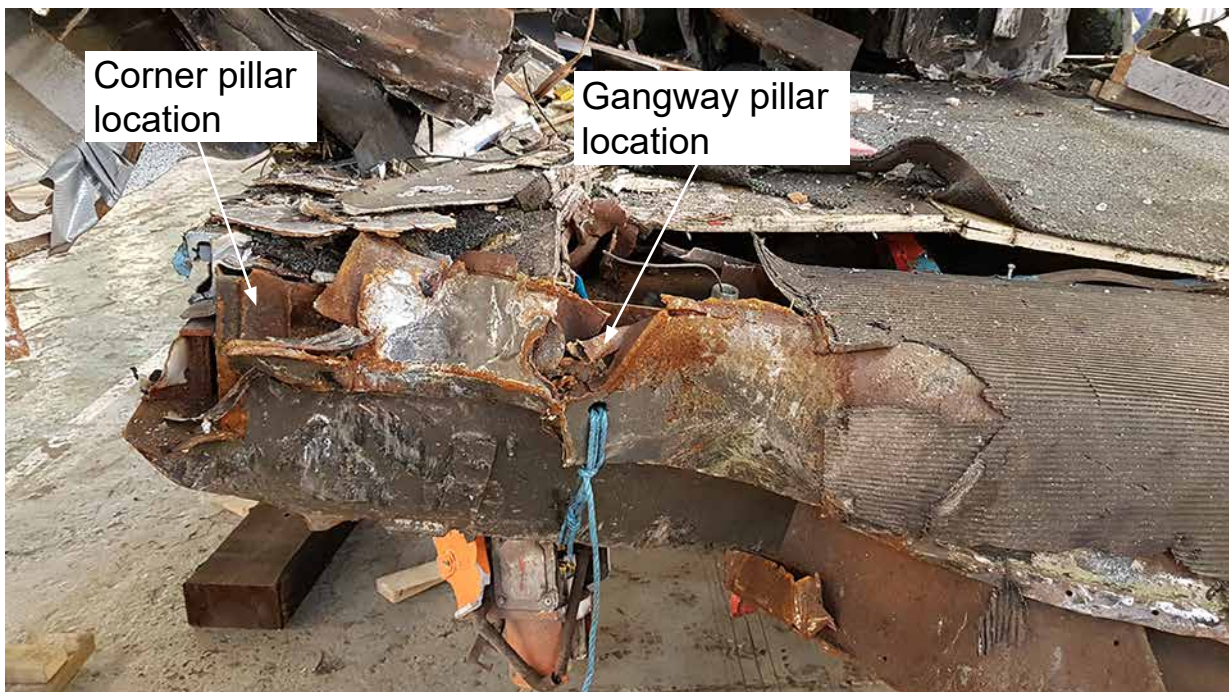
Figure 80: Corrosion on coach D at leading right-hand side of underframe at pillar locations

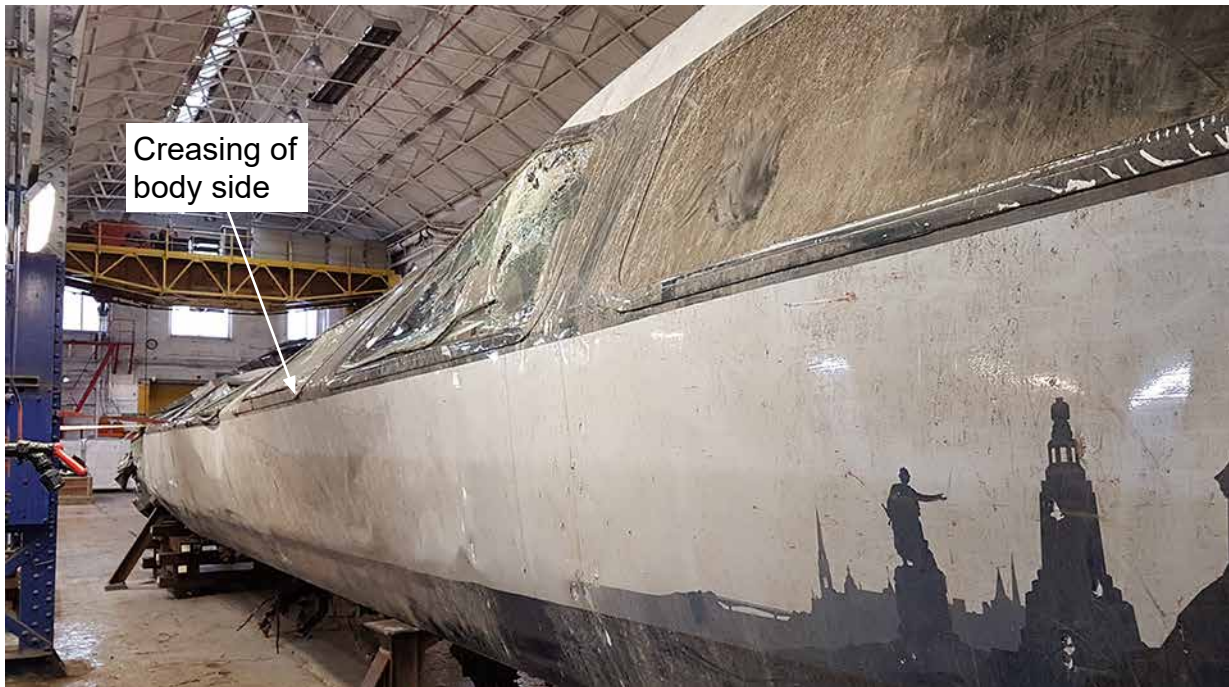
Figure 81: Creasing along left-hand bodyside of coach D

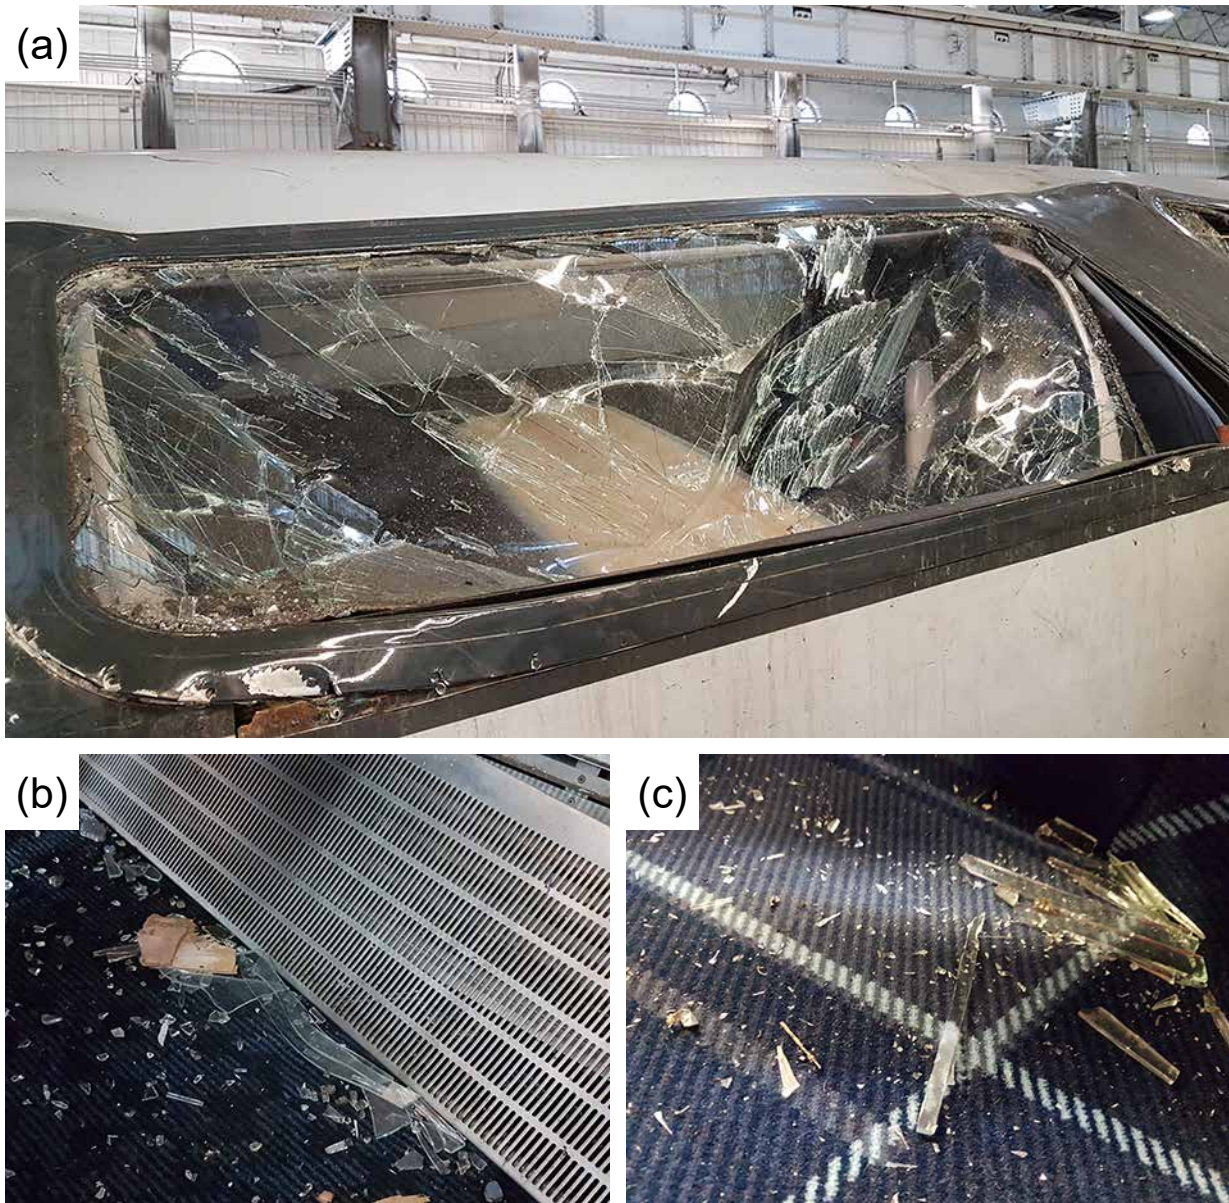
Figure 85: A broken window on coach D with remnants of inner laminated pane (a), ingress of large shards on the floor (b) and on a seat (c)

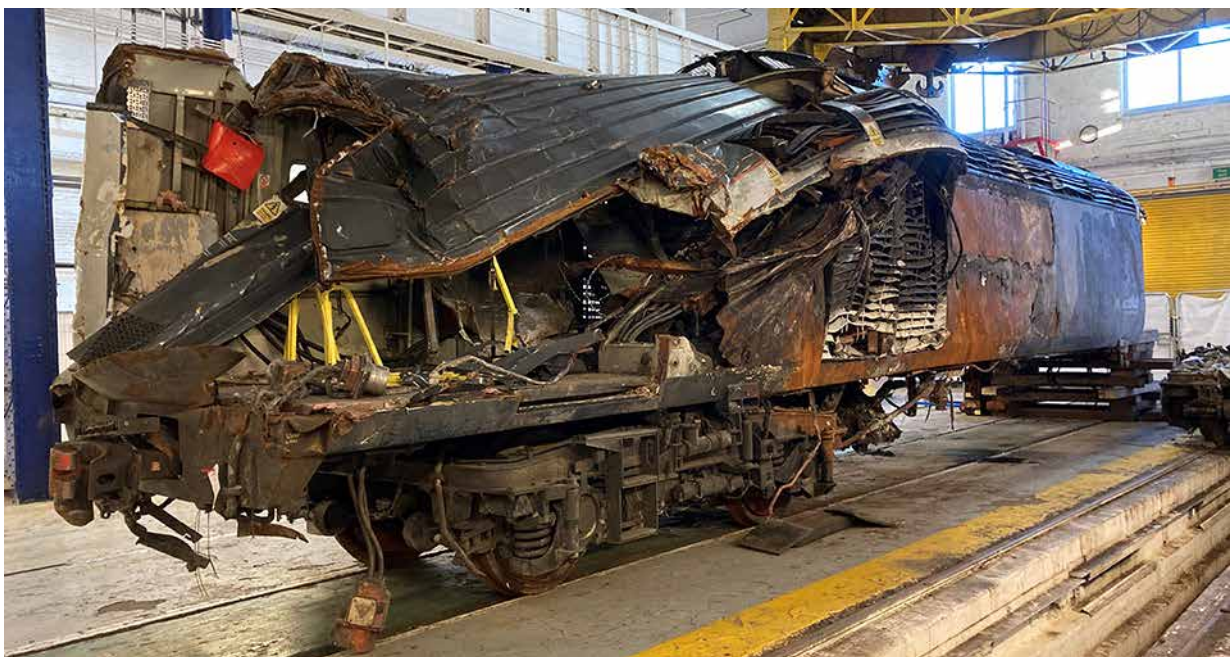
Figure 87: Fire-damaged leading power car
