Rail Accident Investigation Branch

# Rail Accident Report

**Derailement of a passenger train at Carmont,  
Aberdeenshire  
12 August 2020**

Report 02/2022  
March 2022

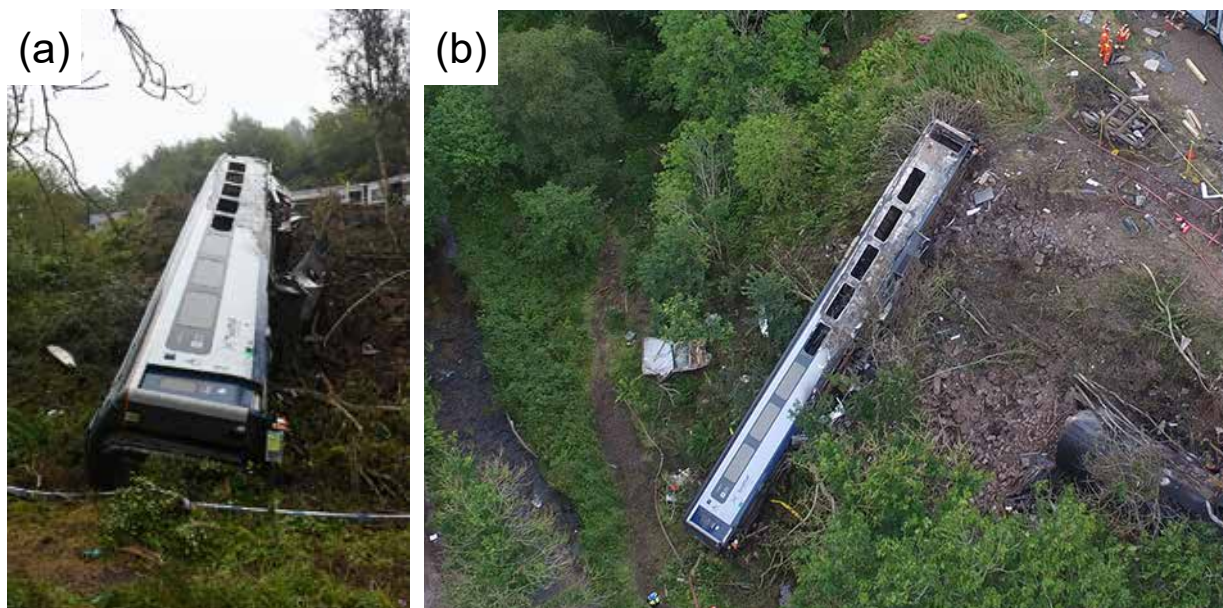
Figure 91: Coach B showing fire damage viewed (a) from bottom of embankment and (b) from overhead

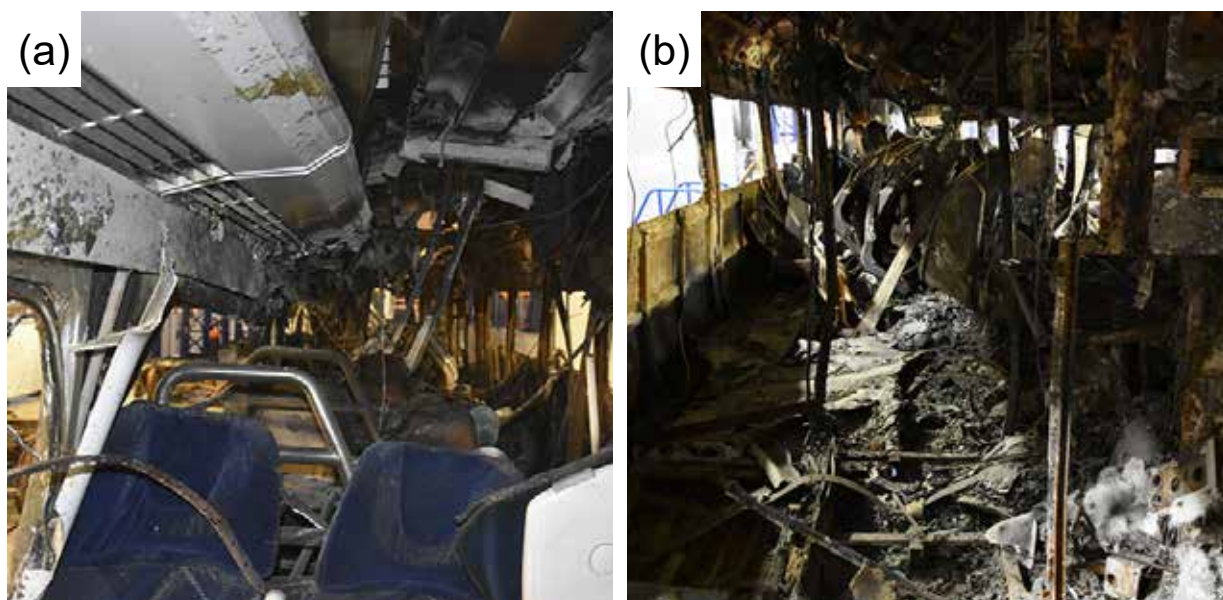
Figure 92: Coach B interior without fire damage at leading end (a) and fire damaged at trailing end (b)

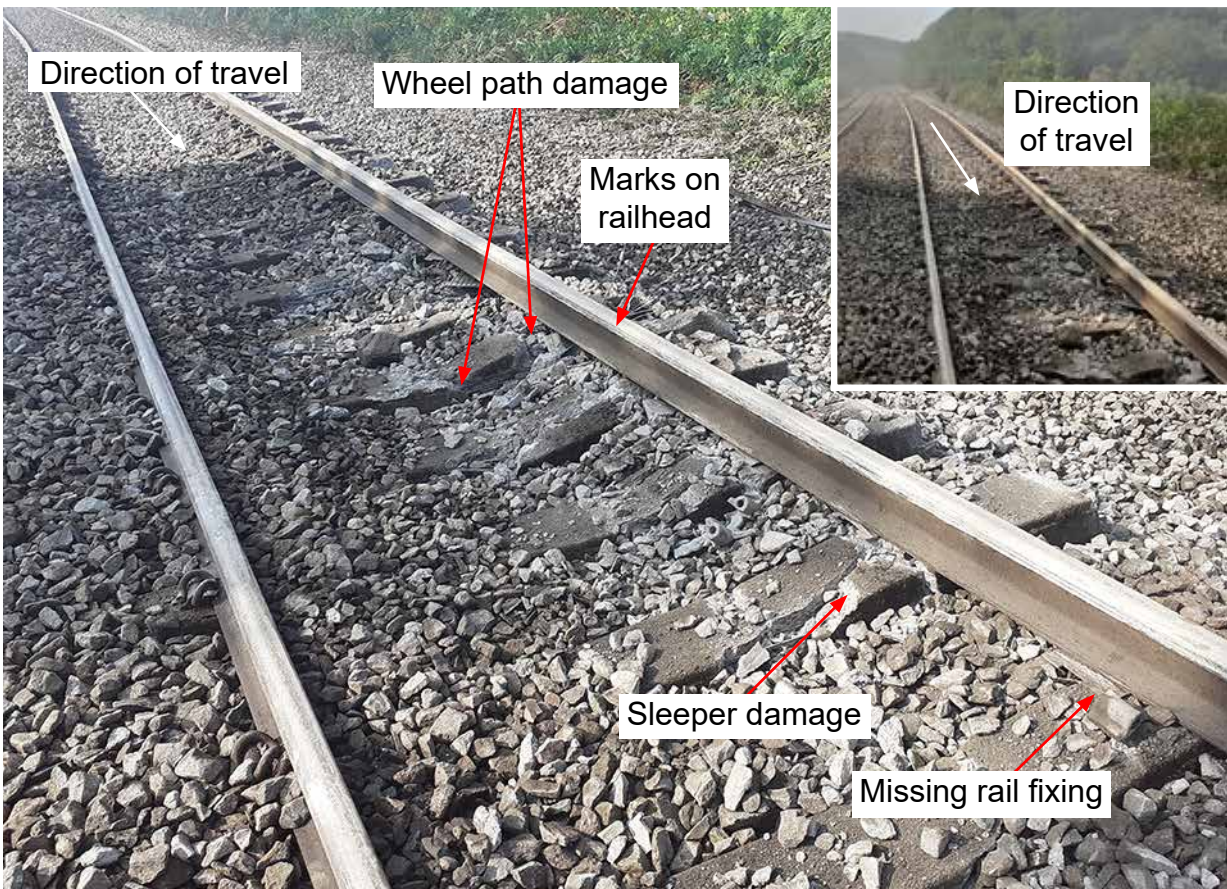
Figure F.1: Track damage looking south from sleeper 80 back towards washout location at 10:35 hrs on 12 August 2020 (Story Contracting)

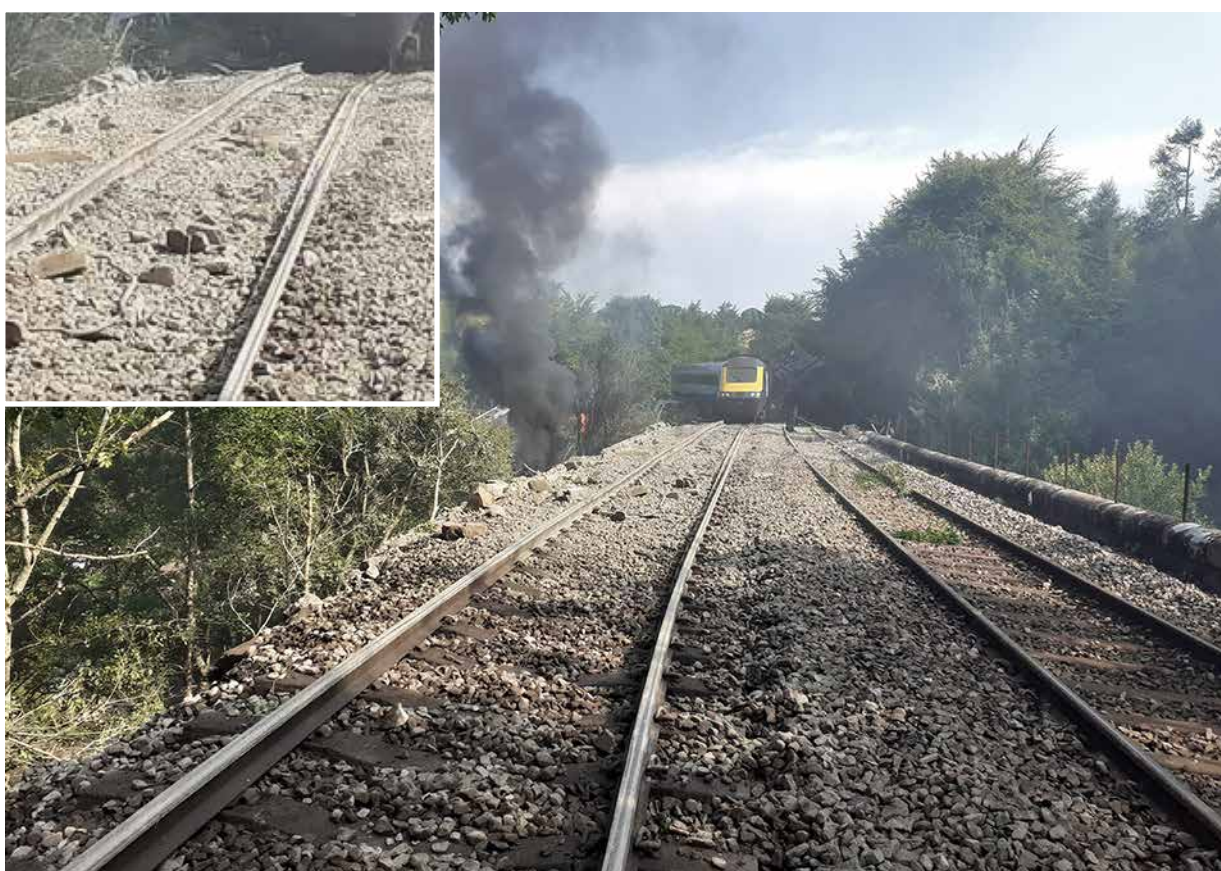
Figure F.2: Track damage across bridge 325 at 10:35 hrs on 12 August 2020 (Story Contracting)

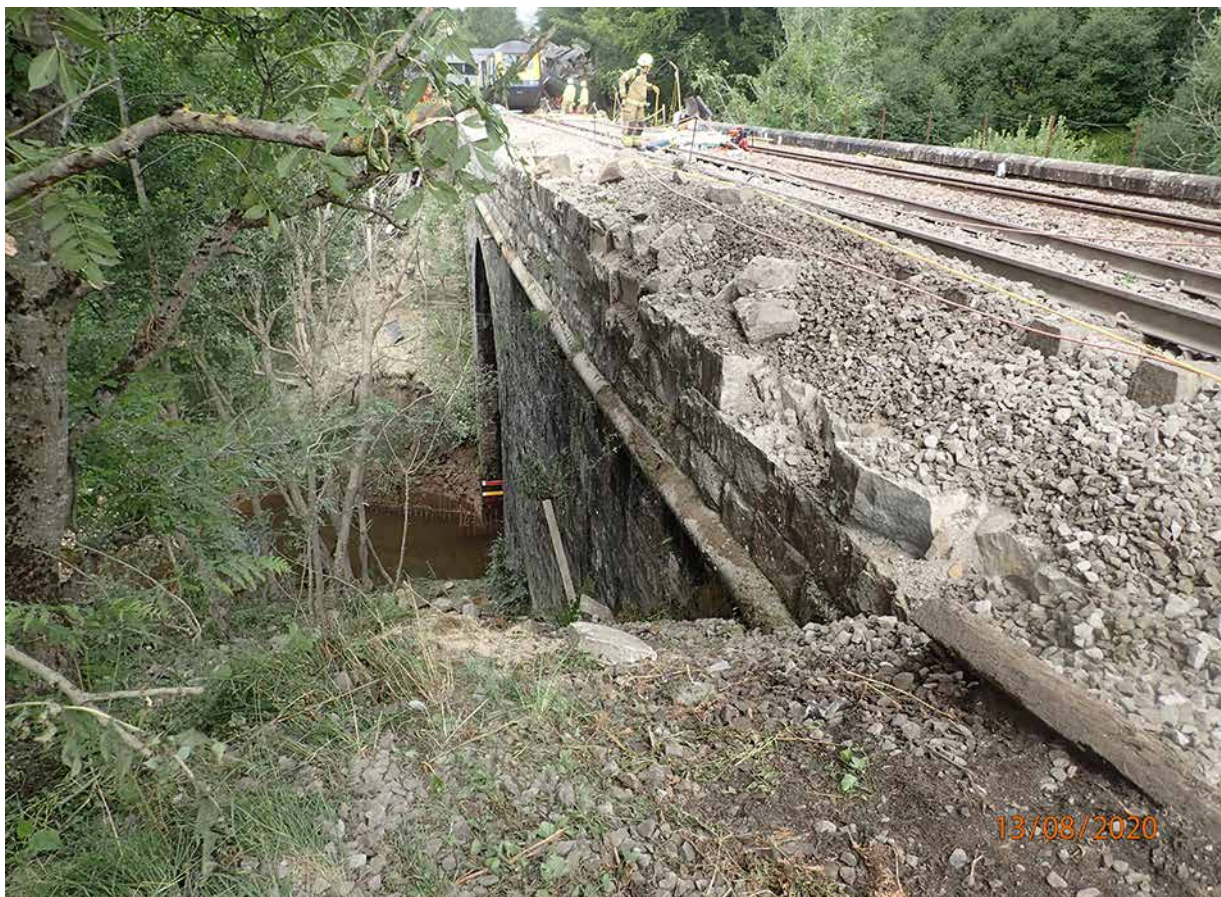
Figure F.5: Down-side parapet looking north showing damage to the parapet end

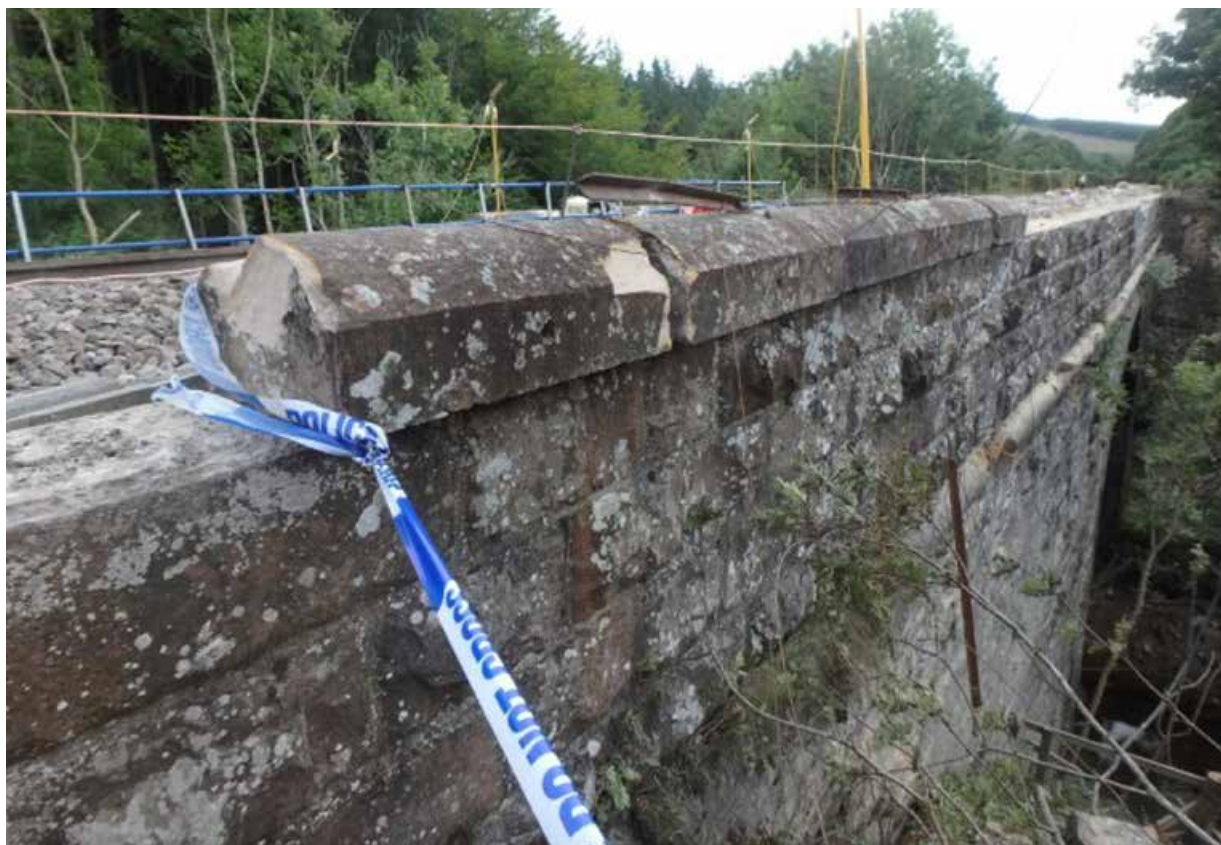
Figure F.6: Down-side parapet looking south showing remaining coping stones (Amey)

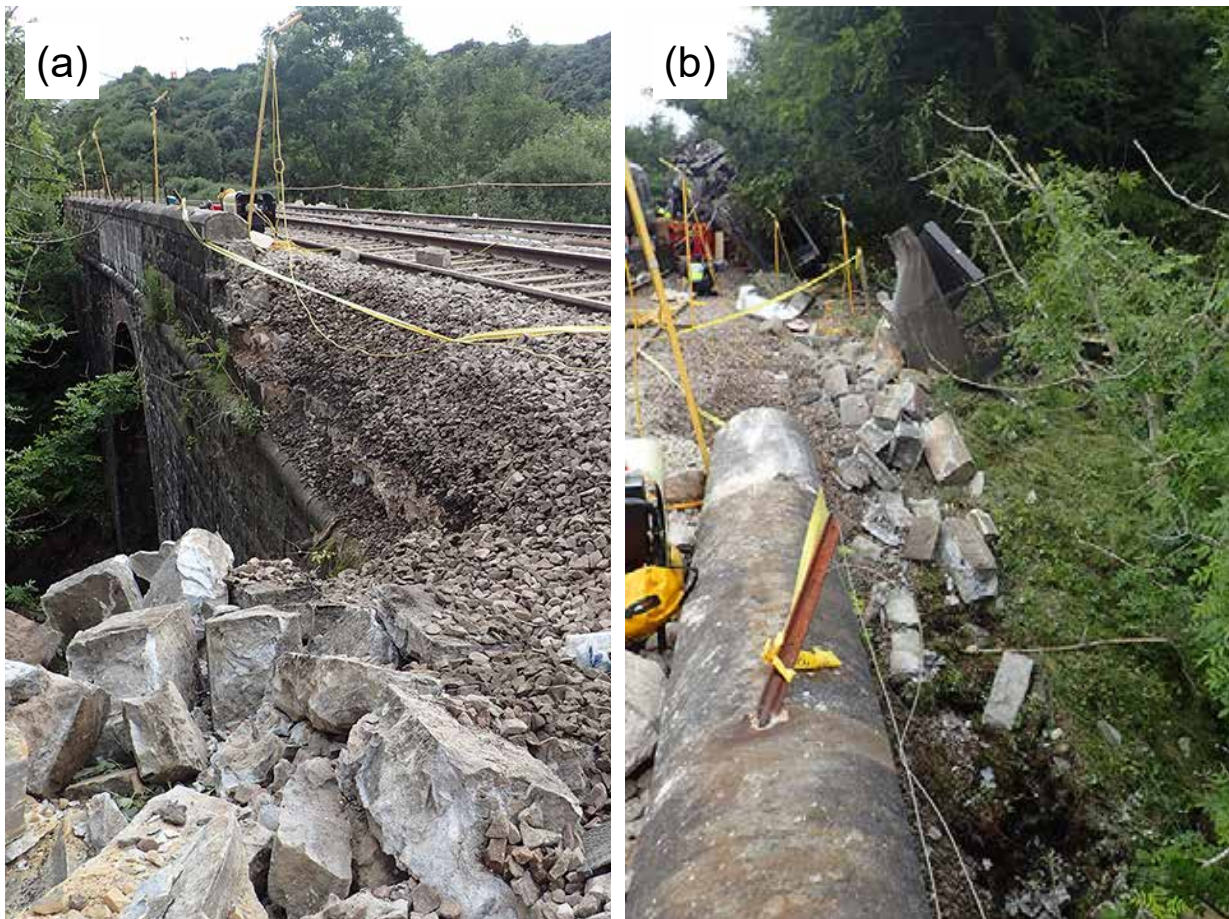
Figure F.8: Up-side parapet damage (a) looking south and (b) looking north

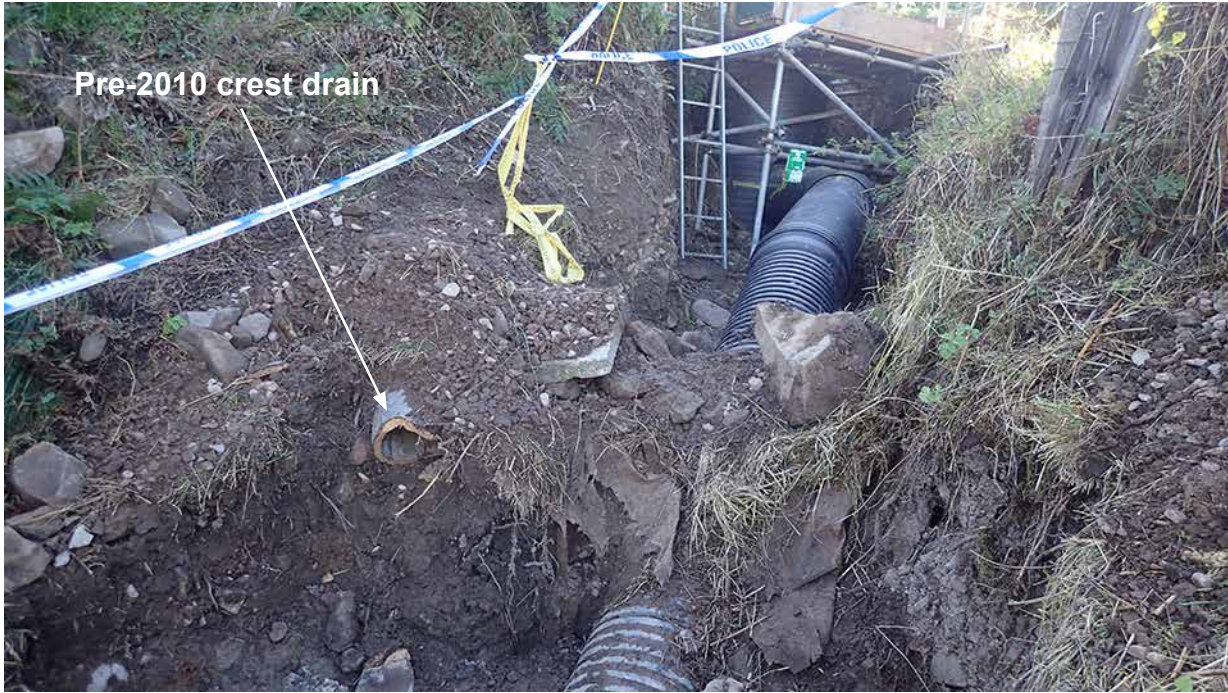
Figure G.4: Image looking upslope from near CP19 towards CP18 showing damaged end of pre-2010 crest drain close to the as-designed position of CP18. Photograph taken during post-accident investigations with scaffolding over as-built position of CP18 visible in background

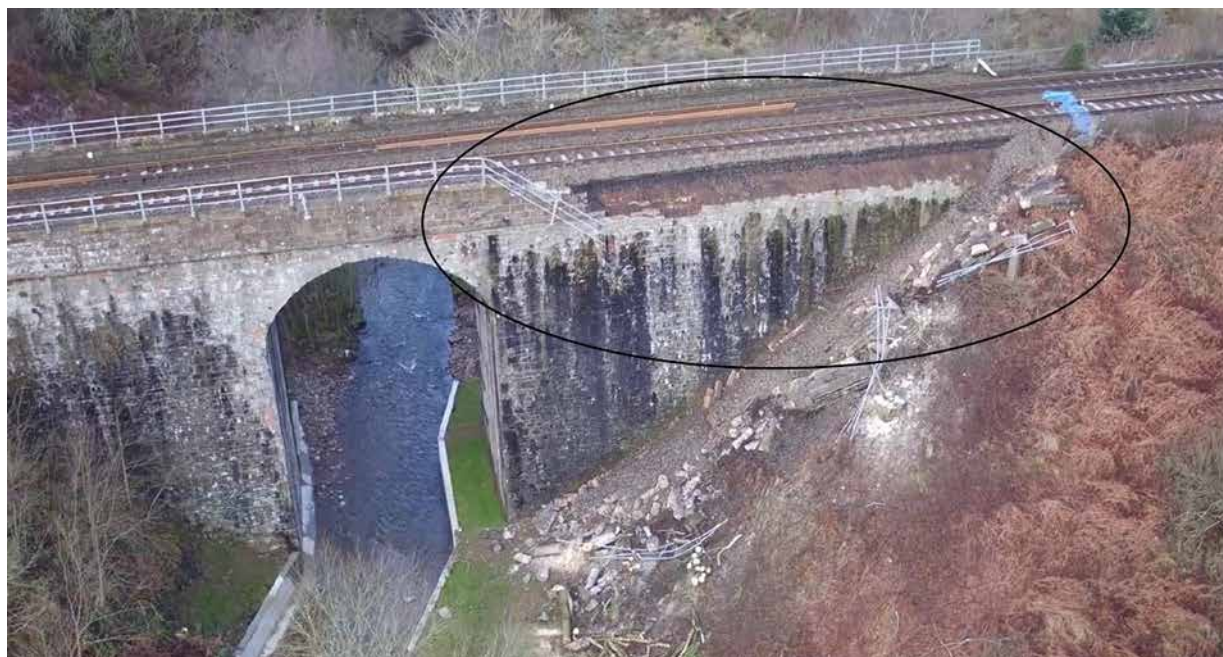
Figure M.1: South-east corner of bridge 328 following the failure of part of its parapet wall on 15 January 2021 (Network Rail)
