Rail Accident Investigation Branch

# Rail Accident Report

**Derailement of a passenger train at Carmont,  
Aberdeenshire  
12 August 2020**

Report 02/2022  
March 2022

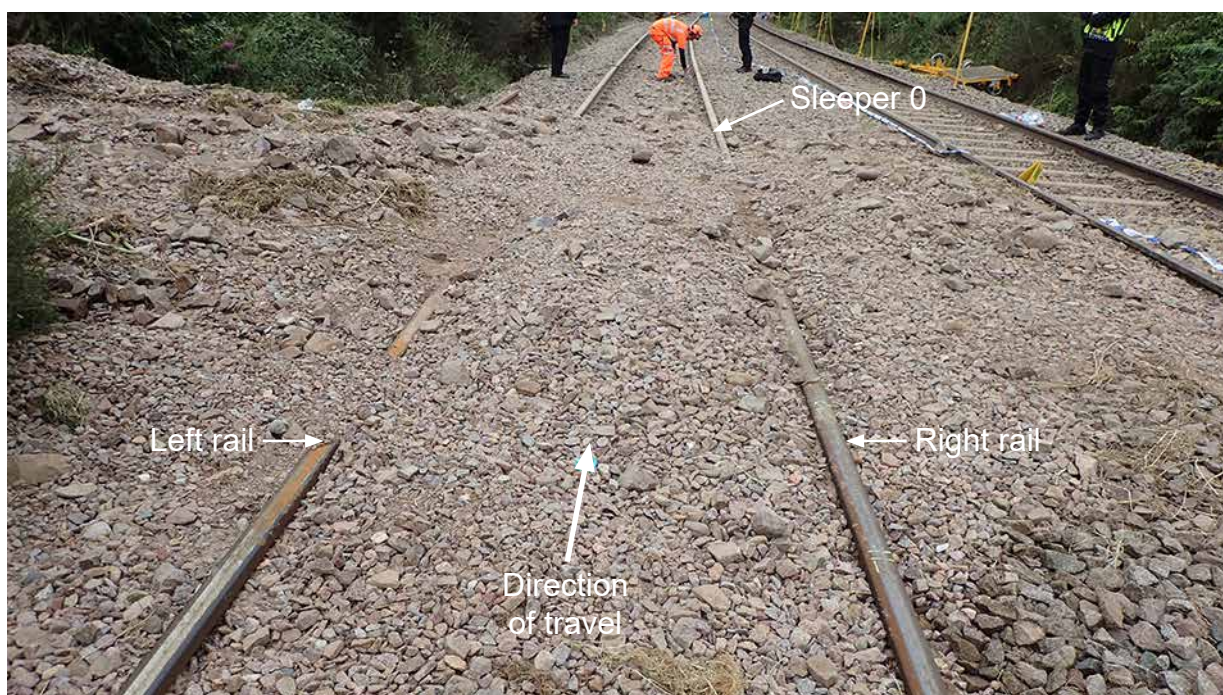
- S4 Train 1T08 derailed because it struck debris washed out from a 15 metre length of steeply sloping drainage trench. This is evidenced by CCTV images from the train, grooves cut through the debris, the absence of derailment marks on the track on the approach to the debris and marks indicating that the leading wheelset had derailed immediately after the debris field.
- S5 The debris mainly comprised gravel with some cobbles and covered the down line for a length of about 10 metres. Estimates made by RAIB after the derailment indicate the maximum depth of debris on the left and right railheads was probably around 170 mm and 135 mm respectively before the train ran through it.

*Washout debris covering the track*

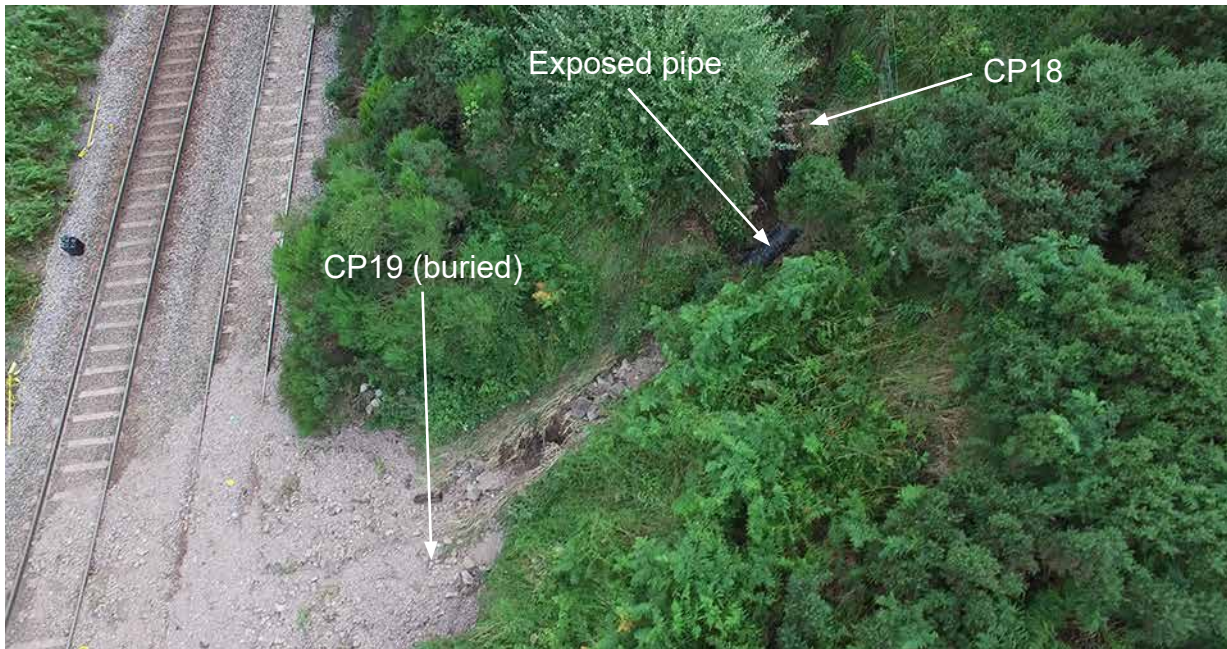
S12 The trench which contained the drainage pipe was filled with gravel (mainly between 20 mm and 40 mm in size) in accordance with normal practice for french drains. However, the use of this gravel in such a steeply sloping trench increased the likelihood of it being washed away should the water reach the drain as a concentrated flow.

*The washout (locations marked 'CP' are catchpits)*

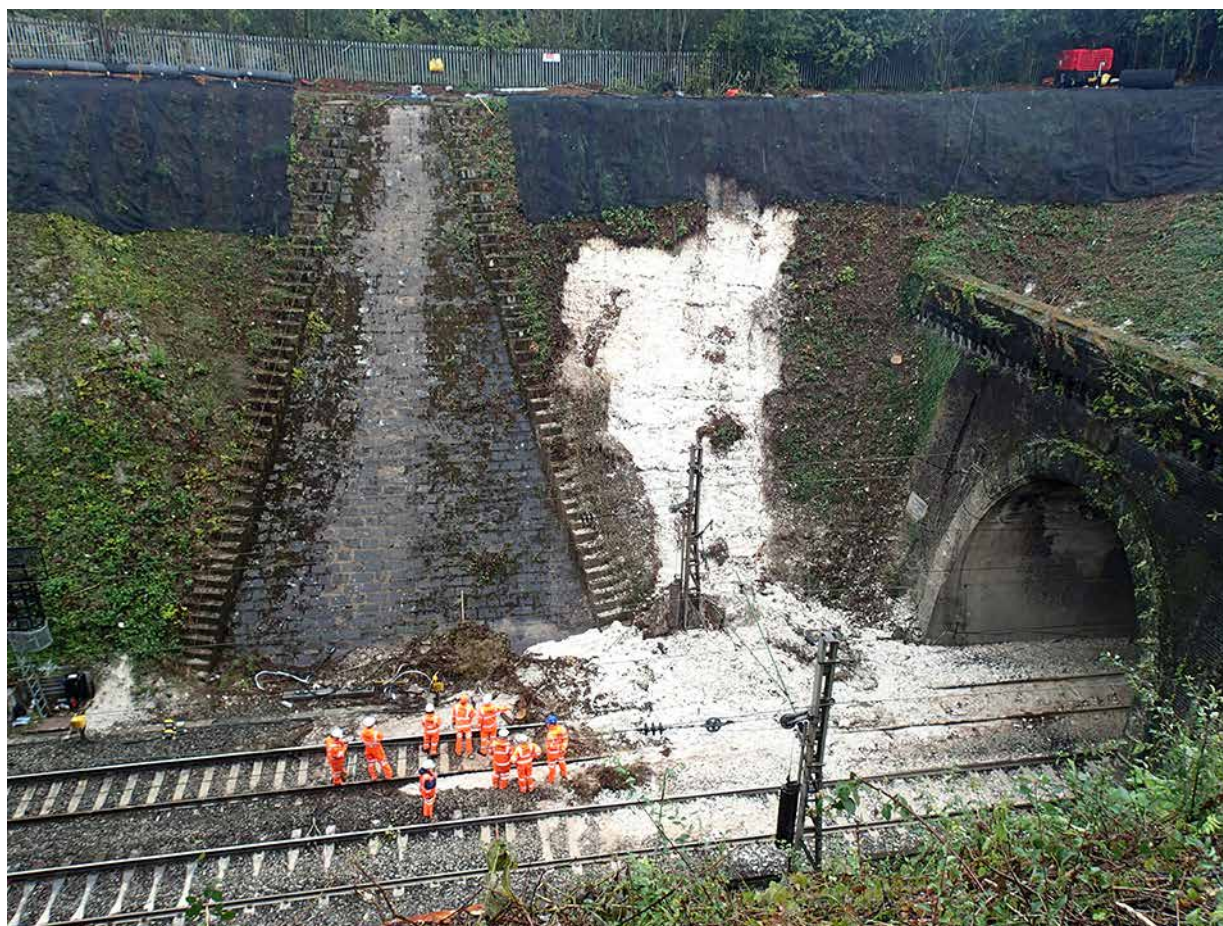
*The landslip at Watford tunnel, September 2016*

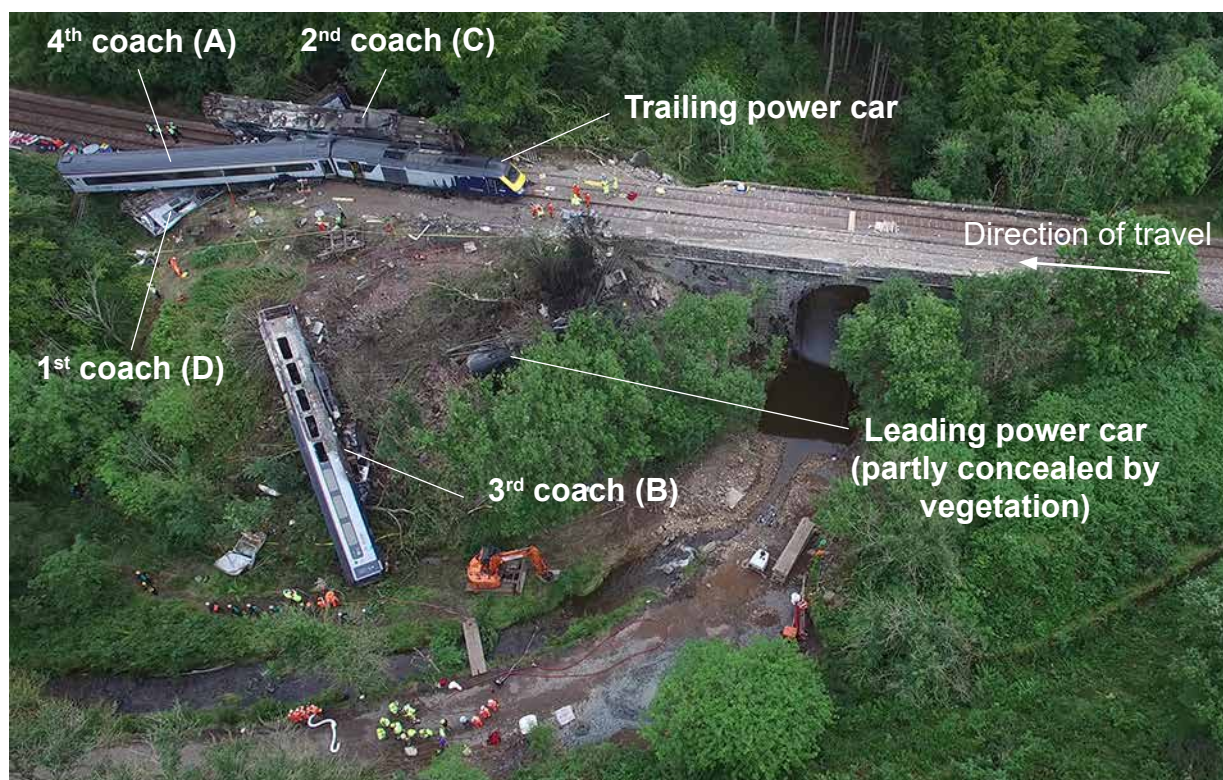
*The derailed train*

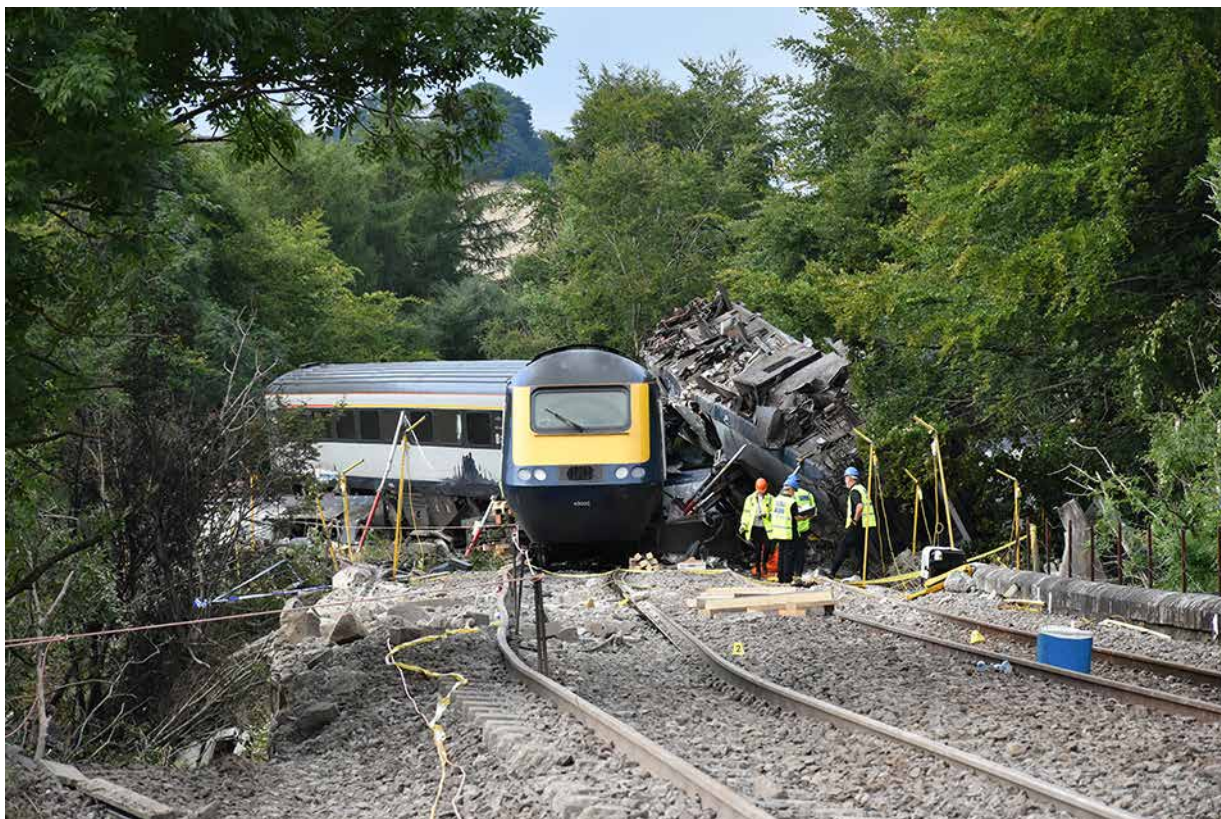
- 5 At around 09:37 hrs on Wednesday 12 August 2020, a passenger train collided with debris washed from a drain onto the track near Carmont, Aberdeenshire, following heavy rainfall (figure 1). The train (*train reporting number* 1T08) was the 06:38 hrs service from Aberdeen to Glasgow which was returning towards Aberdeen because the line to the south was blocked by a landslide.
- 6 The collision caused the train to derail and deviate to the left, before striking a bridge *parapet* which caused the vehicles to scatter. Three people died as a result of the accident: the driver, the *conductor* and a passenger. The other six people on the train were injured. There was catastrophic damage to the train, and significant damage to railway infrastructure (figure 2).

Figure 2: The aftermath of the accident (image taken on 13 August 2020)

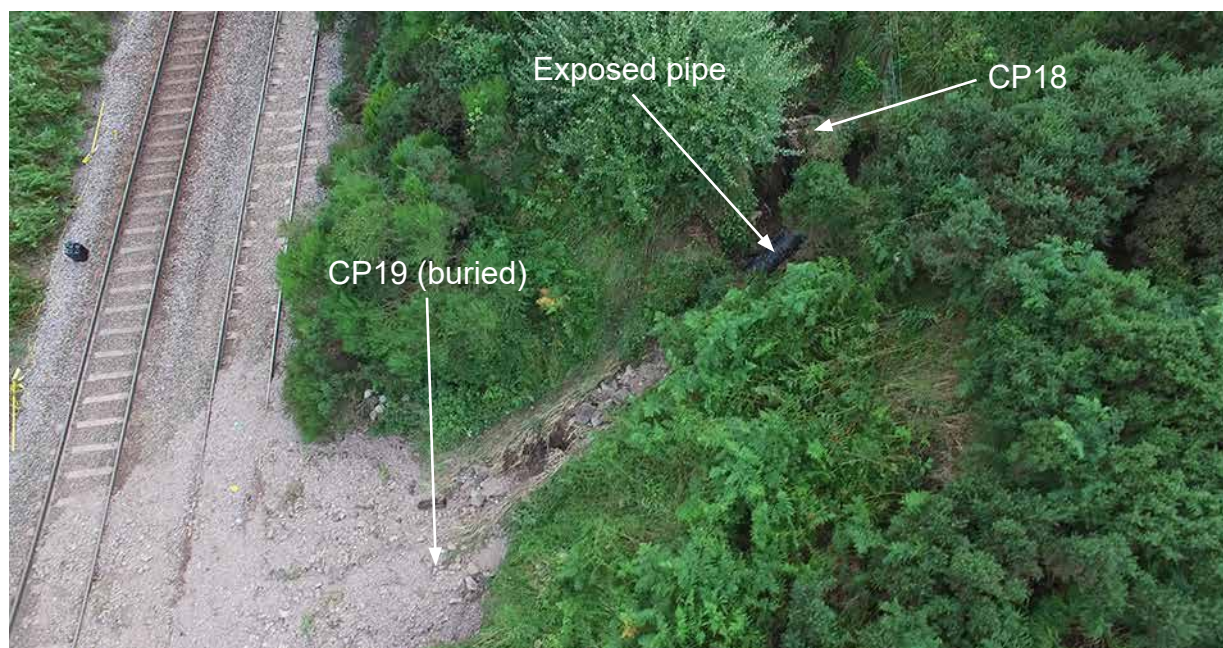
Figure 4: Washout debris on the track

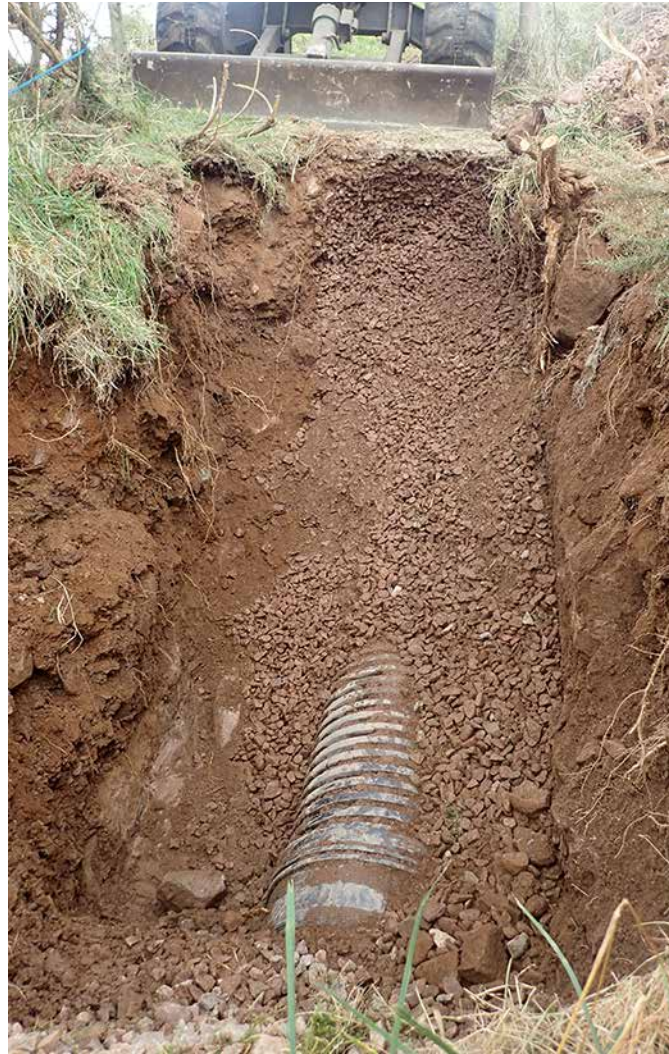
Figure 8: Gravel-filled drain close to washed out areas as exposed during post-accident excavations

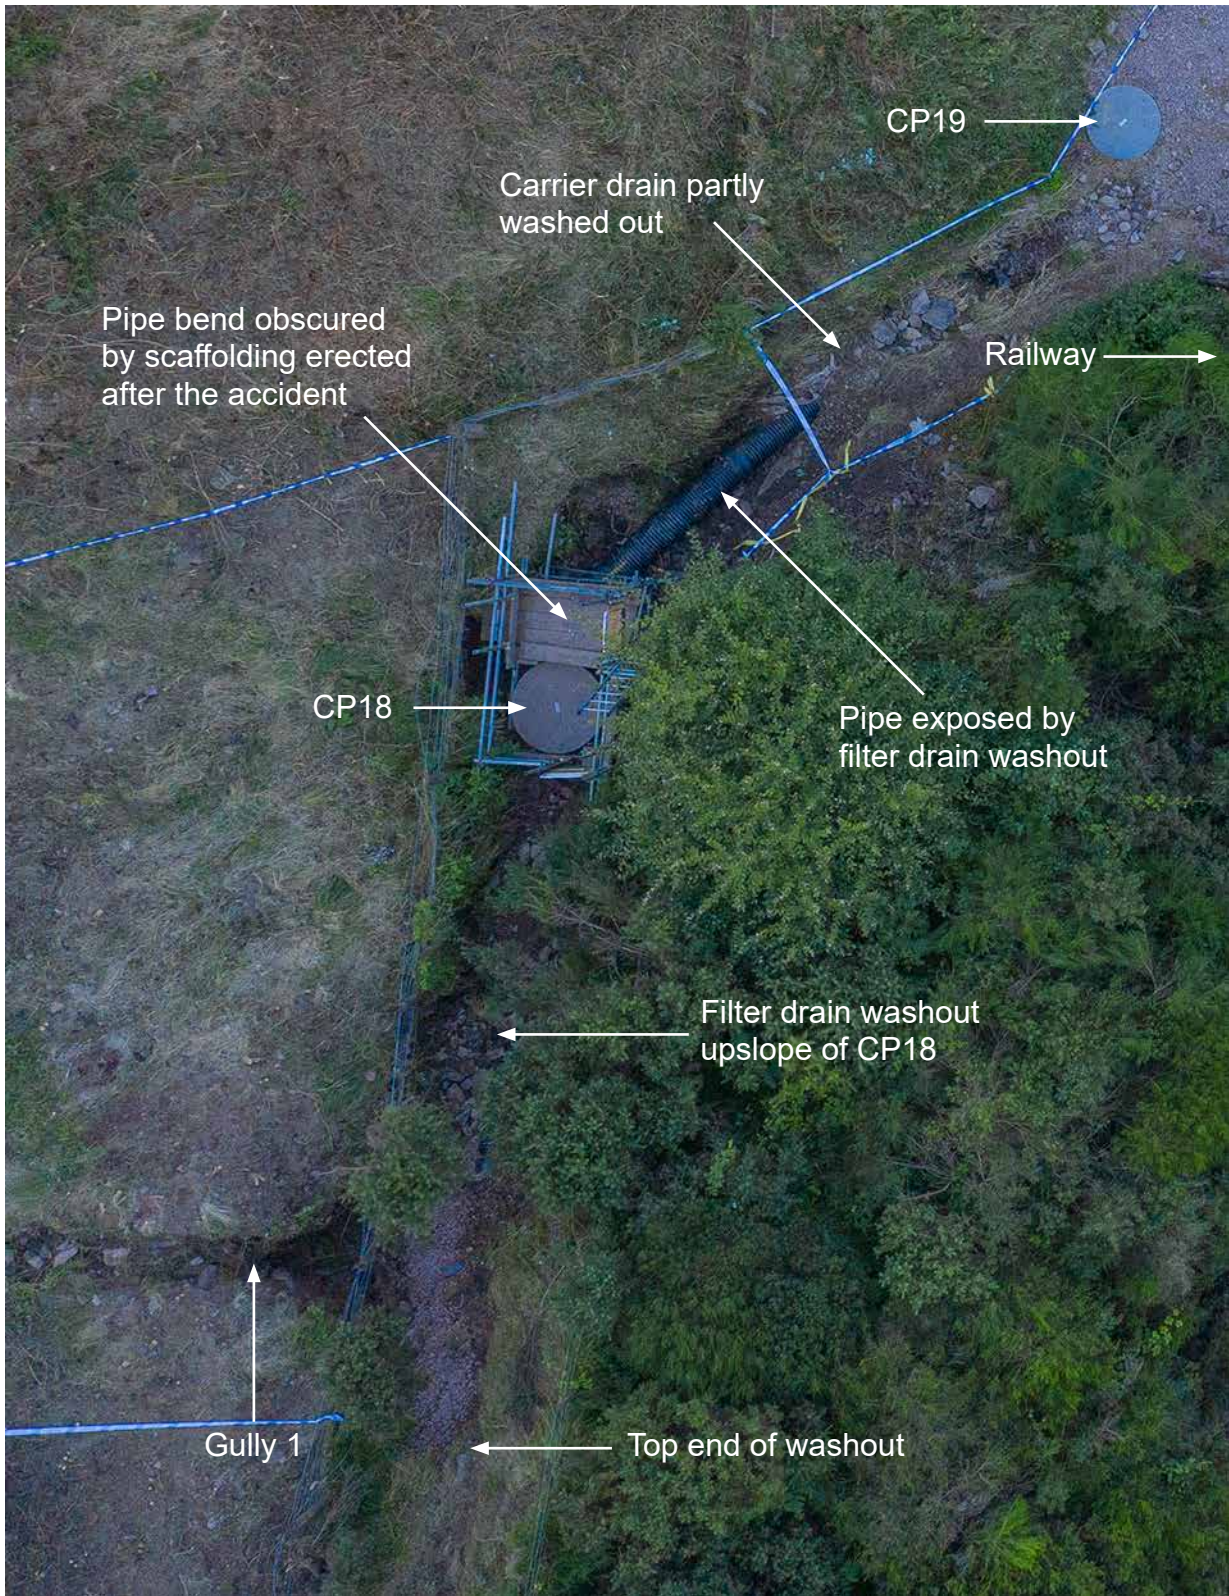
Figure 17: Aerial view of CP18 showing extent of washout

- The gravel-filled 2011/12 drain had washed out for a distance of about 9 metres upslope of CP18 and for the full 6 metre length of gravel-filled drain downslope of this catchpit. Most of the material surrounding the carrier drain upslope of CP19 had remained in place. The drainage pipe in the bottom of the trench was partly exposed but was undamaged and continued to carry water (figures 17, 18 and 30).

- f) The top end of the washout of the 2011/12 drain was about 2 metres upstream of the point where gully 1 met this drain (figure 17), and there was no evidence of the drain being damaged by water flows above this point. Limited regression upstream of gully 1 would be expected as the gravel would not be stable with a vertical face, and eddying of inflowing water would cause some erosion just upstream of the point of entry into the drain.

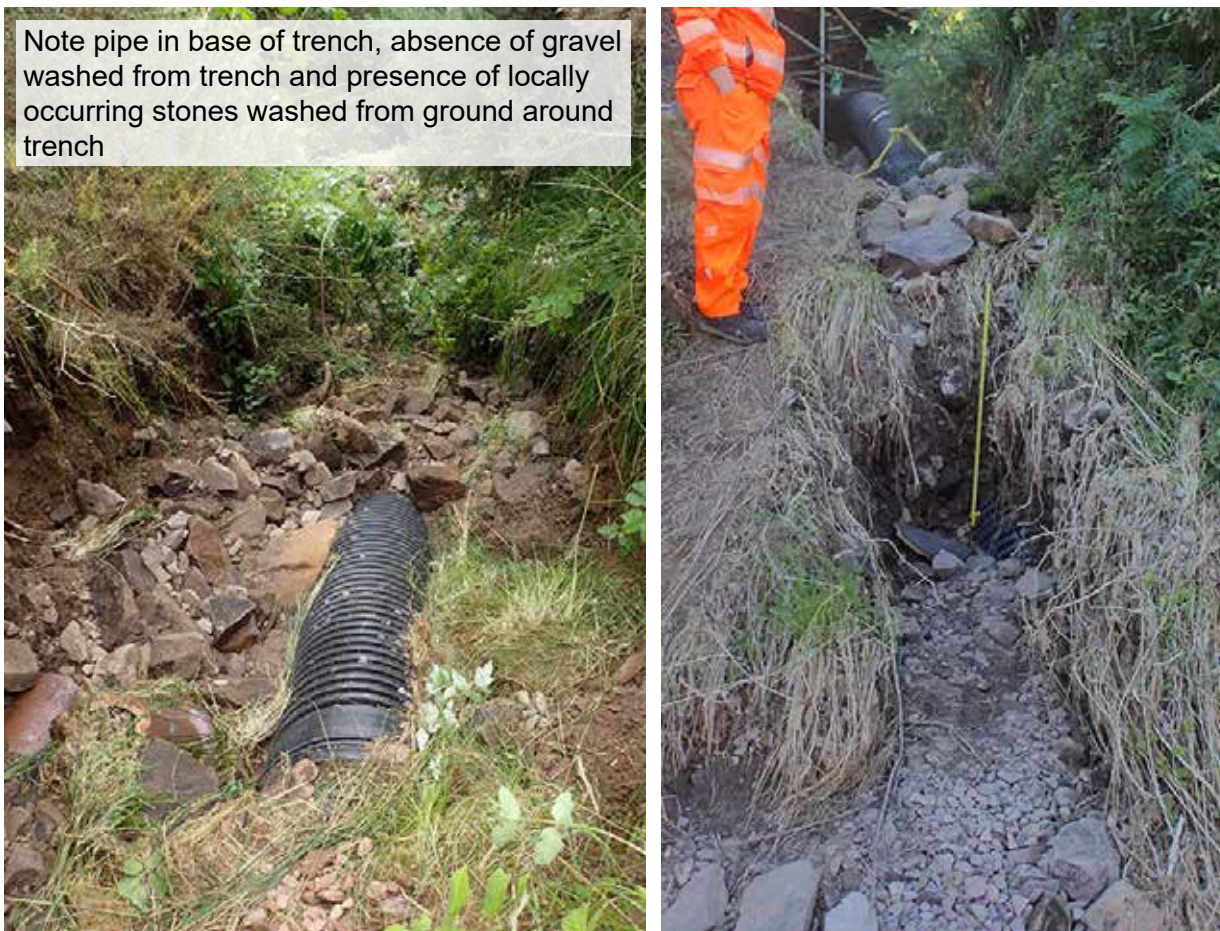
Figure 18: Washout upslope of CP18 (left image) and partial washout downslope of CP18, both images facing towards CP18

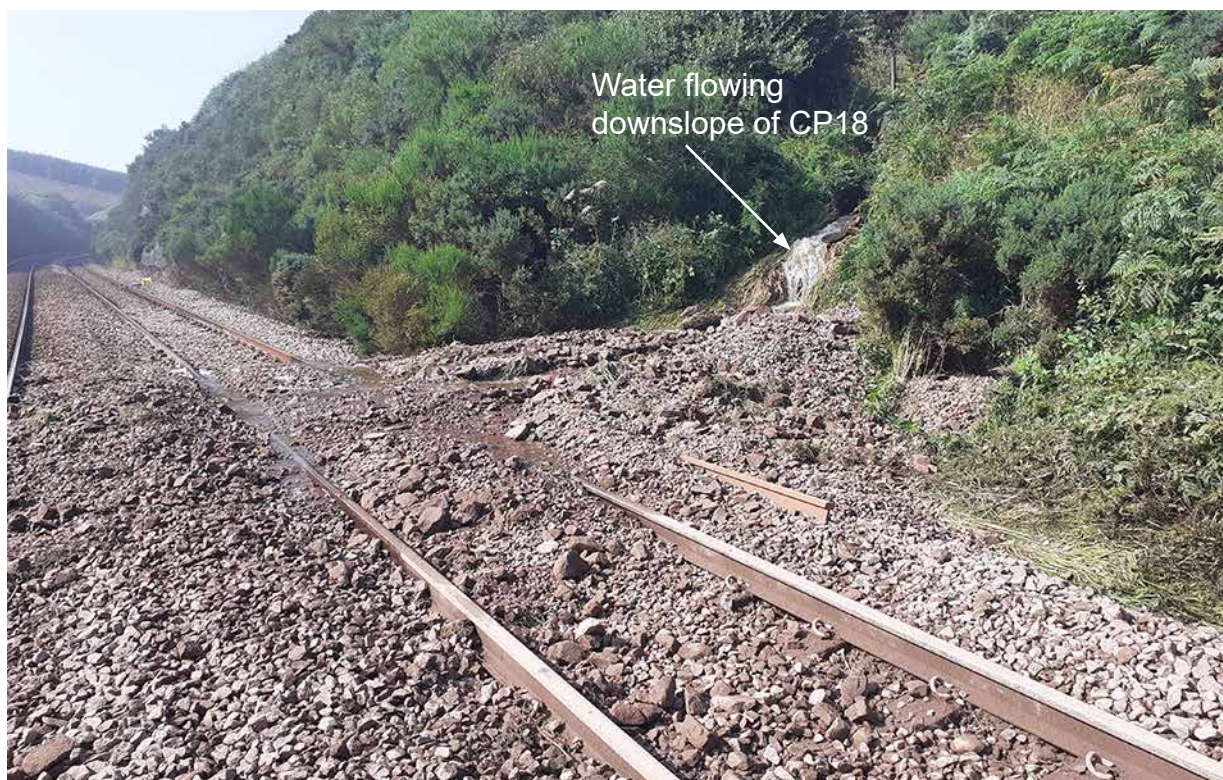
- 59 In the area of bridge 325, north of Carmont signal box, heavy rain between 05:50 hrs and 09:00 hrs on 12 August washed gravel from the 2011/12 drain (paragraph 25), together with stone and soil eroded from the ground on either side of the drain, onto the track. Most of the gravel was washed out from the drain trench for a distance of approximately 9 metres immediately upslope of CP18 and about 6 metres immediately downslope of this catchpit (figure 17 and figure 18). This, and stones from the surrounding ground, covered the down line between 220 miles 1610 yards and 220 miles 1621 yards (figure 19). The precise time at which this occurred is not known, but must have been between 07:07 hrs, when the last train before the accident passed this location (paragraph 50), and the arrival of train 1T08 at 09:37 hrs. Modelling indicates it was probably between 08:15 hrs and 09:00 hrs (appendix H).

Figure 19: Washout debris on the track approximately 55 minutes after the accident. A short length of scrap rail unrelated to the accident is also visible (Story Contracting)

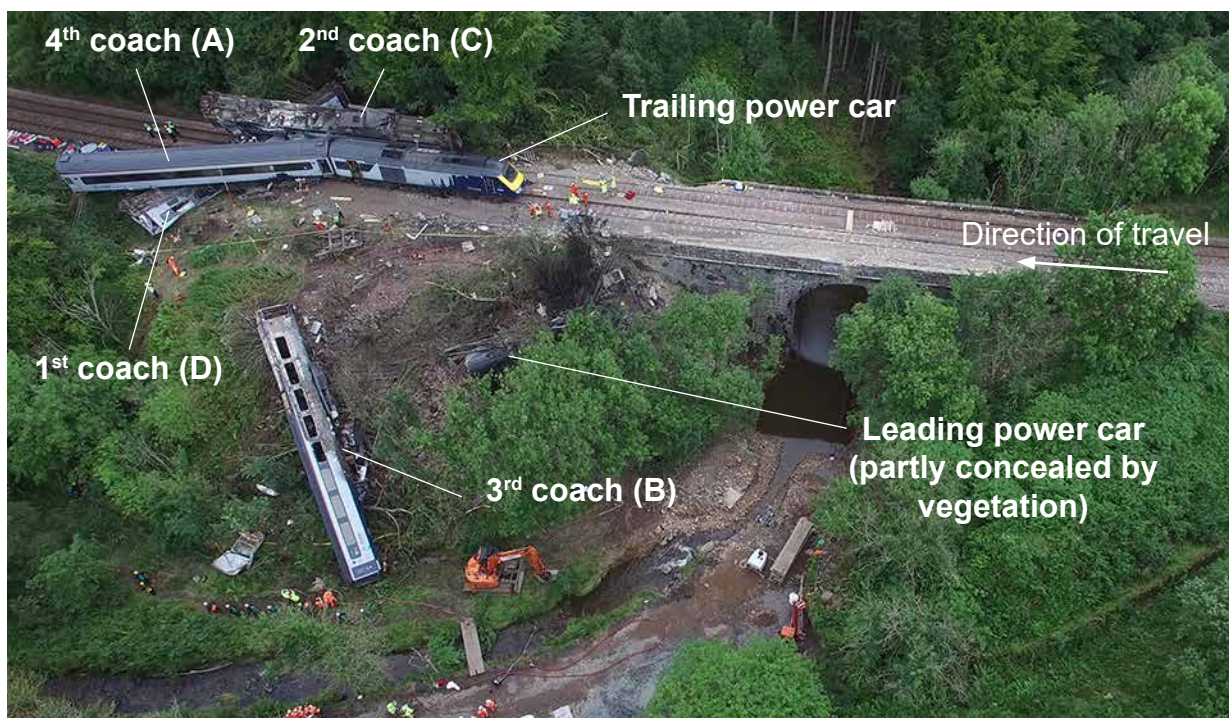
- 61 Three of the following five vehicles travelled in different directions beyond the bridge (figure 20). The first passenger coach (D) came to rest on its roof, almost at right angles to the track. The second passenger coach (C) came to rest overturned onto its roof with its trailing end on top of the first coach and facing the direction of travel. The third passenger coach (B) ran down the steep embankment to the left side of the railway, came to rest on its right-hand side and subsequently caught fire. The fourth passenger coach (A) remained upright and came to rest with its leading end on top of the first coach. The trailing power car remained upright on the down line, still coupled to the rear of the fourth coach. Its left-hand wheels were derailed and its right-hand wheels were resting on the right-hand rail which had rolled over to the right. The behaviour of the train in the derailment and the damage it sustained are described in more detail in paragraphs 453 to 469.

Figure 20: Derailed train

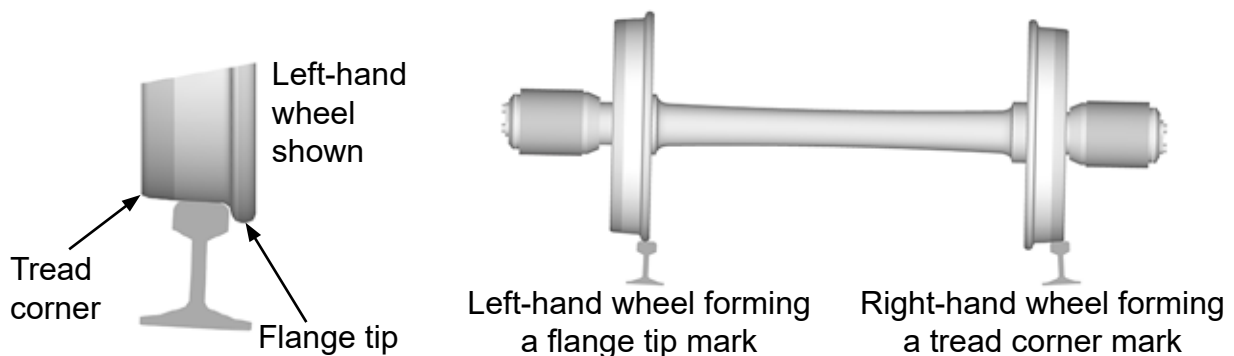
- 75 The first indications of the point of derailment were faint flange tip marks on the head of the left-hand rail close to the northern limit of the debris (designated sleeper 0 during the post-accident examination of the track) and a *tread corner mark* on the right-hand rail at the same position. These marks and the subsequent anticlockwise *yaw* (rotated) attitude of the leading bogie (see paragraph 77) indicated that it was the leading wheelset that had derailed first. As the leading wheelset had run through the washout debris, its left-hand wheel had been lifted up by debris between the wheel and rail, and displaced to the left, such that its wheel flange was running on the railhead (figure 23).

Figure 23: Wheel components and rail marks

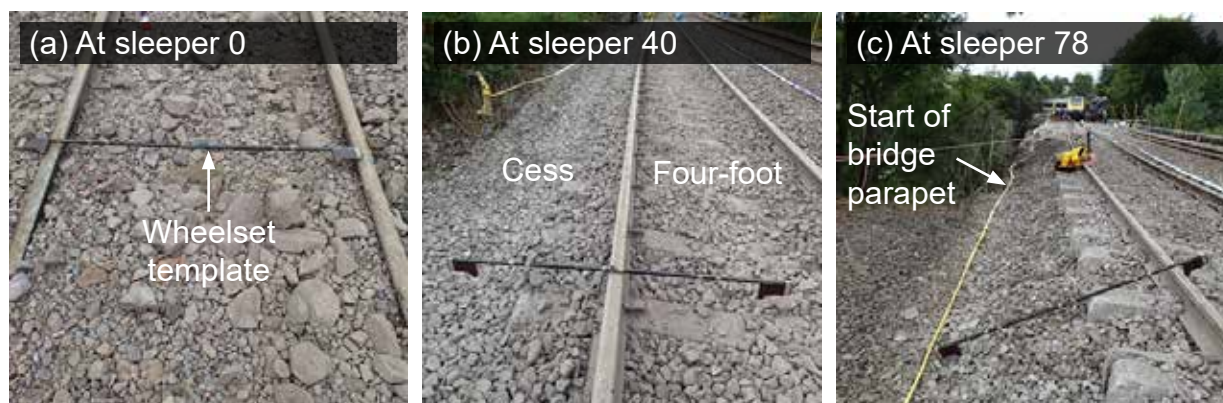
- 76 The track was on a slight right-hand curve with a radius of about 1400 metres at the washout location, and the leading bogie should have been running almost straight. The displacement of the left-hand wheel was likely to have been caused by a combination of lateral forces on the wheel due to curving, the effects of running through deeper debris around the left-hand rail than the right-hand rail (tending to yaw the bogie left), and the small effect of rail curvature over the distance that the left-hand wheel flange traversed over the railhead. It is likely the right-hand wheel was also lifted as it ran through the debris. It then dropped into the *four-foot* just as the left-hand flange passed over the left-hand rail and dropped entirely off the rail and into the cess (figure 24a).

Figure 24: Position of leading wheelset (shown by wheelset template) from washout to bridge 325

- 79 Observations of the derailed wheel paths in the ballast, showed the leading power car continued to drift further to the left as it approached the bridge, indicated by the position of the wheelset template (representing the leading wheelset) in figure 24b and 24c. From around sleeper 78 (approximately 55 metres beyond sleeper 0) and before the start of the bridge at sleeper 88 (approximately 61 metres beyond sleeper 0), the right-hand wheels of the leading bogie climbed over the left-hand rail and into the cess. The leading power car deviated even further to the left and subsequently came into collision with the end of the bridge parapet. Damage on the leading bogie indicates that the leading power car struck the bridge parapet slightly to the left of the vehicle centre line, which at that point had deviated between 2.0 and 2.4 metres from the centre line of the track.

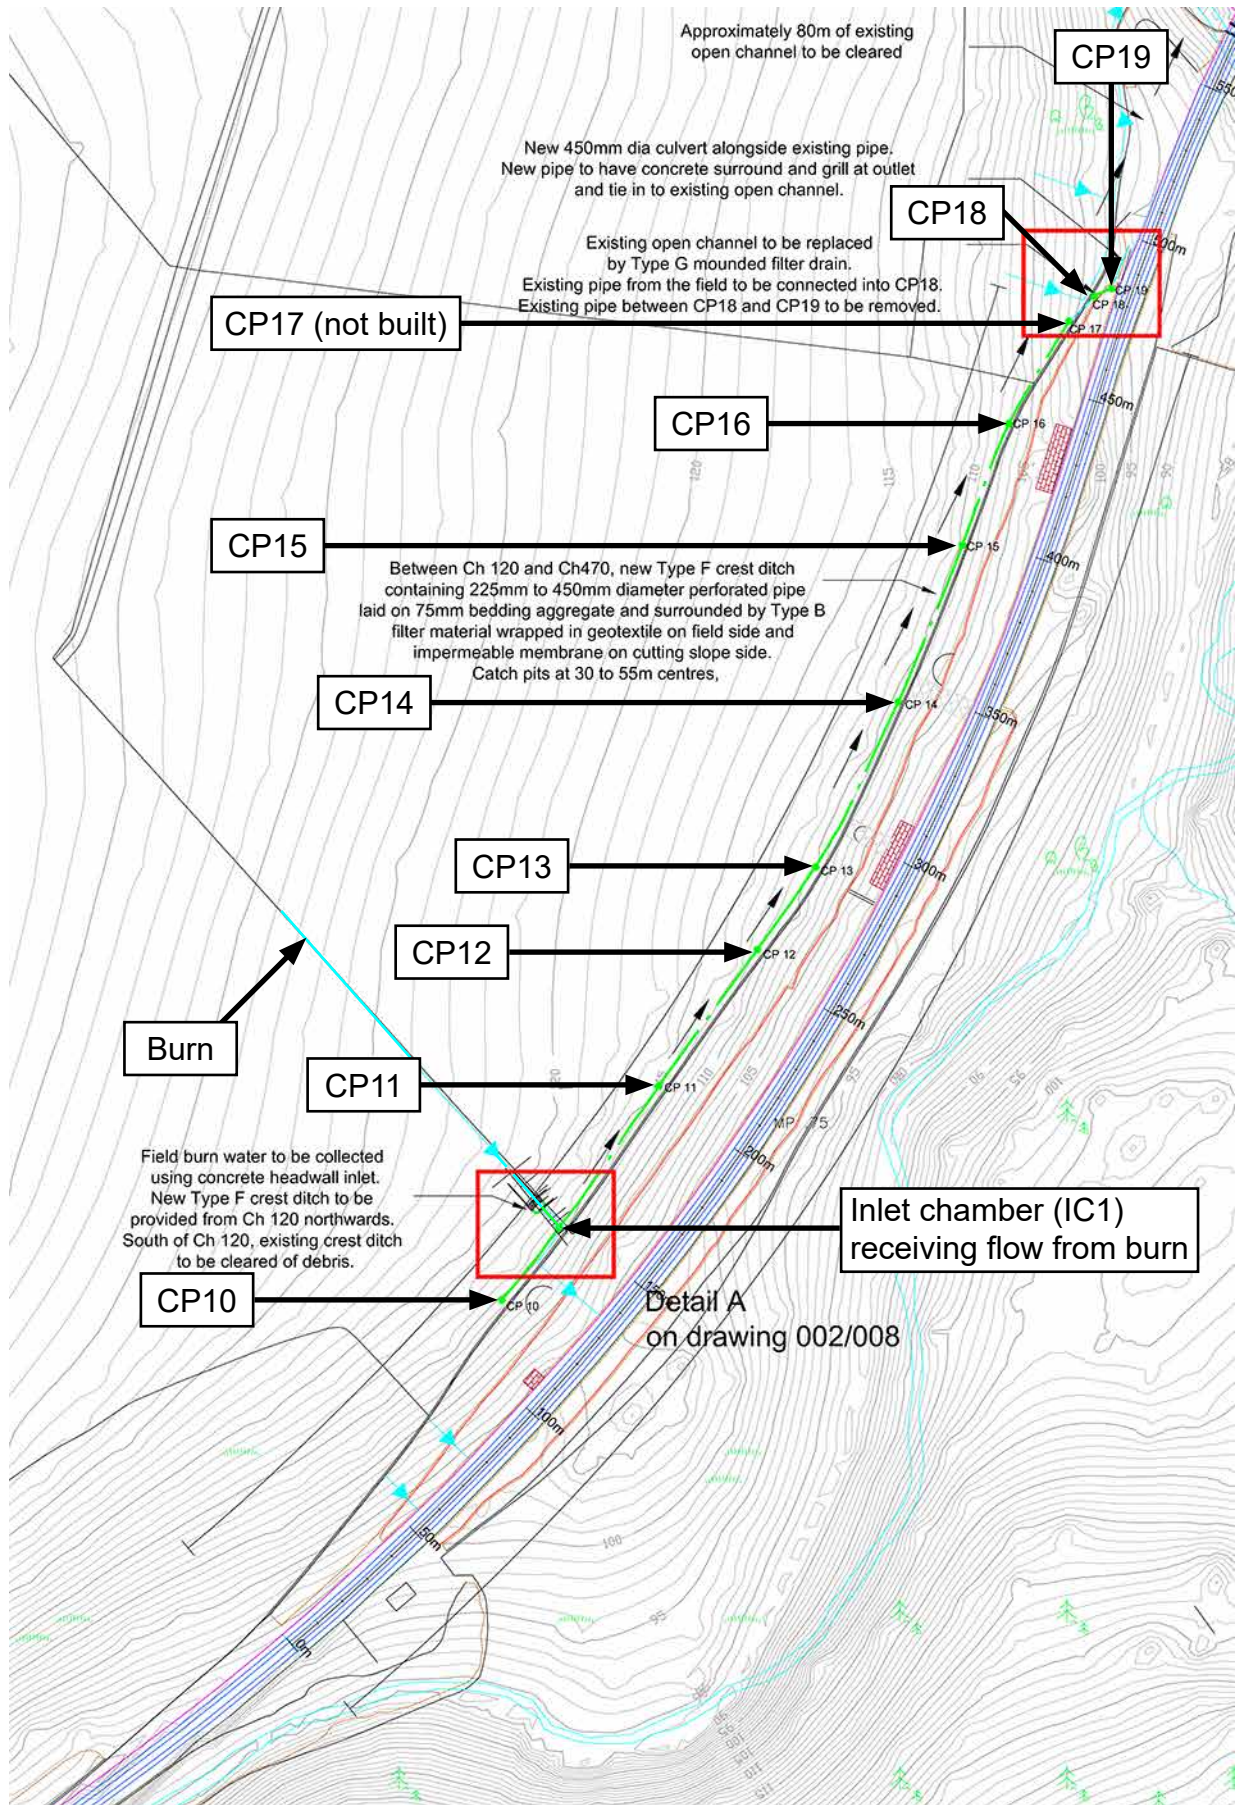
Figure 27: Drain design – plan. Annotated version of Arup drawing 002/001 issue 4. As-built layout differs

- i) There was no physical evidence demonstrating whether washout upslope of CP18 was initiated before, concurrently with, or after washout downslope of the catchpit.

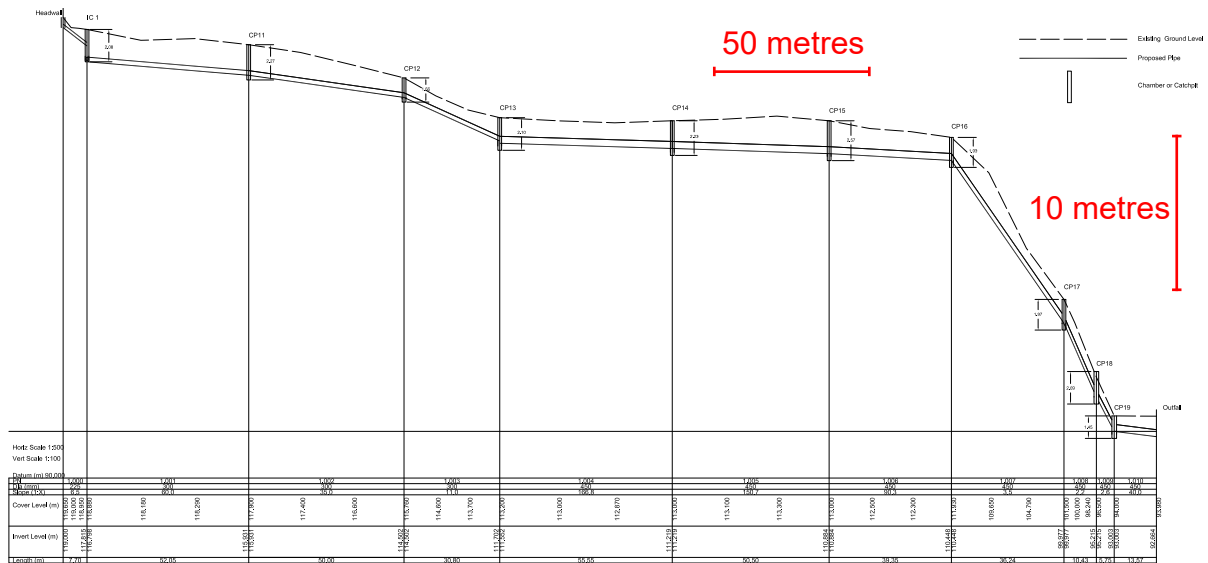
Figure 28: Drain design – elevation with exaggerated vertical scale. Annotated version of Arup drawing 002/005 issue 3. As-built layout differs

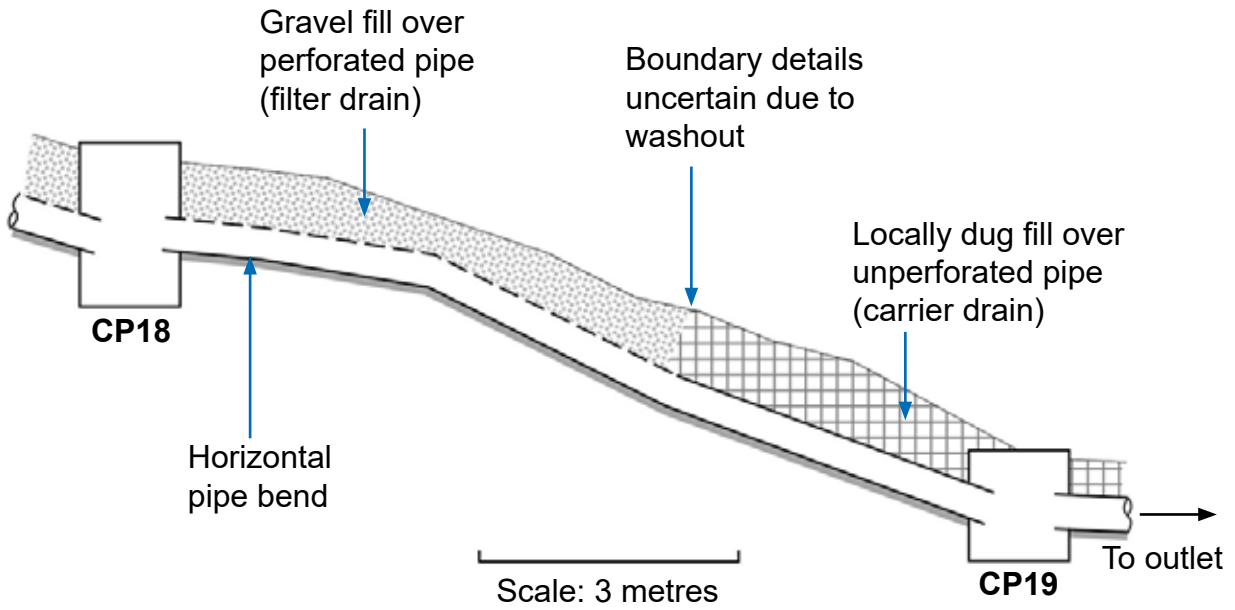
Figure 30: Drain profile downstream of CP18 showing fill before washout (derived from AECOM report appendix S)

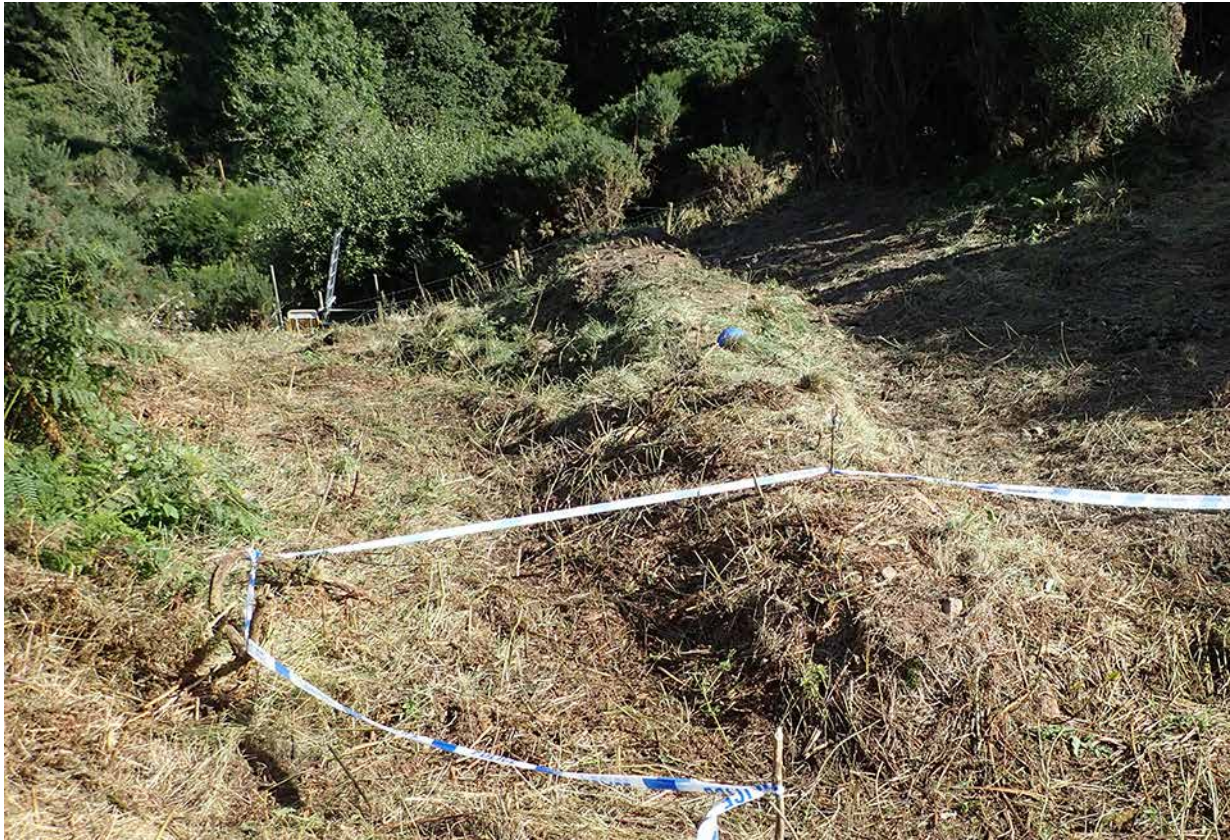
Figure 34: Bund viewed facing towards the 2011/12 drain post-accident after clearance of vegetation

- 98 A post-accident survey, conducted over several days as the gorse-cover was carefully removed from the funnel surface, located a bund (artificial ridge) which was almost certainly absent before the 2011/12 drain was constructed (figures 34, 35 and 36). This bund intercepted most water flowing into the funnel and guided it towards the 2011/12 drain at a point about 7 metres upslope of CP18. A gully, with a shape consistent with being caused by water erosion, had formed on the upslope side of this bund and is designated gully 1 in this report (figures 32 and 33). Another gully had developed in the lowest part of the funnel, on the line of the pre-2010 ditch and passing close to CP18 (gully 2). It intersected the 2011/12 drain immediately downslope of CP18. The effect of the bund was observed and recorded during wet weather on 25 August 2020 when water flowed along gully 1 without a corresponding flow in gully 2.

130 There is strong evidence that a bund, which diverted flows towards the 2011/12 drain and so initiated the washout 7 metres upslope of CP18, was a feature constructed at about the time that the drain was completed (figures 34, 35 and 36). Evidence that the feature is artificial is provided by its relatively uniform cross-section, its linear alignment over a length of about 20 metres, and by construction debris (wire and small pieces of geotextile) found embedded in the bund.

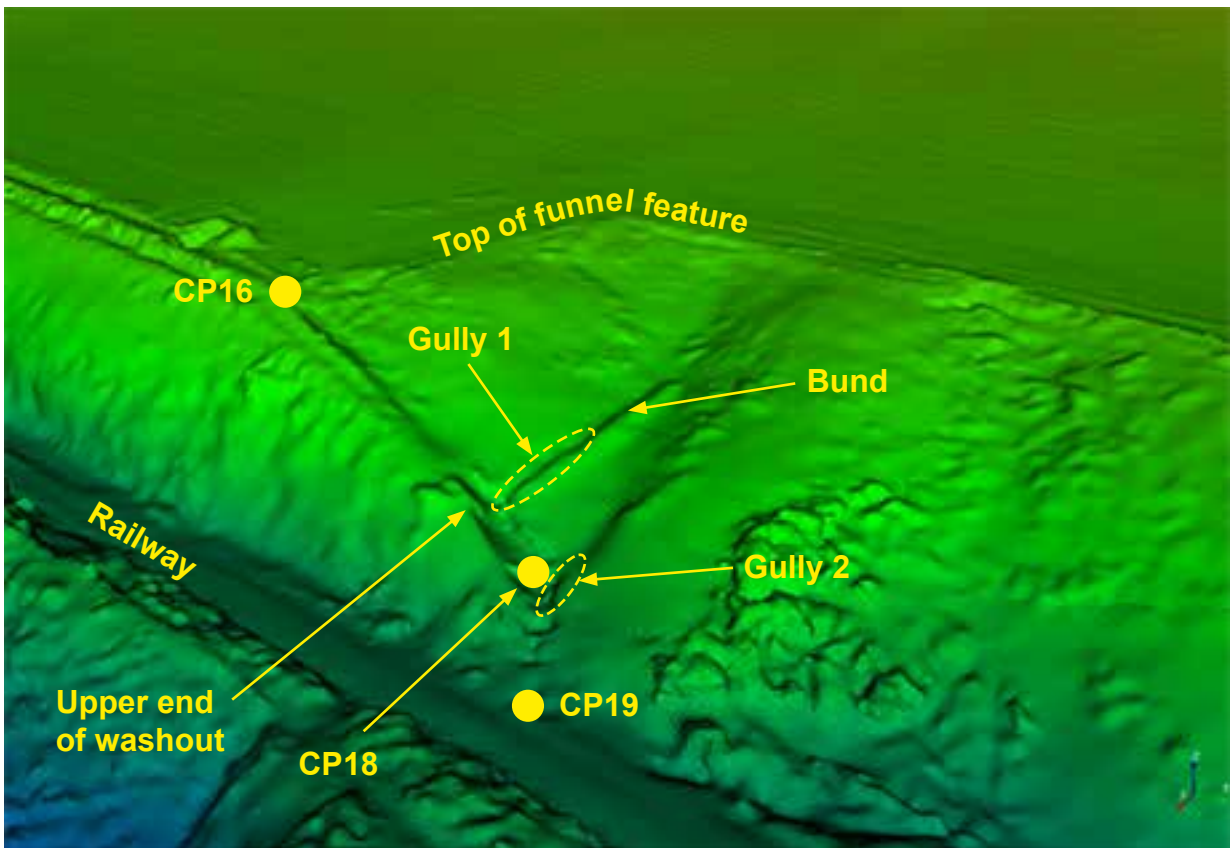
Figure 35: Post-accident funnel details shown on 2020 LiDAR data

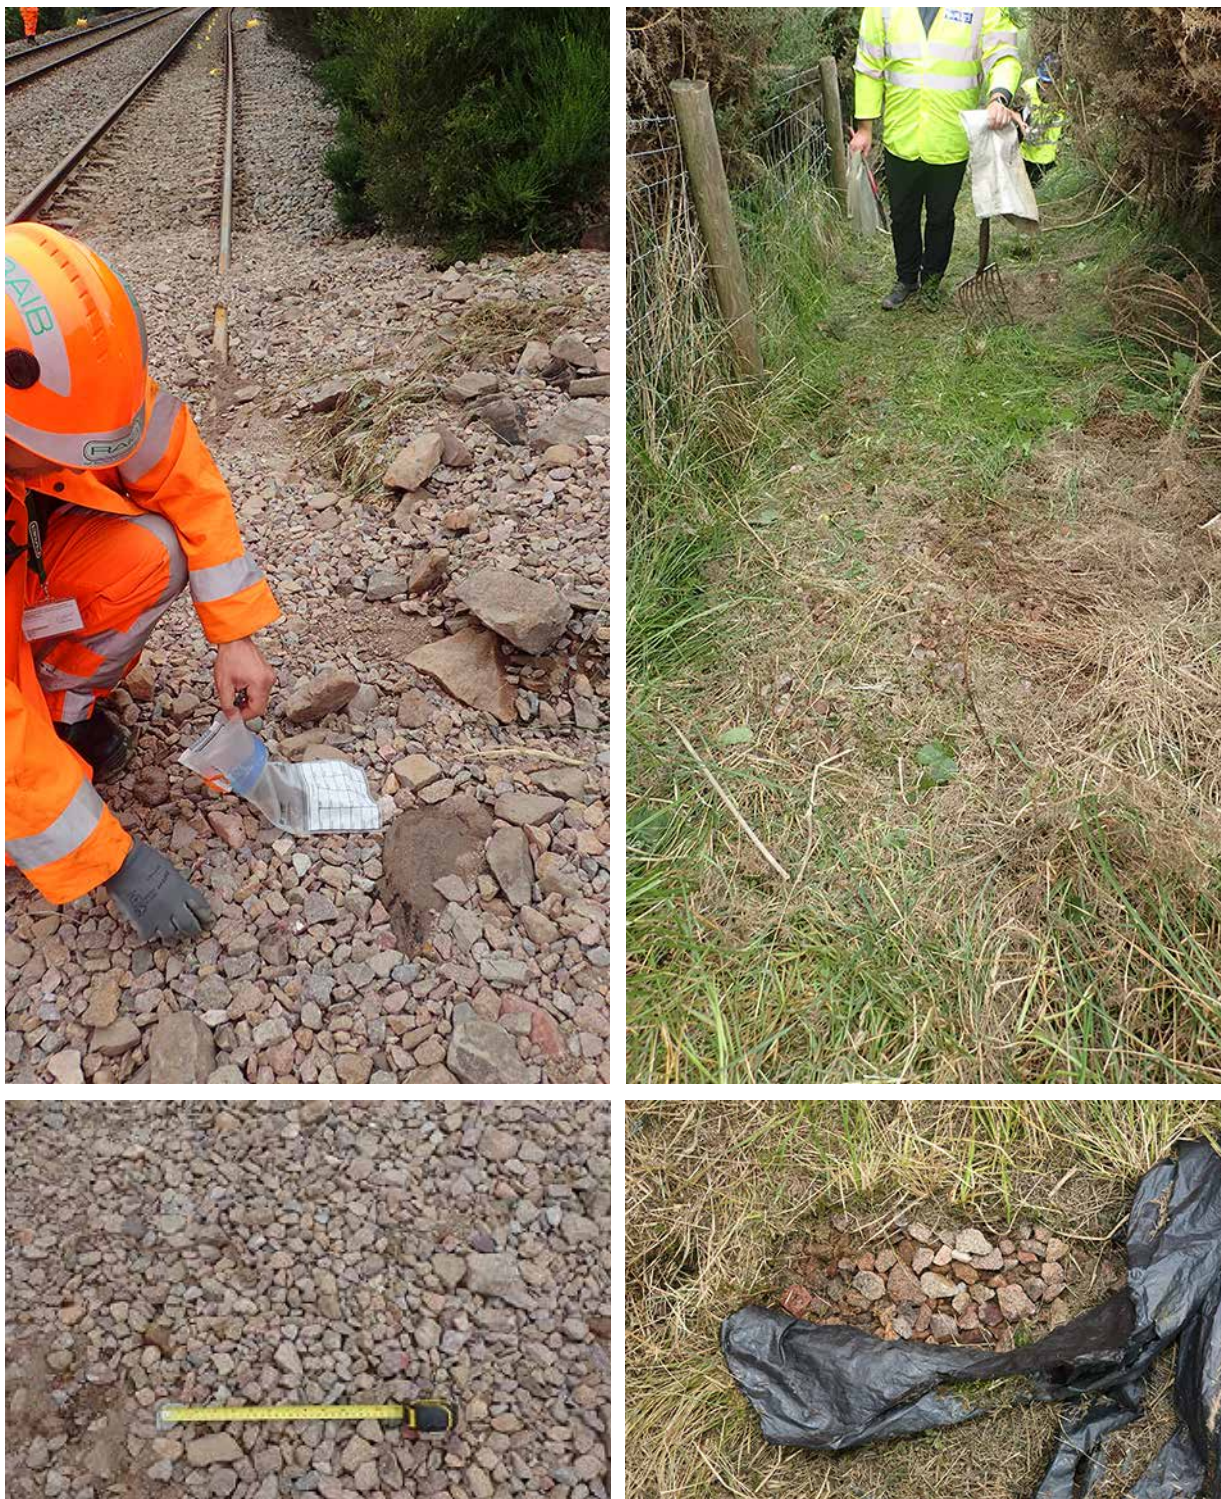
- 99 Site inspection by RAIB in the period immediately after the accident found that:
- The debris on the track comprised a pinkish-grey granite gravel with some gravel and cobbles of grey stone (figures 20 and 37).

- The pinkish-grey granite gravel on the track was similar to that found in the drain immediately upslope of the washout (figure 37), indicating that this gravel had reached the track from the drain.

*Figure 37: Landslip debris (left-hand images) and undamaged area of 2011/12 drain between washout and CP16. Surface of drain, probably protected by discarded plastic sheet since around the time it was constructed, shown in lower right image (Police Scotland)*
