Rail Accident Investigation Branch

# Rail Accident Report

**Derailement of a passenger train at Carmont,  
Aberdeenshire  
12 August 2020**

Report 02/2022  
March 2022

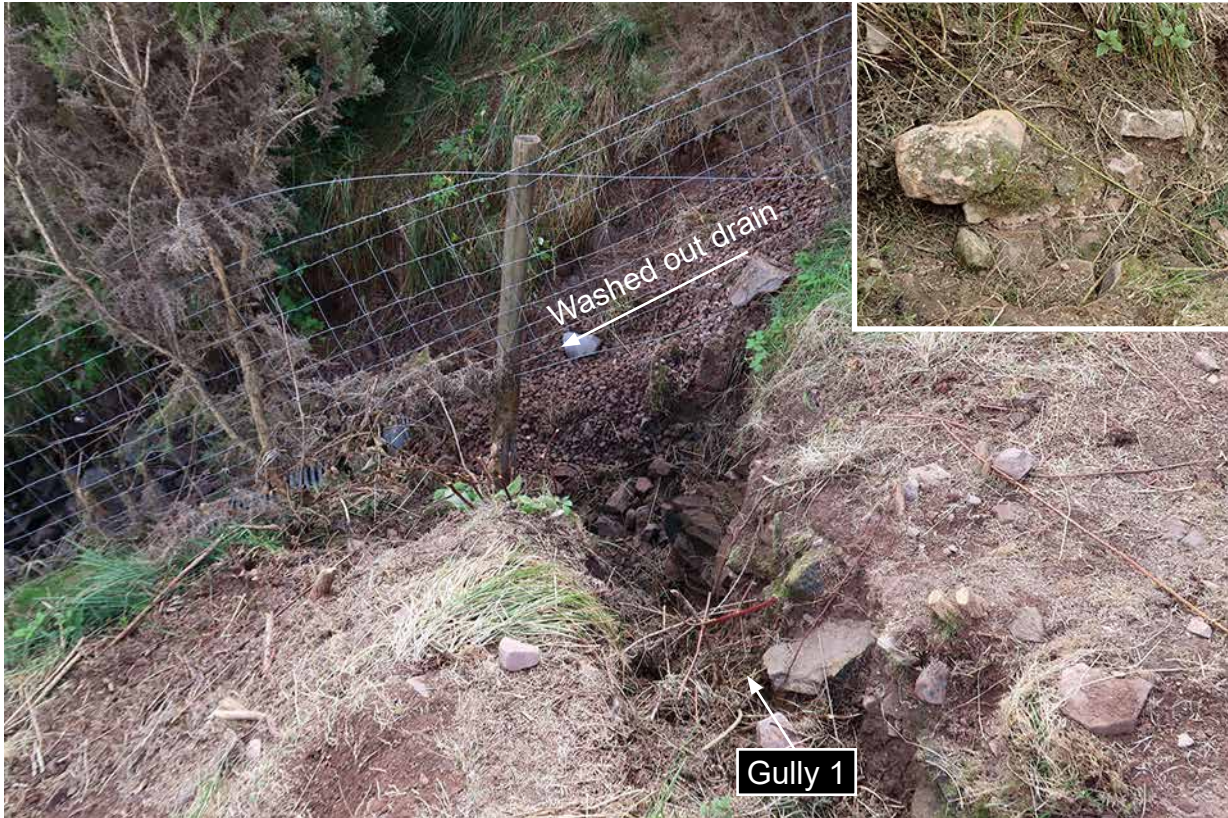
Figure 38: Gully 1 erosion at junction with 2011/12 drain (ORR/Coffey). Inset shows organic growth in base of gully 1 just outside main picture

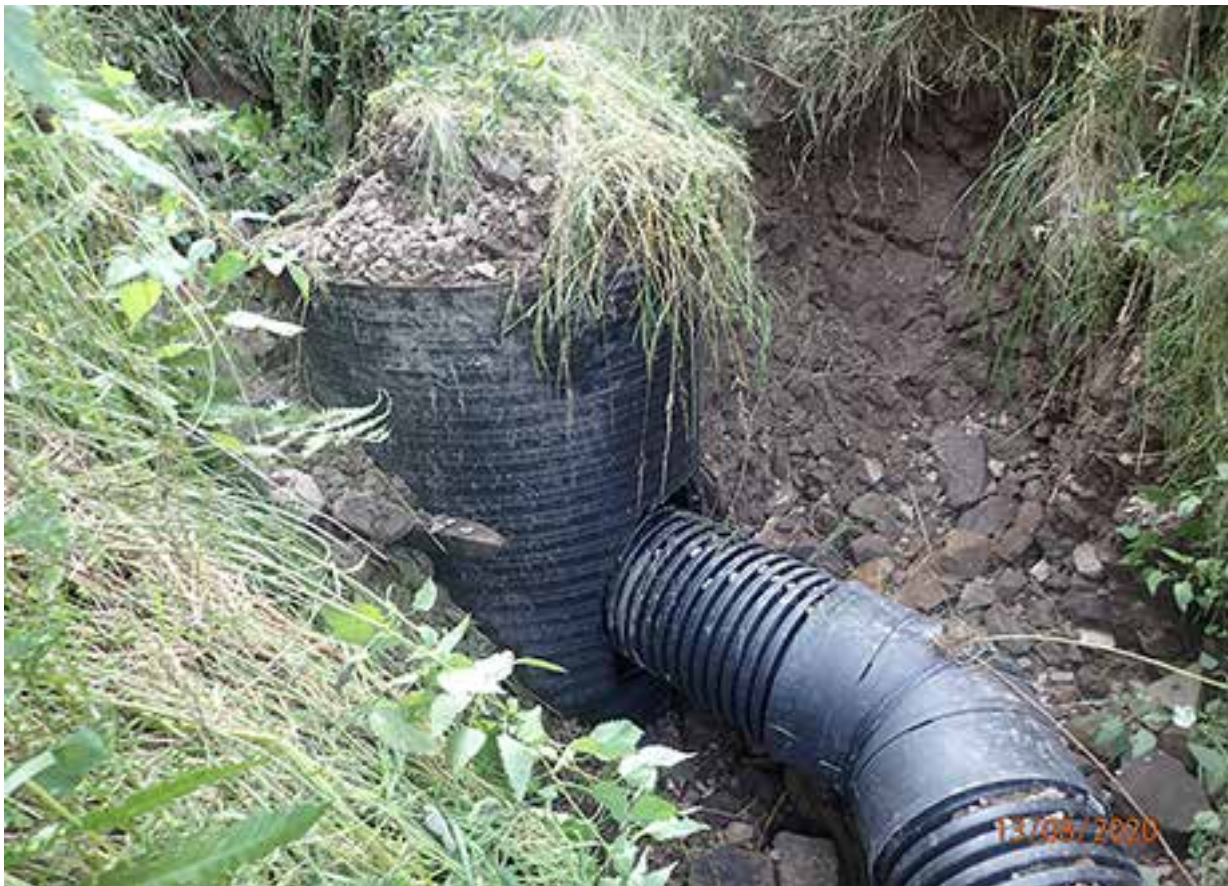
Figure 39: CP18 viewed from downslope on 13 August 2020 with the end of gully 2 visible at the upper right of the image

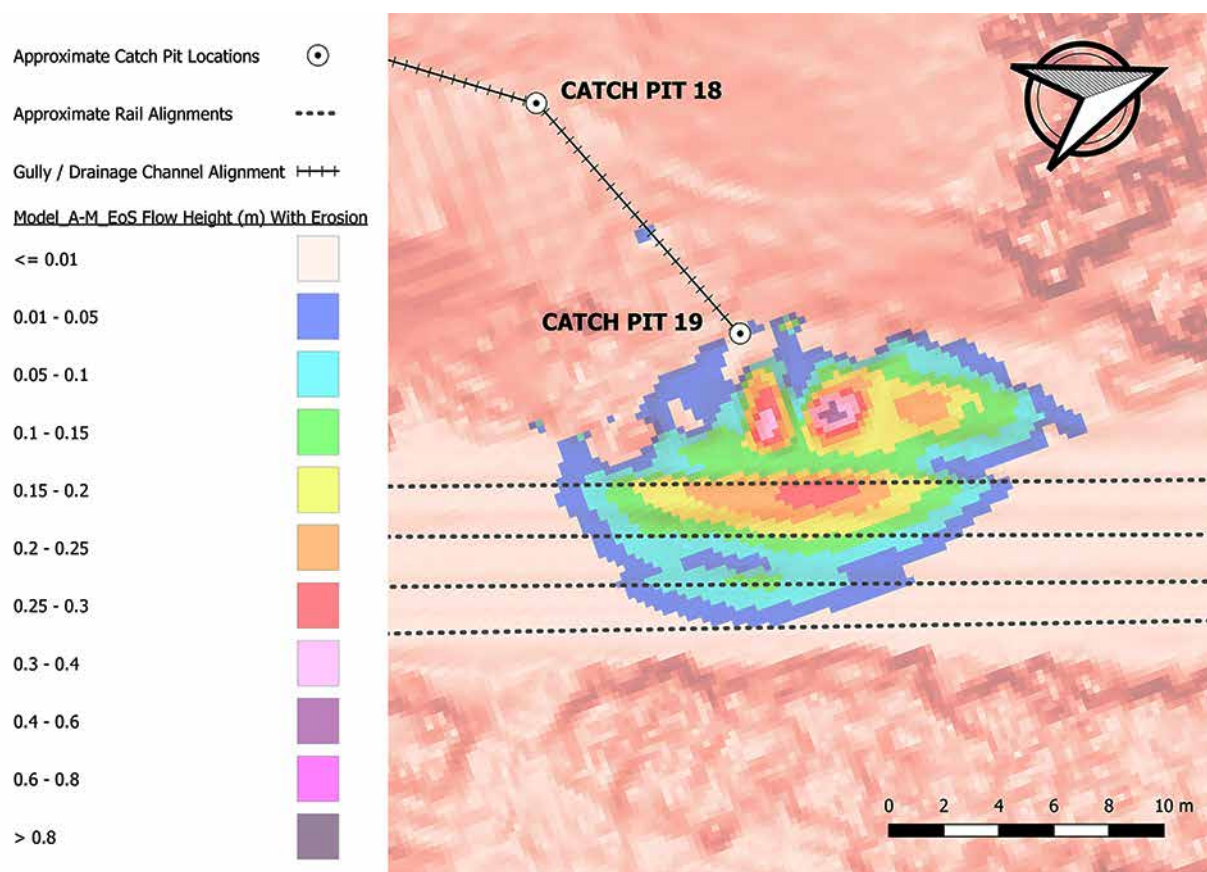
109 The sediment analysis based on 86 litres/sec flow predicted that about 13 m<sup>3</sup> of material would be eroded from the drain and deposited in a debris fan extending over the railway (figure 44). Based on LiDAR surveys undertaken by Police Scotland, RAIB estimated that 23 m<sup>3</sup> of material was eroded from the drain and surrounding ground, with the fan of debris covering the track and surrounding area estimated as having a volume of 16 m<sup>3</sup>. The fan value excludes some material deposited in a ditch alongside the railway and the finer soil particles which would have been washed towards, and into, Carron Water.

Figure 44: Theoretical deposit depths (in metres) for ~86 litres/sec flow (AECOM)

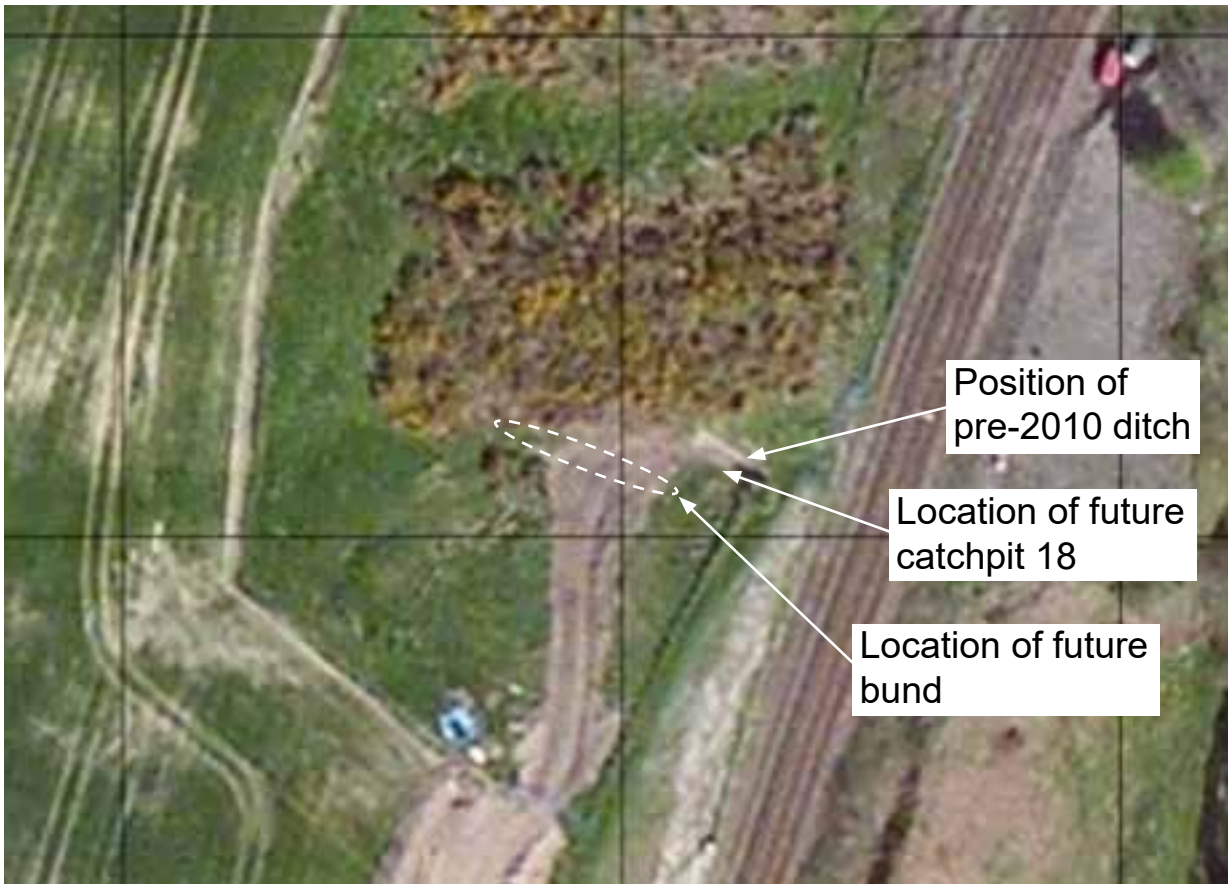
131 The bund is not shown on the detailed survey undertaken in May 2010 after removal of gorse from this area and is not shown on any Arup drawing. The words used by Carillion to describe surface water flow in TQ20 are inconsistent with the presence of a bund when TQ20 was drafted (paragraph 122). The bund crossed an area used as a route for excavators and other machines moving up and down the slope, as shown by a satellite photograph of the site in late April 2011 (figure 46). A bund crossing this route would have made use of the route difficult and possibly unsafe.

Figure 46: Satellite image April 2011 (Network Rail/ESRI Wayback imagery)

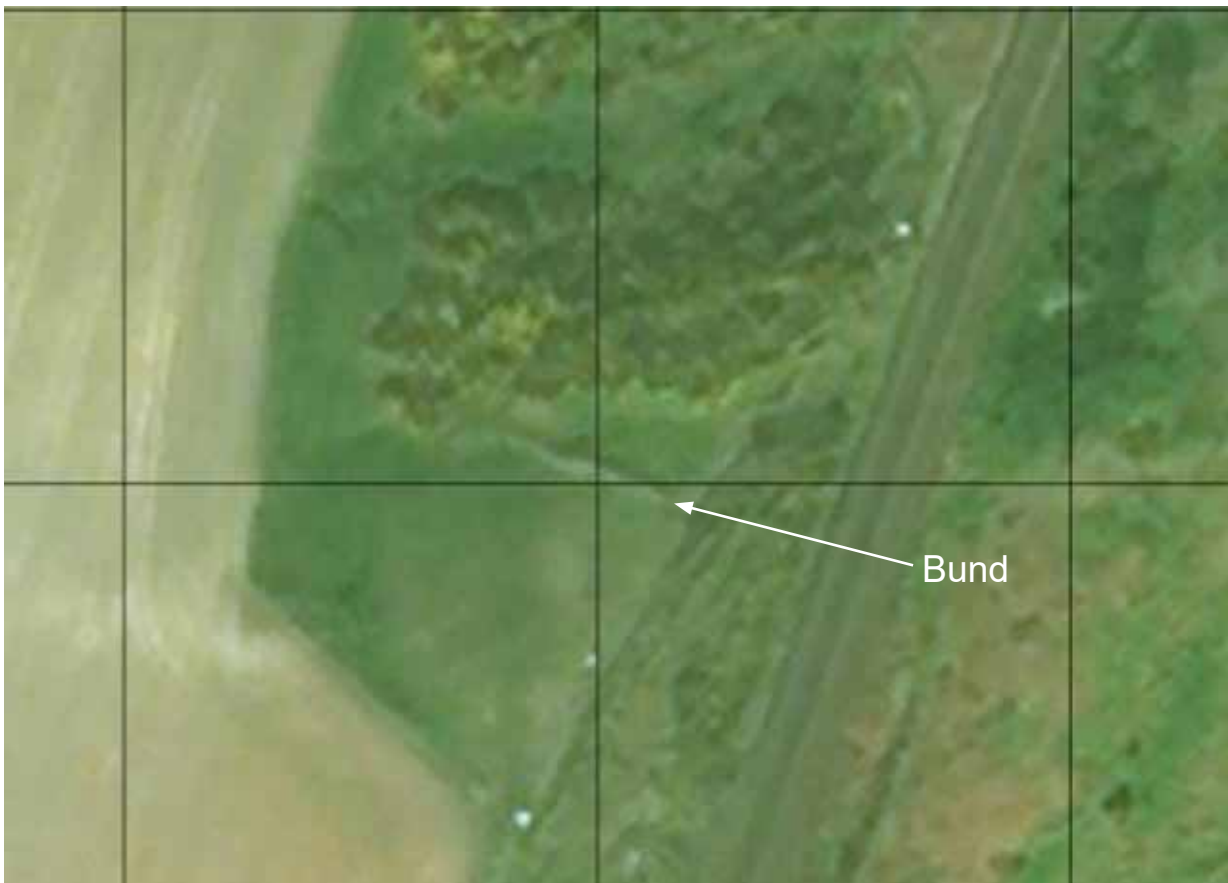
Figure 47: Satellite image April 2014 (Network Rail/ESRI Wayback imagery)

- 132 The bund is visible in a satellite photograph of the same area in April 2014 (figure 47). The larger, thus likely to be the older, gorse growing from the bund was found to contain 'tree' rings indicating approximately seven years' growth (that is, growing since around 2013). There is no evidence of any construction work in the area of the bund after completion of Carillion's drainage work.

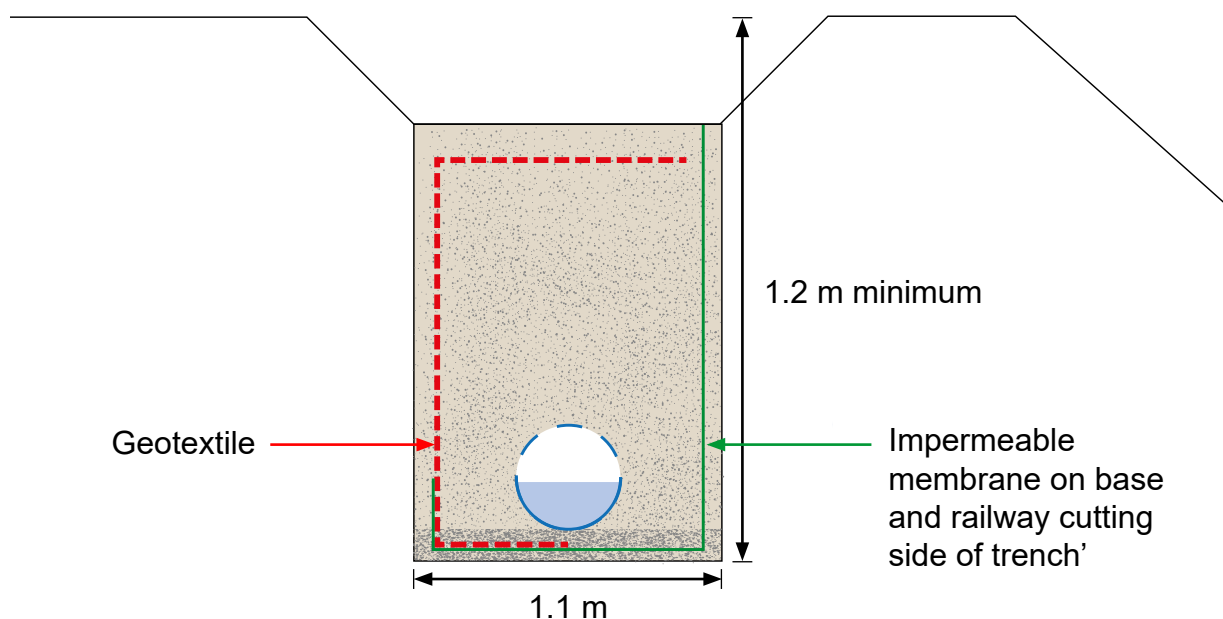
- 145 Arup's design for the 2011/12 drain required a geotextile to be placed on the upslope (field) side and near the top of the gravel. This is a sheet with very small holes which allows water, but not fine soil particles, to pass through it. This was intended to prevent fine particles in surface runoff water from being washed into the spaces between the gravel where they would impede water flow to the pipe. An impermeable membrane was specified on the downslope (railway) side and lower part of the trench, to prevent water seeping out of the drain and into the adjacent cutting slope where it could cause instability. The geotextile and the impermeable membrane are shown on Arup drawing 002/002 issue 04 'Drains and Pits' and in a photograph taken during construction at a location between the south end of the 2011/12 drain and CP16 (figures 49 and 50).

Figure 49: Drain as shown on Arup drawings (simplified from Arup drawing 002/002)

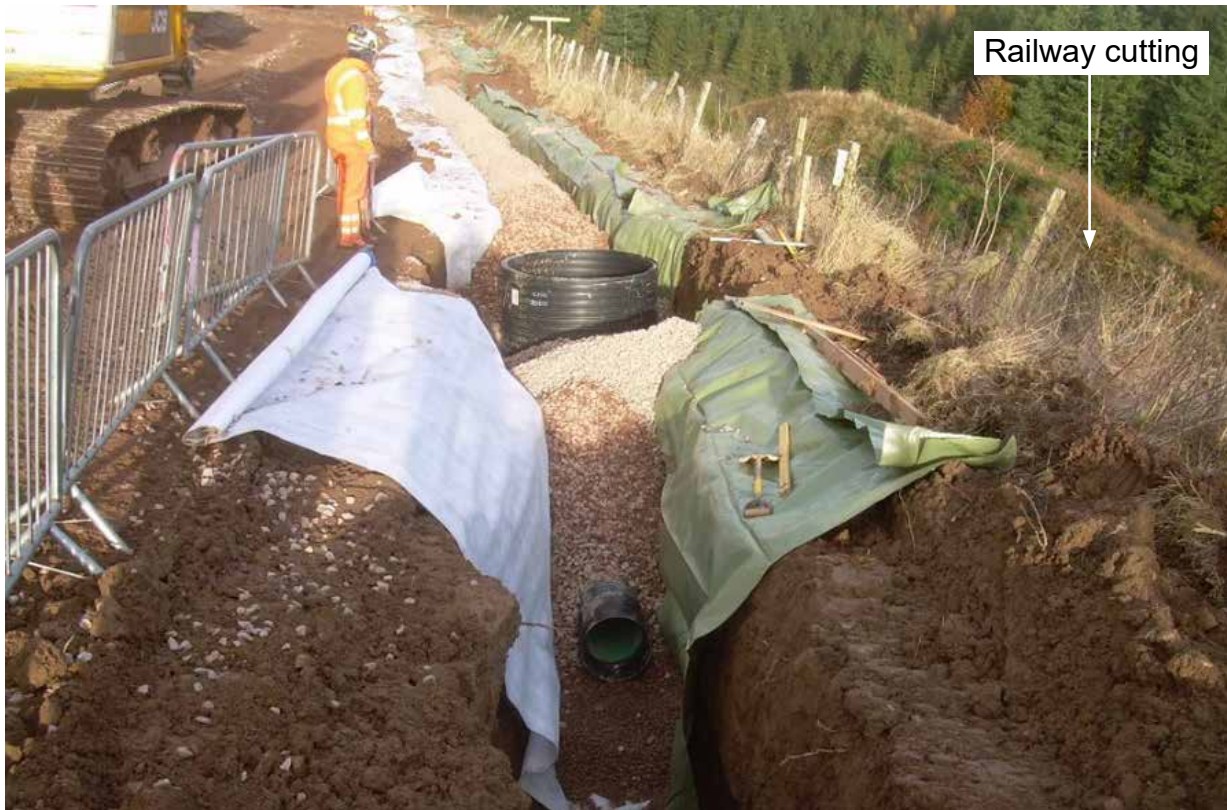
Figure 50: Drain under construction in late 2012 showing section between CP11 and CP16 looking north (Network Rail)

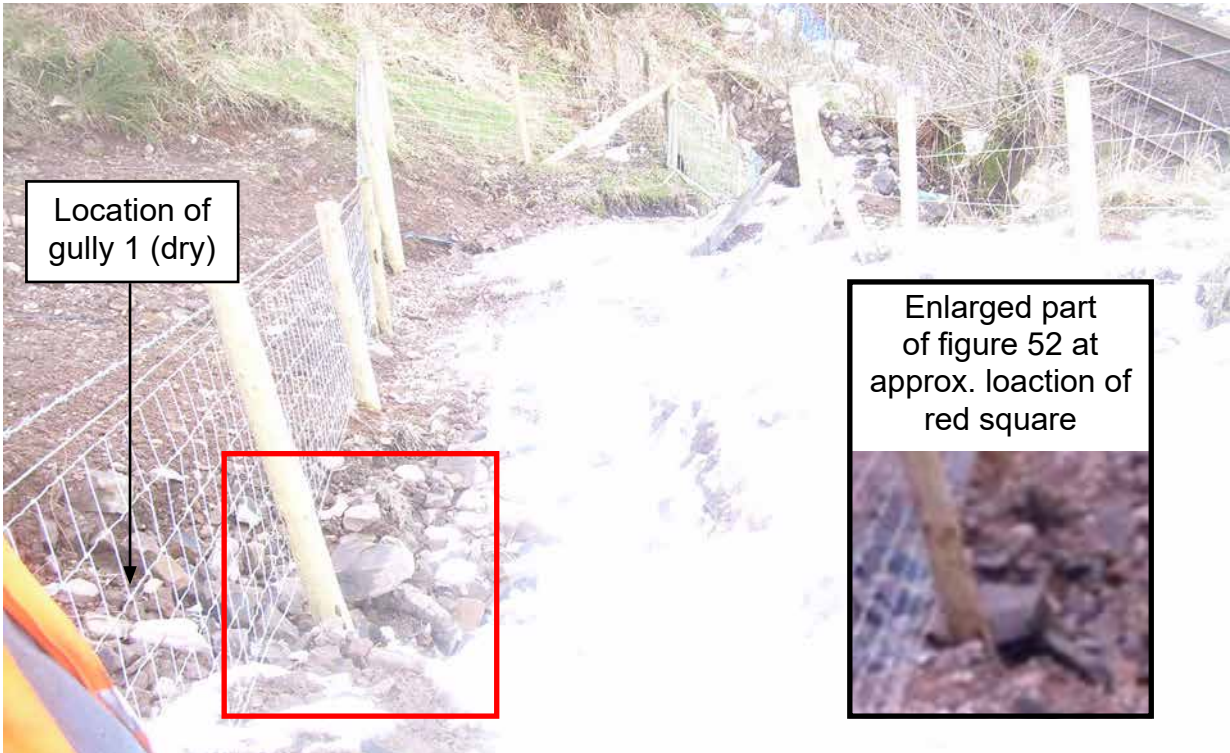
Figure 53: Surface of drain in light snow looking towards CP18 and railway in March 2013 during an inspection of the completed works (Network Rail). The original image is over-exposed

- 187 A photograph of this area was taken during an inspection of the completed works by Carillion and Network Rail in March 2013. Although the photograph is of poor quality, it indicates that the flow of surface water into the drain was established by the time of this visit (figure 53). Snow cover means the photograph cannot be used to definitively determine whether erosion on the surface of the 2011/12 drain was also still present. However, the limited areas visible on this photograph suggest remedial work had not taken place; there is no evidence of the ground surface disturbance likely to have accompanied any remedial work undertaken in response to the December 2012 photograph.

- 188 It is very unlikely that the slight erosion of the gravel surface would have been immediately recognised as a precursor to a sudden washout affecting railway safety. However, it is clear evidence of a problem requiring action such as repair, monitoring, investigating the source of the water and/or reference to the drain designer (Arup). It is possible that actions such as these would have resulted in provision of safe and effective drainage so avoiding the washout in August 2020.

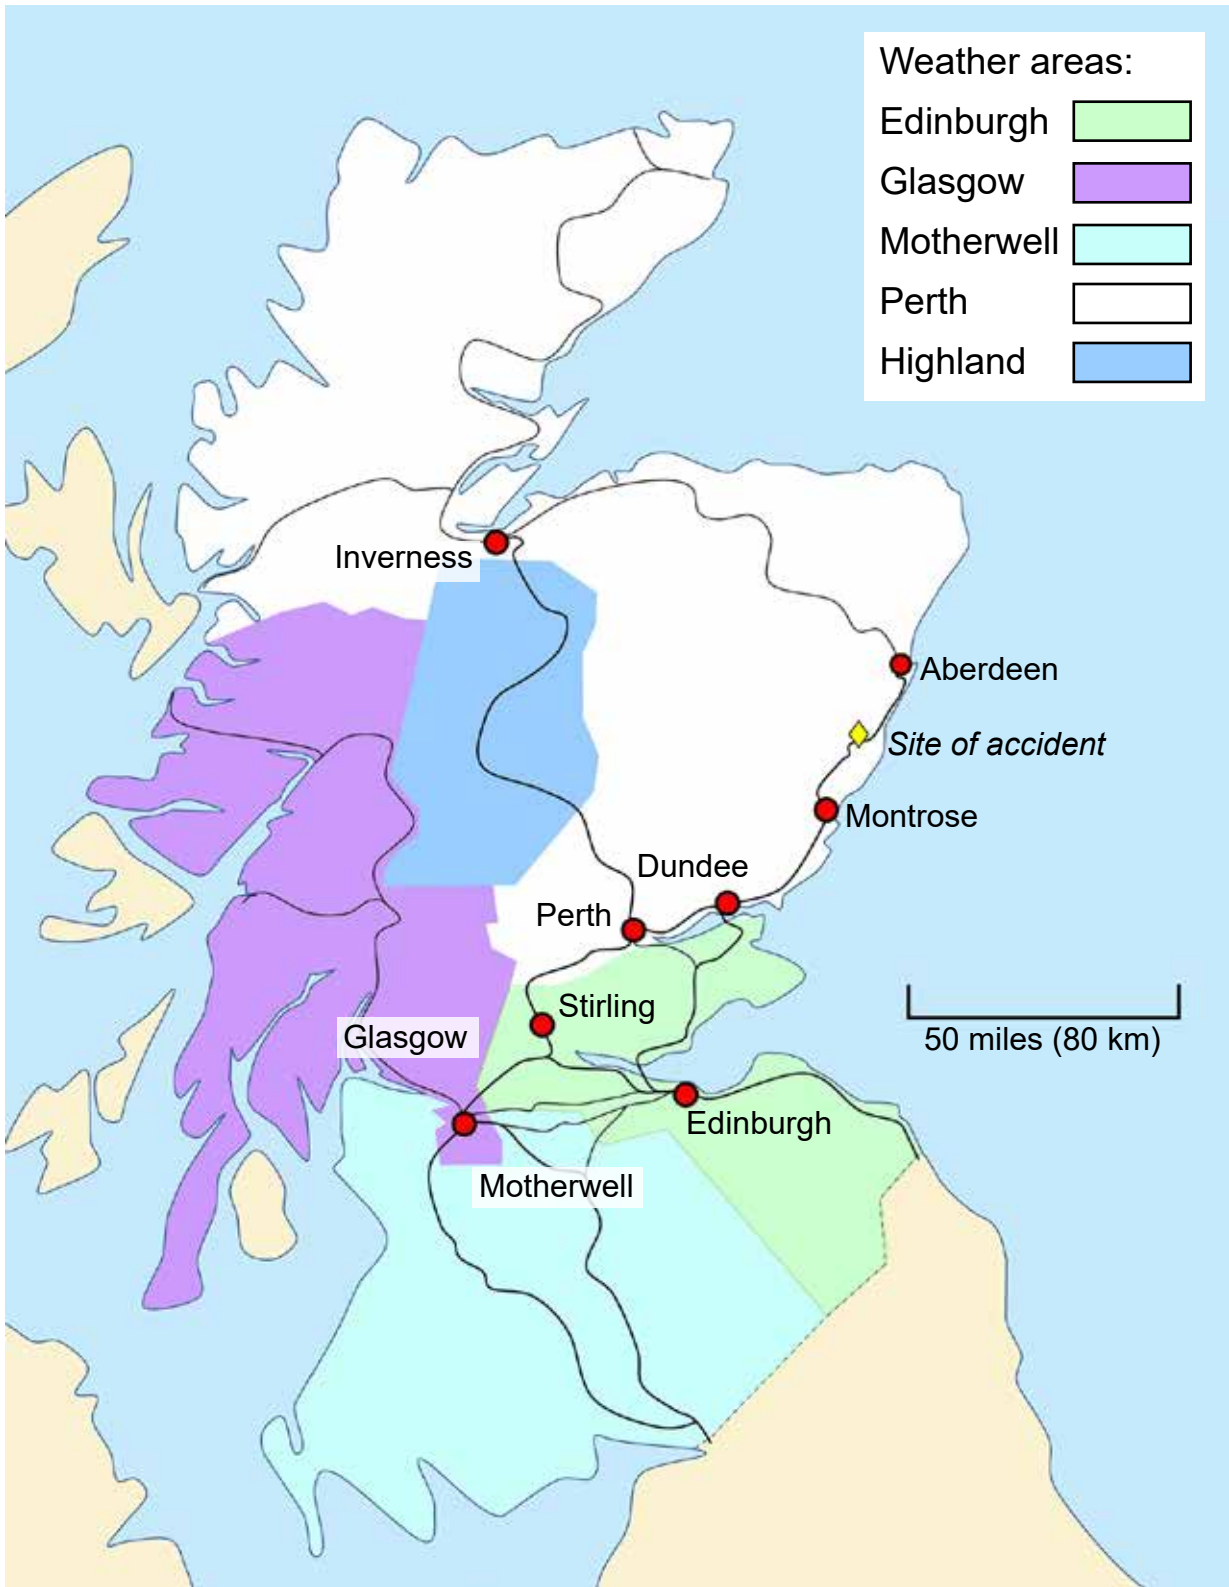
Figure 56: Forecast areas in Scotland

- 308 Witnesses stated that in Scotland a 'majority of areas' approach was taken so a 'red day' would be declared by the RCM if extreme weather was forecast in three or more of the five forecast areas for Scotland (figure 56). However, events in the lead-up to the accident demonstrates that this approach was not consistently applied (for example, the forecast for 11 August contained extreme weather forecast in three of the five areas and yet no 'red day' was declared).

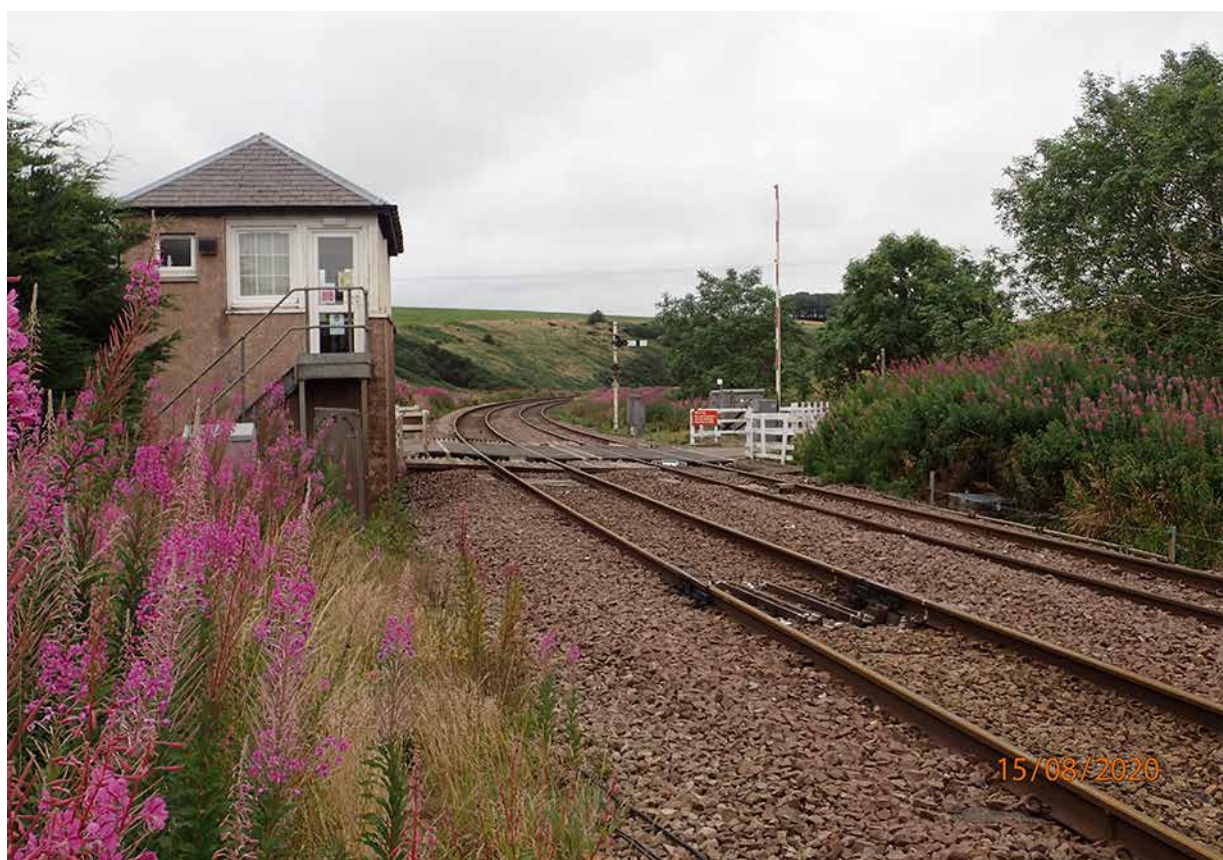
Figure 57: Carmont signal box looking north

- 253 The Carmont signaller had no indication that the line was obstructed between his location and Stonehaven when authorising the movement of train 1T08 to Stonehaven. After passing his signal box, train 2B13 had passed the location of the washout at 07:07 hrs and reached Stonehaven station at 07:13 hrs, with its driver subsequently confirming that he had seen no indication of a problem (paragraph 50). The Carmont signaller was told that this train had reached Stonehaven during a phone call with the Stonehaven signaller at 07:19 hrs, during which they concluded there was no known obstruction of the up line, so this could be used for the northbound movement of train 1T08 if necessary (the movement was actually made on the down line). Neither signaller had received any indication of an obstruction at the washout location when, at and after 09:08 hrs, they exchanged the messages needed to authorise the northward movement of train 1T08 to Stonehaven.

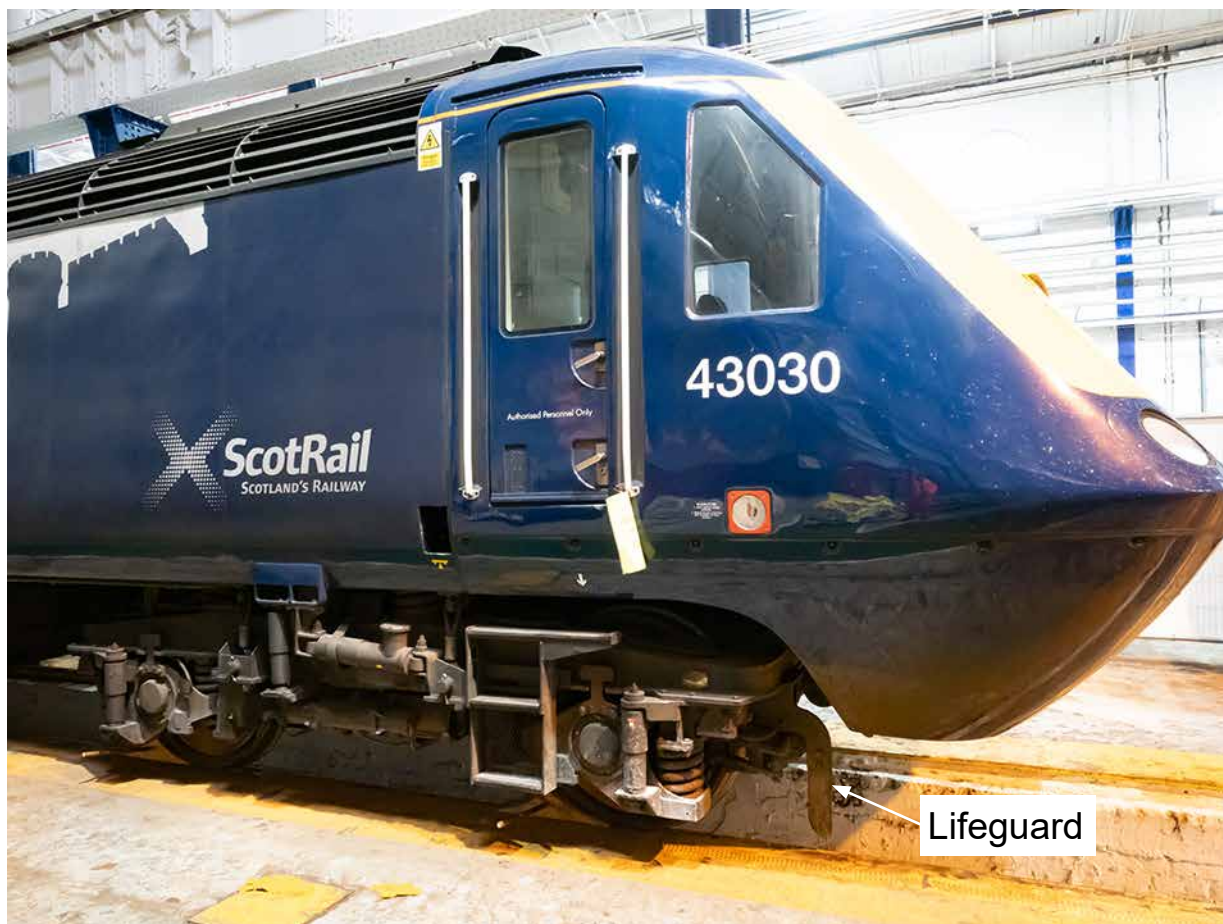
268 Lifeguards on rail vehicles are heavy metal brackets fitted immediately in front of the leading wheels of a train. Their purpose is to prevent small<sup>30</sup> obstacles getting under the leading wheels and causing derailment. Figure 58 shows one of the lifeguards fitted to the trailing power car.

Figure 58: HST lifeguard (trailing power car)

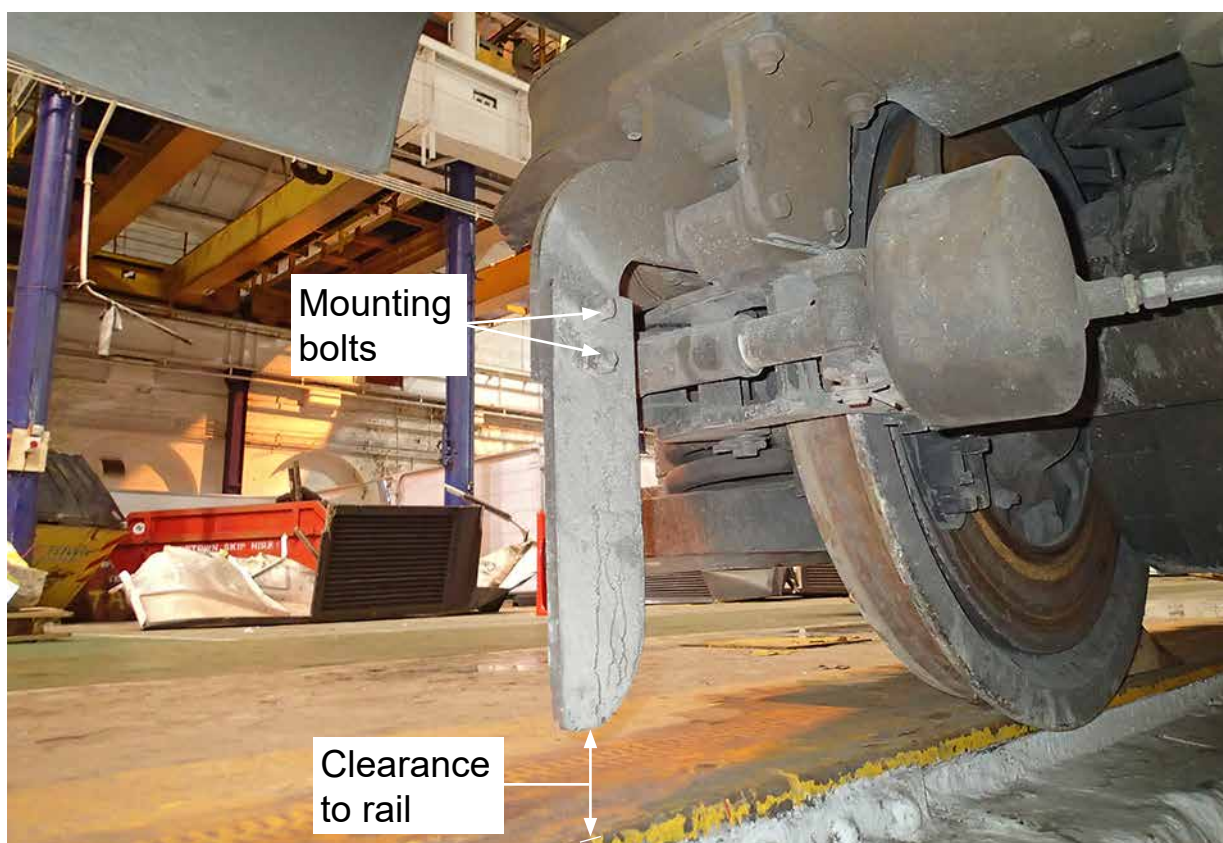
269 To allow for suspension movements and wheel wear, lifeguards are mounted with a clearance between the bottom of the lifeguard and railhead (figure 59) to ensure the lifeguard never contacts the railhead during normal operations. The amount of clearance varies between train types and until 2011 there was no specified value in British railway standards. From 2011 the LOC&PAS TSI<sup>31</sup> (now superseded by the LOC&PAS NTSN<sup>32</sup> which imposes the same requirement) applied to new rolling stock and introduced a height range above the railhead of between 30 mm and 130 mm in all conditions. There is a parallel requirement in British domestic standards, introduced from 2011, for a lifeguard to be positioned as close as reasonably practicable to the railhead taking into account wheel wear, suspension movements, suspension wear and assembly tolerances. The clearance of the lifeguards above rail level on the leading power car could not be measured due to the damage they sustained in the accident. The clearance on the trailing power car was measured by RAIB as 58 mm for both lifeguards. The normal operational range for HST power cars is 48 to 85 mm.

Figure 59: Lifeguard mounting bolts and clearance between bottom of lifeguard and railhead

- 271 The HST lifeguard was designed before the introduction of GM/RT2100. The lifeguard comprises a vertical blade made from mild steel which is bolted to a bogie-frame mounted bracket by means of two bolts (figure 59). Using design drawings, RAIB has calculated that the ultimate strength of the HST lifeguard is around 15 kN. This is less than half the minimum ultimate strength of lifeguards compliant with current standards. The weakest point of the HST lifeguard is the lower of the two attachment bolts, which shears when the lifeguard is overloaded, allowing the lifeguard to rotate backwards, so preventing it from carrying any significant load and performing a clearing function. At Carmont both lifeguards failed at the bolted joint and rotated backwards. This mode of failure is similar to that seen in a previous accident, but in that case the train struck heavy debris from a fallen bridge parapet, which would have been likely to have damaged a modern lifeguard.<sup>34</sup>

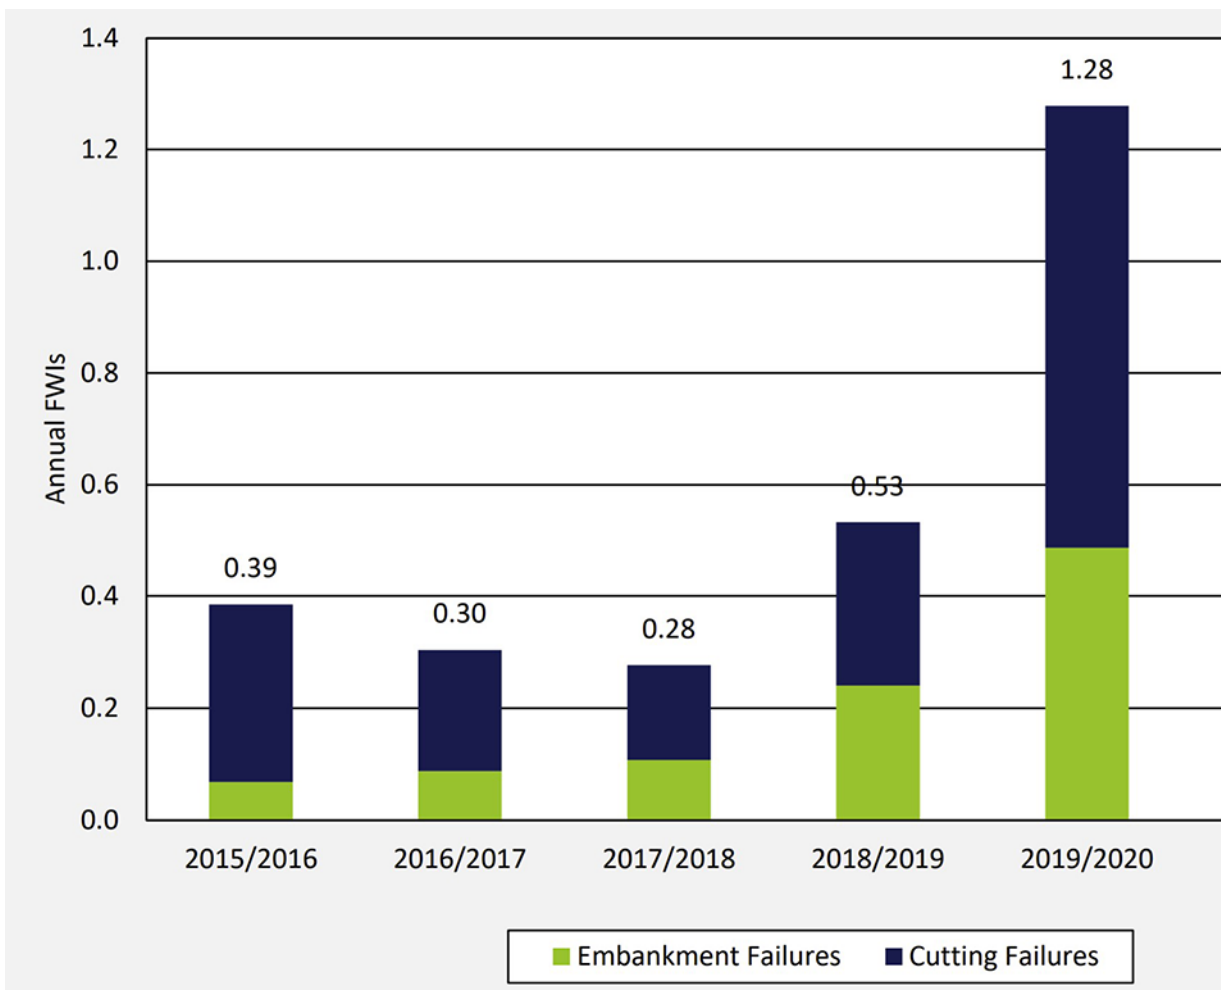
- 385 According to the PIM data provided by RSSB, the FWI/year associated with failures of earthworks in 2016/17 was 0.30 (table 4, and figures 65 and 66). In 2018/19, the estimate of FWI/year had risen to 0.53. In 2019/20 the estimated FWI/year had risen to 1.28, driven by the number and severity of storms during 2019/20 that resulted in earthwork failures (figure 67). This meant that earthwork failure now accounted for 27% of all train accident risk and about 60% of the train accident risk associated with asset integrity.

387 At first sight, the presentation of the PIM data in figures 65 and 66 might suggest that the risk from earthwork failures only started to rise in April 2018. However, since this risk is closely linked to the variability of the weather, it is important that risk management decisions are based on a longer view of changes in risk. The earthwork failure data at figure 64 shows that the five-year rolling mean average number of earthwork failures has been gradually rising over the last decade. Furthermore, rainfall data collected over the last 160 years suggests an increase in the UK’s average annual rainfall since the 1980s (figure 68). Since rainfall is closely linked to the risk of earthwork failure, it is likely that the underlying risk of earthwork failure has been rising for some considerable time.

Figure 66: Train accident risk from earthwork failures 2016 to 2020 (RSSB)

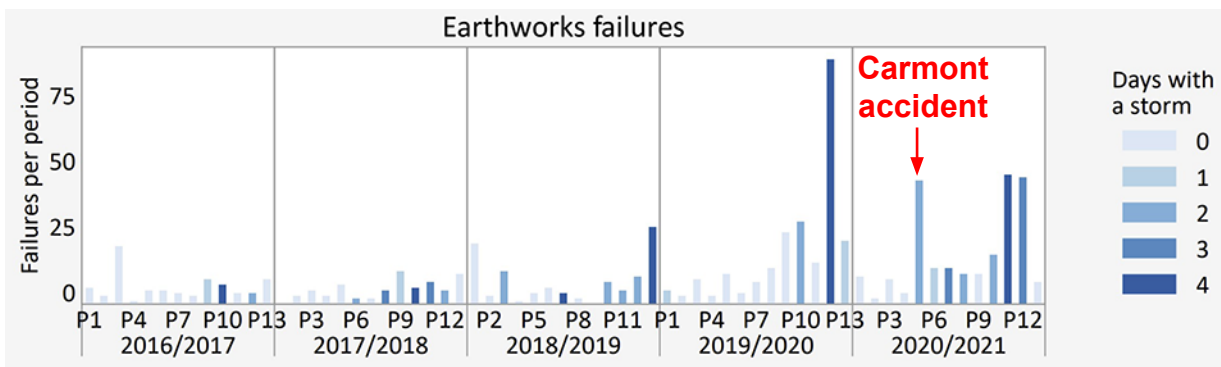
Figure 67: Earthwork failures and storm days plotted against time (RSSB)

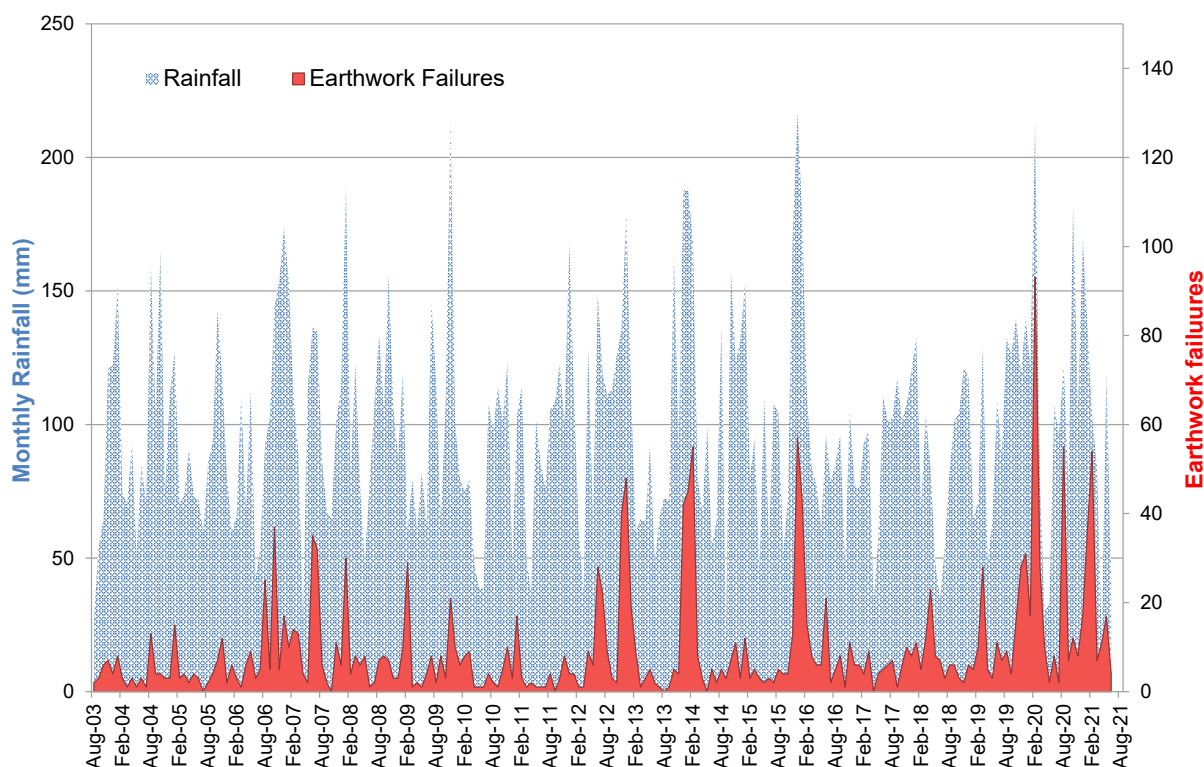
401 Earthwork failures (including those involving drainage) are usually related to periods of heavy rainfall. The correlation is apparent in figures 70 and 71 but is stronger than these plots suggest as the rainfall data is a nationwide monthly average, and so does not fully reflect a few days of very heavy rain and/or heavy rain limited to only part of Great Britain. The need for mitigation at earthwork locations is not dependent on recognising the precise mechanism for endangering the railway. As at Carmont, this is often impractical, so safe railway operation depends on recognising that extreme weather can result in unpredictable events at locations not previously considered to present a high risk.

Figure 70: Timeline of earthworks failures and rainfall 2015 to 2020 (Network Rail NR/L3/CIV/185 failures and Met Office national average rainfall data (<https://www.metoffice.gov.uk/pub/data/weather/uk/climate/datasets/Rainfall/date/UK.txt>))

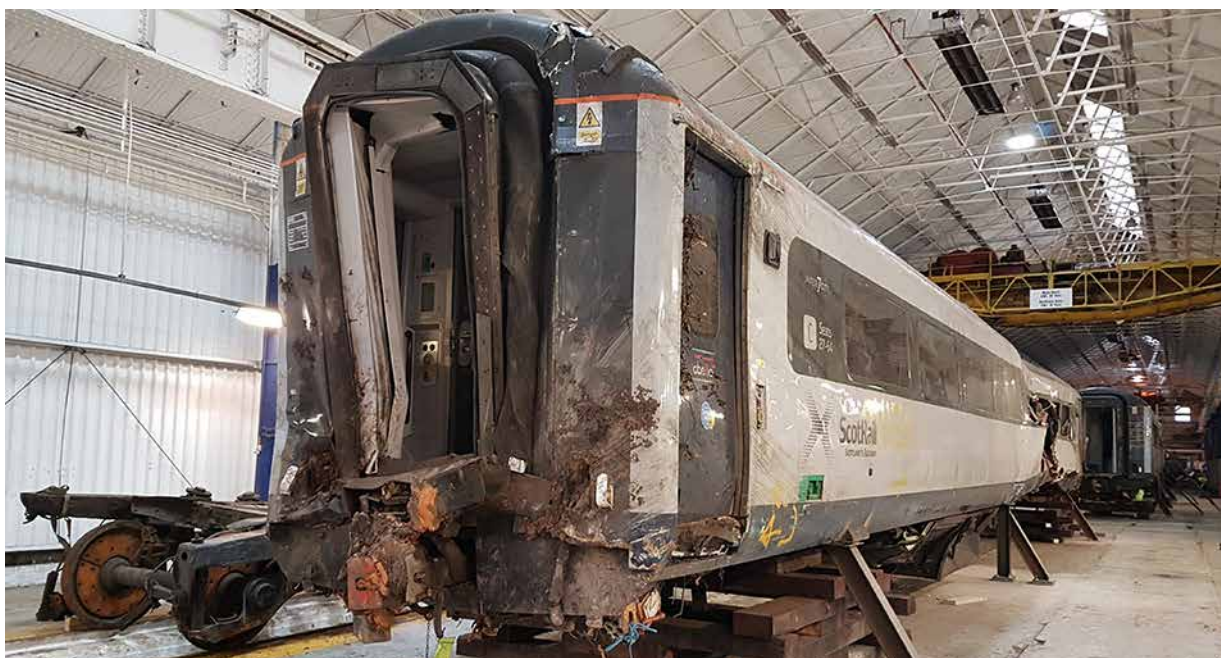
466 The second coach (C) sustained damage to the leading vestibule, which had struck trees and the rising bank on the right-hand side of the railway (figure 76). There was localised penetration damage to the trailing left-hand side (figure 77), most likely as a result of impacts with detached bogies. There was also penetration damage to the trailing right-hand side where coach A had struck coach C, leaving a part of coach A's cantrail (a longitudinal structural member running along the vehicle length above the windows) embedded in the side of coach C. Four windows along the left trailing side were broken through. The coach retained its survival space and the interior furniture remained in place, except within a localised area at the trailing end where the seats had been pushed into the aisle as a result of penetration damage to the left-hand body side. Both bogies became detached and there was severe damage to underframe equipment.

Figure 76: Leading end of coach C

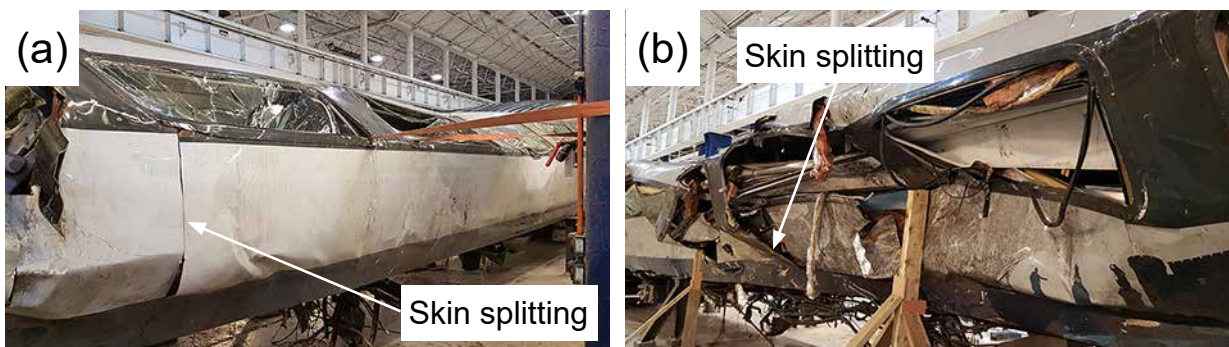
Figure 82: Bodyside skin splitting on coach D, left side (a) and right side (b)

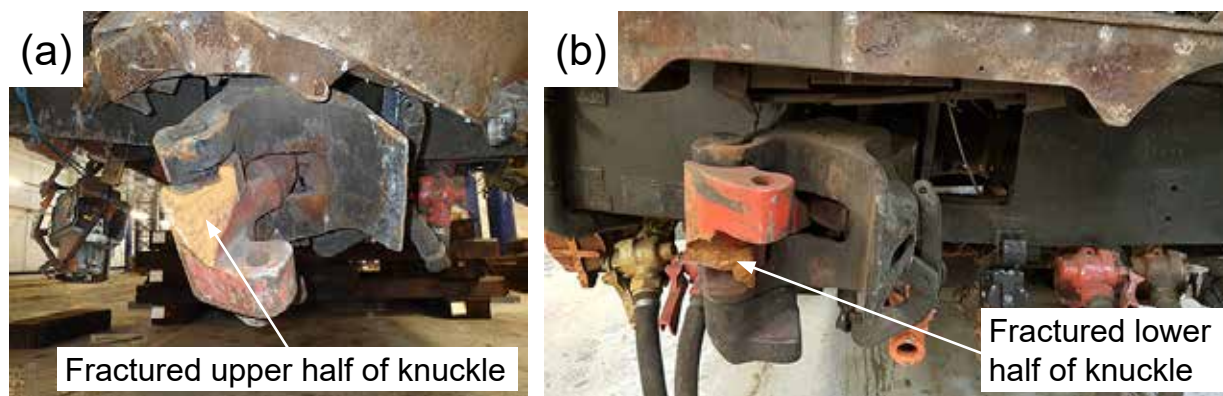
503 The typical failure mode of the coupler was fracture of either the upper or lower half of the knuckles of the coupler (figure 83). The same failure mode of the Alliance coupler was also noted in the investigation following the derailment at Ufton Nervet.<sup>56</sup>

Figure 83: Fractured knuckles on the couplers of coach D leading end (a) and trailing end (b)

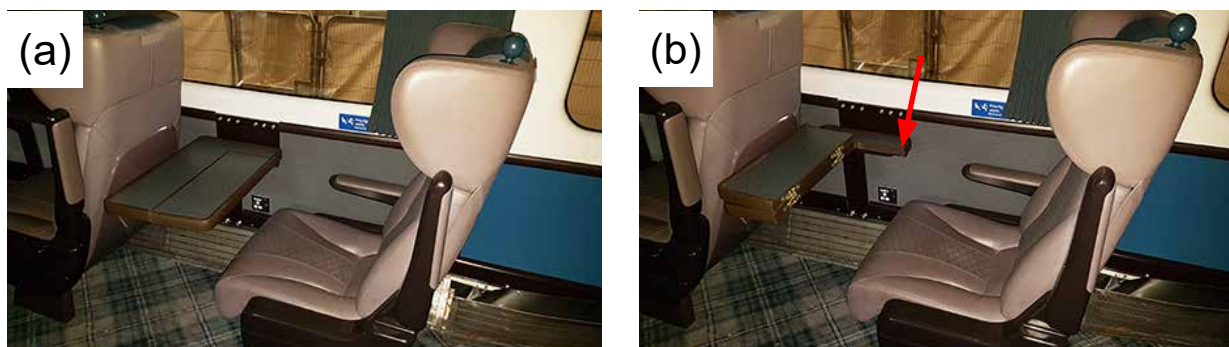
- 510 The folding tables used with the single 'priority' seats at four locations in the first class coach A were observed to have a particularly sharp corner when in the folded position (figure 84b). This corner could cause injury to a seated forward-facing passenger in the event of a train collision in which they were thrown forwards into the table. The same folding table design is also used in coach B at two locations adjacent to wheelchair positions. In the coach B positions, it poses less of a risk to a passenger sitting in a wheelchair because the side of the wheelchair frame would impact the sharp corner. When in the flat (down) position, no sharp edge is presented (figure 84a). No occupants were seated next to these folding tables or injured by them during the derailment at Carmont.

Figure 84: First class folding table from coach A in flat position (a) and folded position (b). Sharp corner indicated by red arrow. The same table design is also used at two positions in coach B
