Rail Accident Investigation Branch

# Rail Accident Report

**Derailement of a passenger train at Carmont,  
Aberdeenshire  
12 August 2020**

Report 02/2022  
March 2022

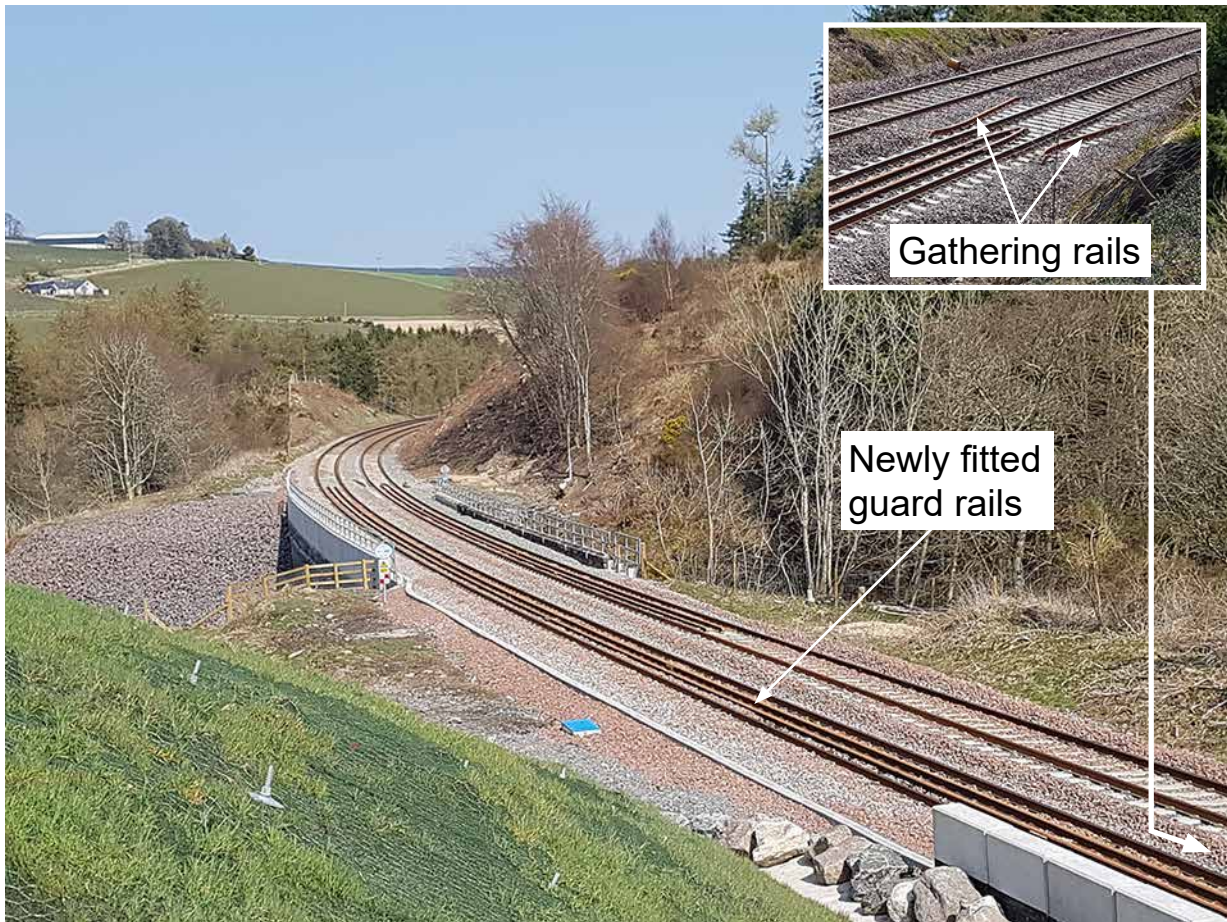
537 At the time of the derailment, no guard rails were installed on the approach to and over the bridge at Carmont. The purpose of guard rails is to contain any derailed wheels so that they remain close to the track and do not allow the train to deviate into collision with the infrastructure (for example, tunnel portals, bridge parapets) or trains on adjacent lines. Guard rails usually comprise a pair of parallel steel rails fitted to the sleepers in the four-foot. The ends of the rails are usually tapered so that they converge to a point at the centre of the track and are able to gather any derailed wheels. Gathering rails can also be fitted outside the running rails. To be effective in guiding a derailed train approaching a high-risk area, guard rails need to extend for a sufficient distance on the approach to the tunnel, bridge or other feature that poses the potential risk to the derailed train. Guard rails have since been installed at the Carmont accident site as part of the track reinstatement works (figure 86).

Figure 86: Guard rails fitted post-accident at bridge 325. The gathering rails are positioned at the start of the guard rails to the right of the main picture

621 Guard rails were fitted on both up and down lines on the approach to bridge 325 when the track was relaid after the accident (figure 86). The protection includes gathering rails (paragraph 537) and, on the down line, extends beyond the site of the washout.

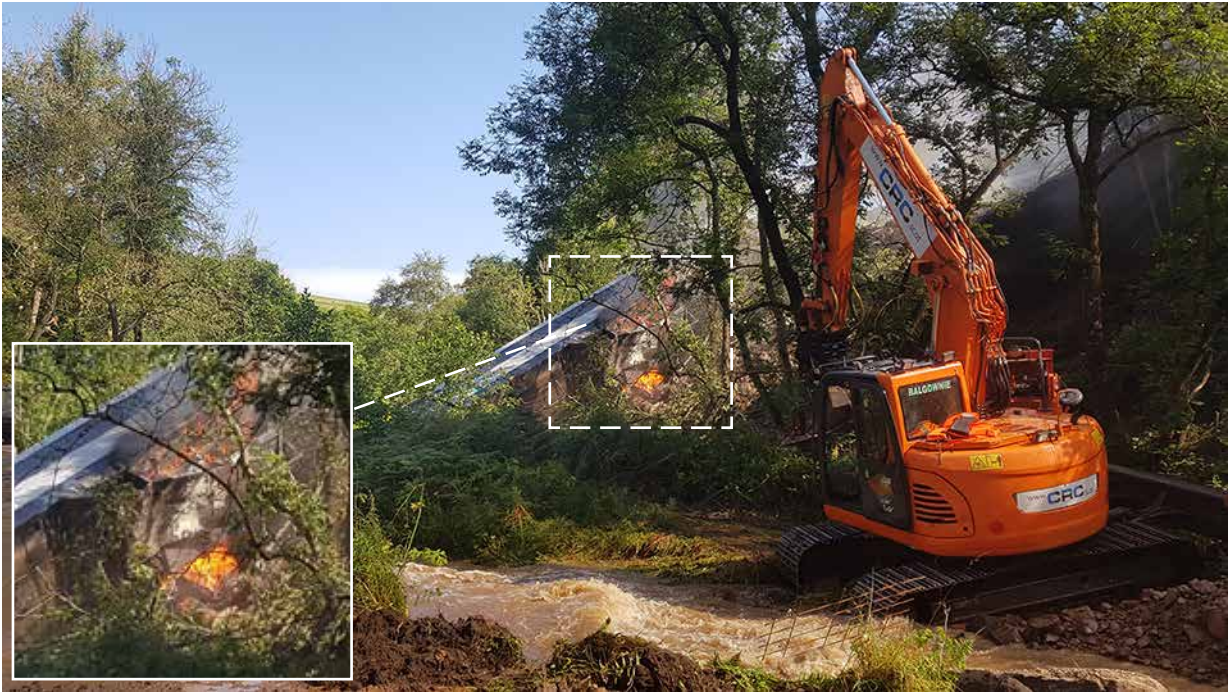
549 Coach B caught fire after coming to rest on the embankment flank with its right-hand side on the ground and sloping so its leading end was lower than its trailing end. The fire was not apparent to witnesses until around 11:00 hrs (approximately 90 minutes after the accident). Photographs indicate that no fire was apparent before 10:22 hrs, but by 11:09 hrs a significant fire had developed around the battery box (figure 88). The following paragraphs describe the evidence showing that this was the source of the fire which then entered the coach through a floor opening, required for the ventilation system, before spreading up towards the rear of the coach.

Figure 88: Coach B on fire at 11:09 hrs (Mark Davidson)

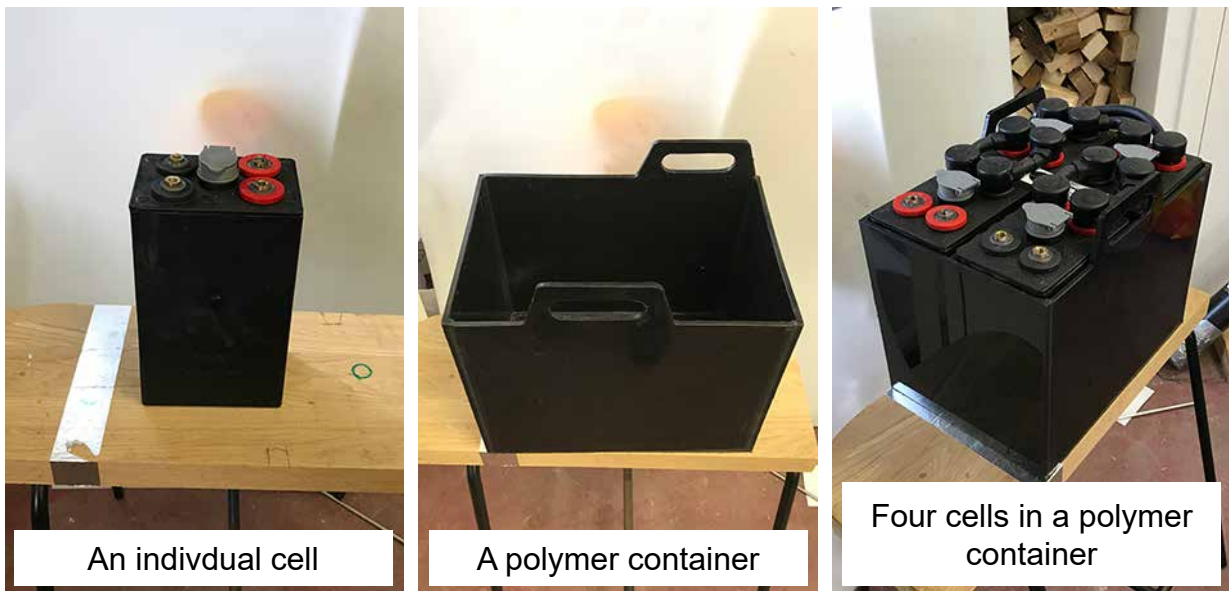
550 Coach B equipment included auxiliary batteries located in a battery compartment on the right-hand side of the underframe, between one-third and halfway along the coach from the front. The battery compartment contained 48 individual lead-acid cells, each of which contains 2 kg of a polymer material. These individual cells are packaged in groups of four, each group contained within a polymer box containing sheets of polymer honeycomb (figure 89).

Figure 89: Coach B auxiliary battery arrangement

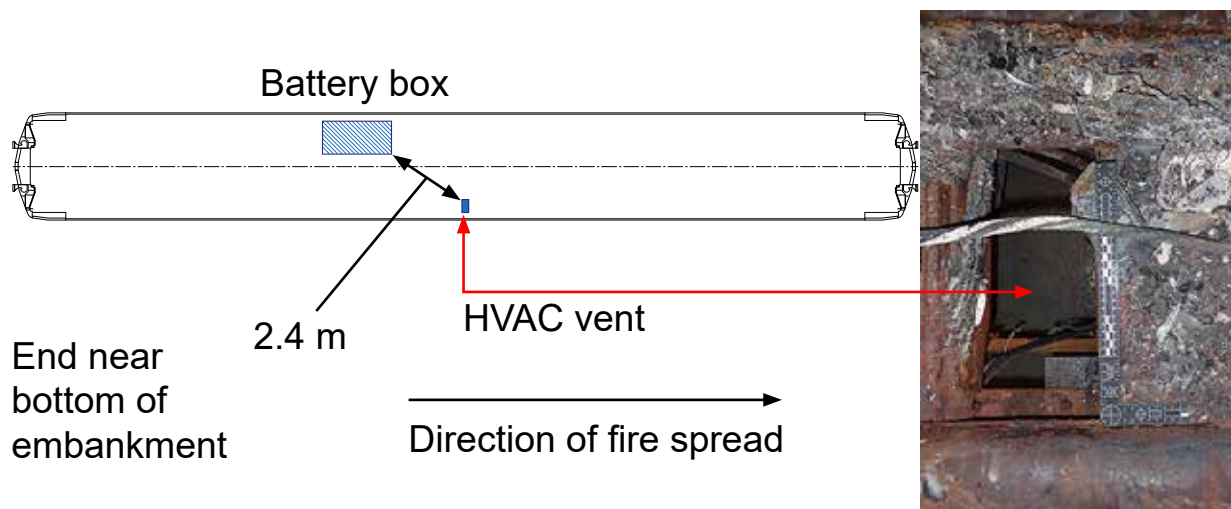
557 The subsequent spread of the fire was a result of the coach coming to rest on its right-hand side on the slope, with its trailing end uppermost. This orientation meant that the fire naturally extended across the underframe and grew towards the trailing end of the coach. The rectangular hole on the left-hand side, designed to allow air from the HVAC system into the passenger compartment, was likely likely to have been the route of the fire into the coach's interior. This hole, measuring approximately 280 mm by 160 mm, is 2.4 metres away from the battery box, diagonally across the underframe.<sup>67</sup> It was exposed during the accident because the lightweight sheet metal ducting previously connected to it was stripped away from the underframe during the accident. The hole with evidence of surrounding fire damage is shown in figure 90.

Figure 90: Opening for ventilation system in coach B floor

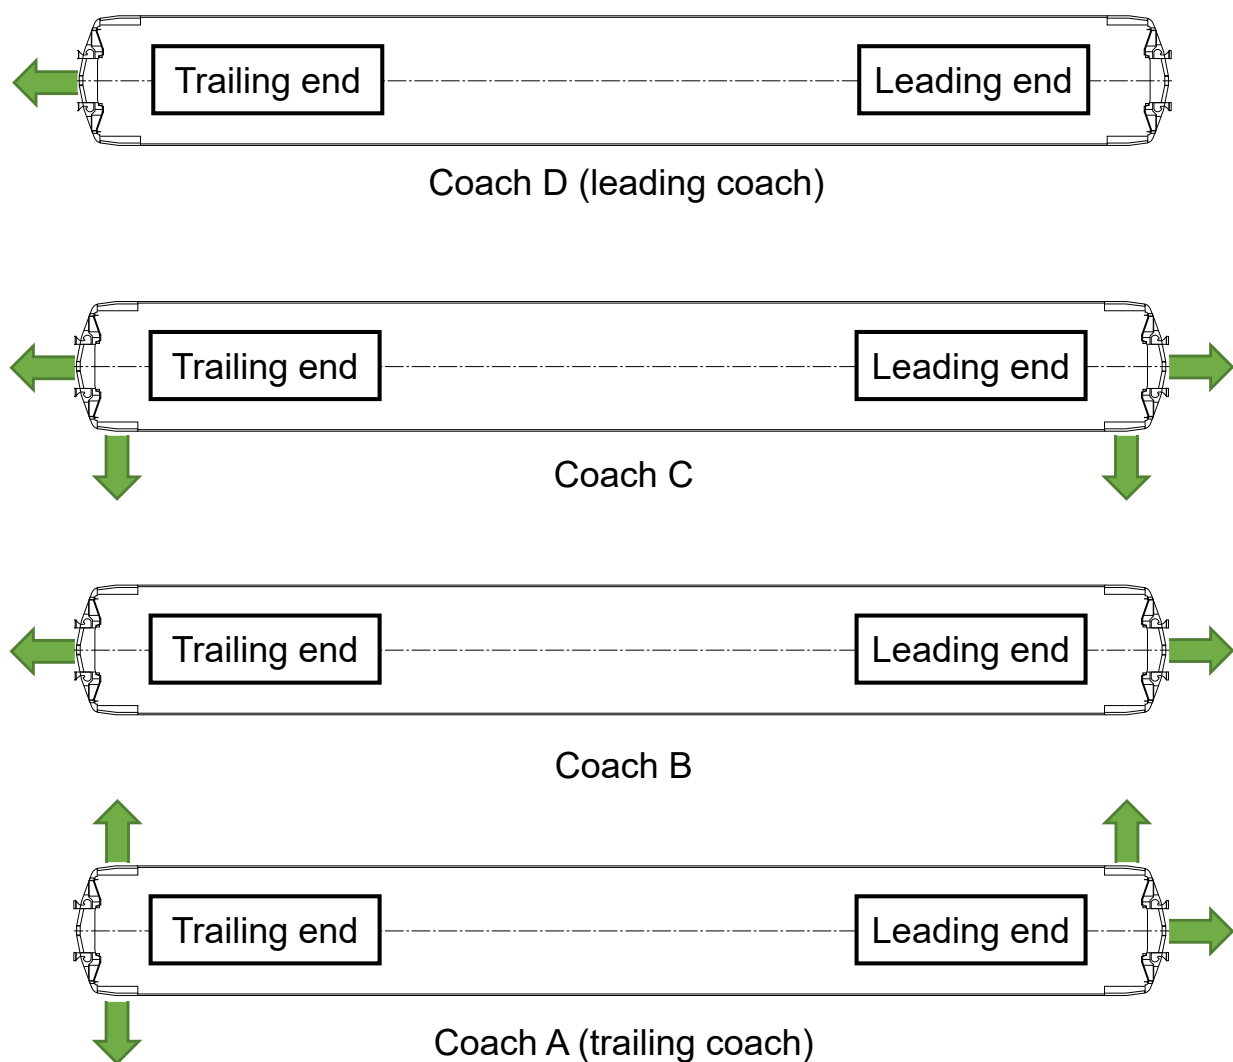
564 Post-accident inspections of the train after it was removed from the accident site were undertaken to determine the status of the egress routes, taking into account the disposition of the vehicles on site. The forces required to manually open the doors after activating the emergency door release (where possible) were also measured. Those which required a greater force than 250 Newtons (25 kg force) were considered too difficult to open and considered unavailable. Figure 93 shows the available egress routes.

Figure 93: Egress routes available to survivors from each vehicle

565 Coach D only had only one egress route available (discounting broken windows). All the other coaches had a minimum of two routes available. Coach B, which had rolled onto its side, only had two routes because the doors on the low side were blocked and those on the high side would have been difficult to open due to their position above anyone in the coach. There were no egress issues resulting from the power door modifications to the mark 3 coaches.

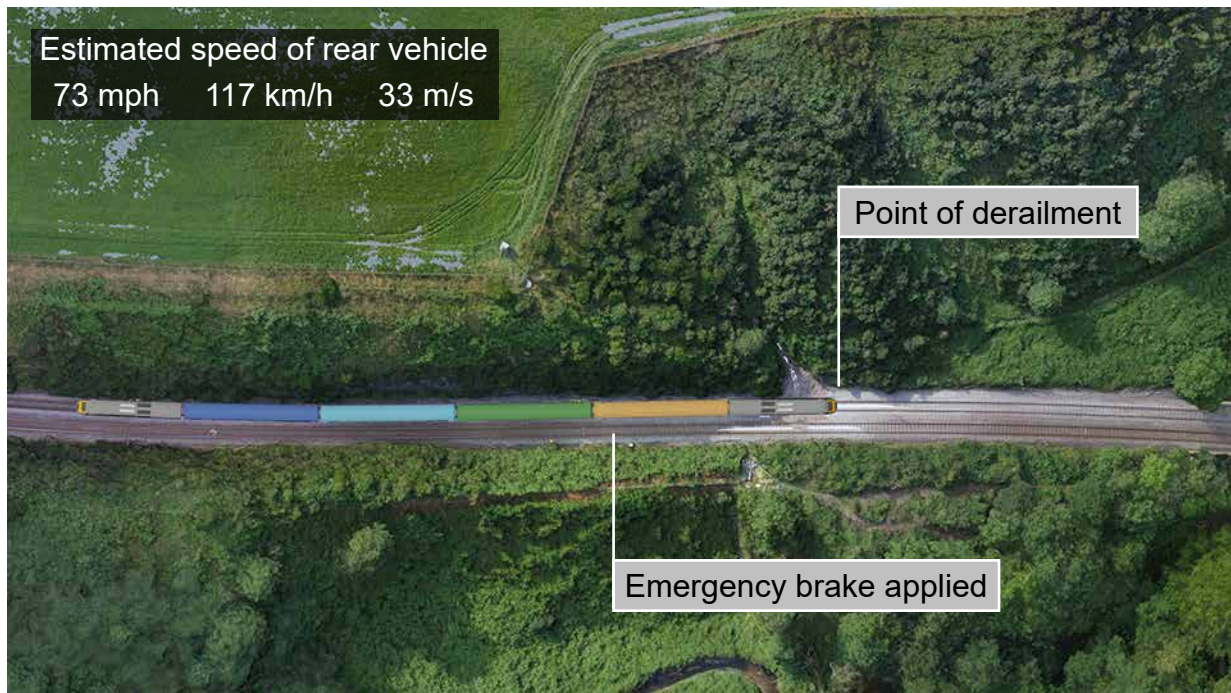
Figure E.1 ( $T= 0$  seconds):

- Leading power car's leading bogie derails to the cess immediately after running over washout debris, followed by trailing bogie.

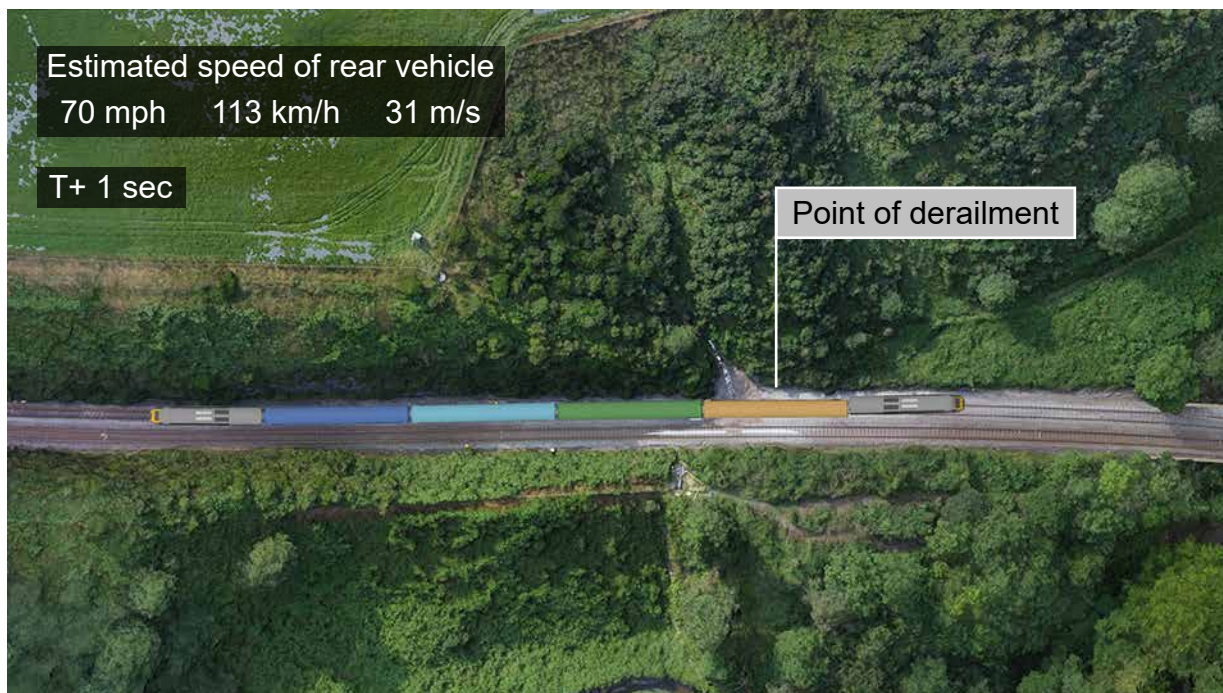
Figure E.2 (T+1 second):

- Leading power car's derailed leading bogie deviates further to the left.
- Derailed trailing bogie is restrained by coach D.

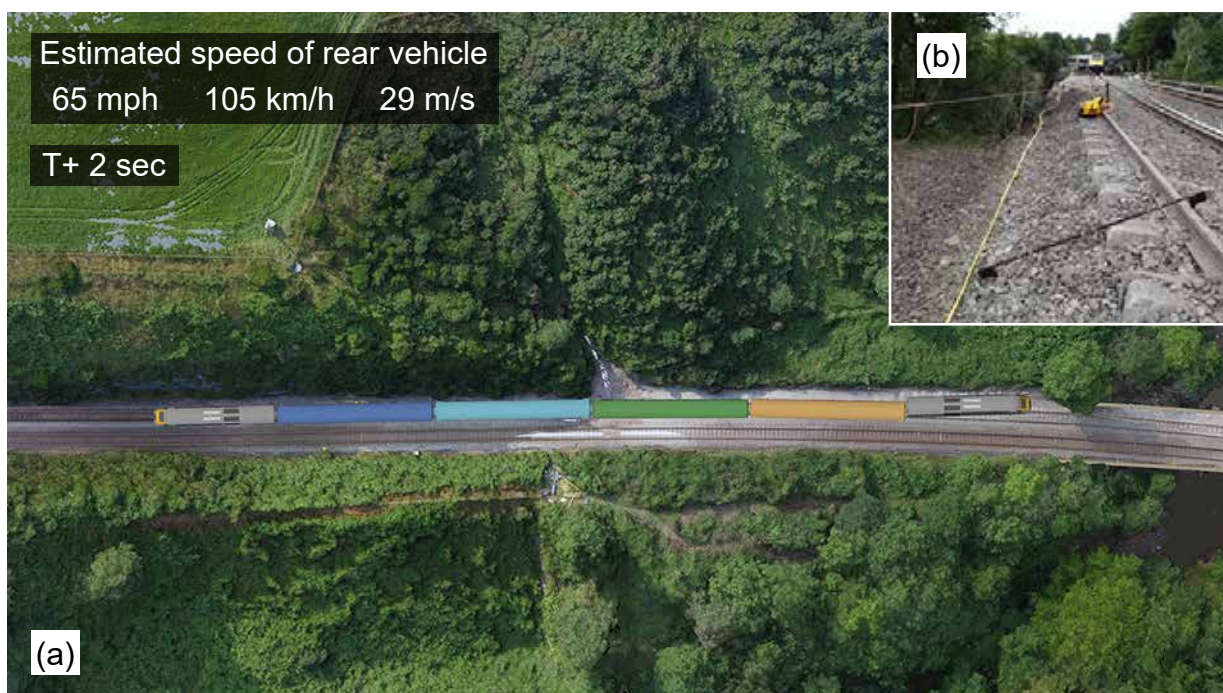
Figure E.3 (T+2 seconds):

- Leading bogie of the power car deviates further to the left and towards parapet, image (a).
- Trailing bogie is running derailed but still restrained by coach D.
- Inset image (b) shows position of leading wheelset (depicted by wheelset template) at sleeper 75 (around 53 metres from the washout).

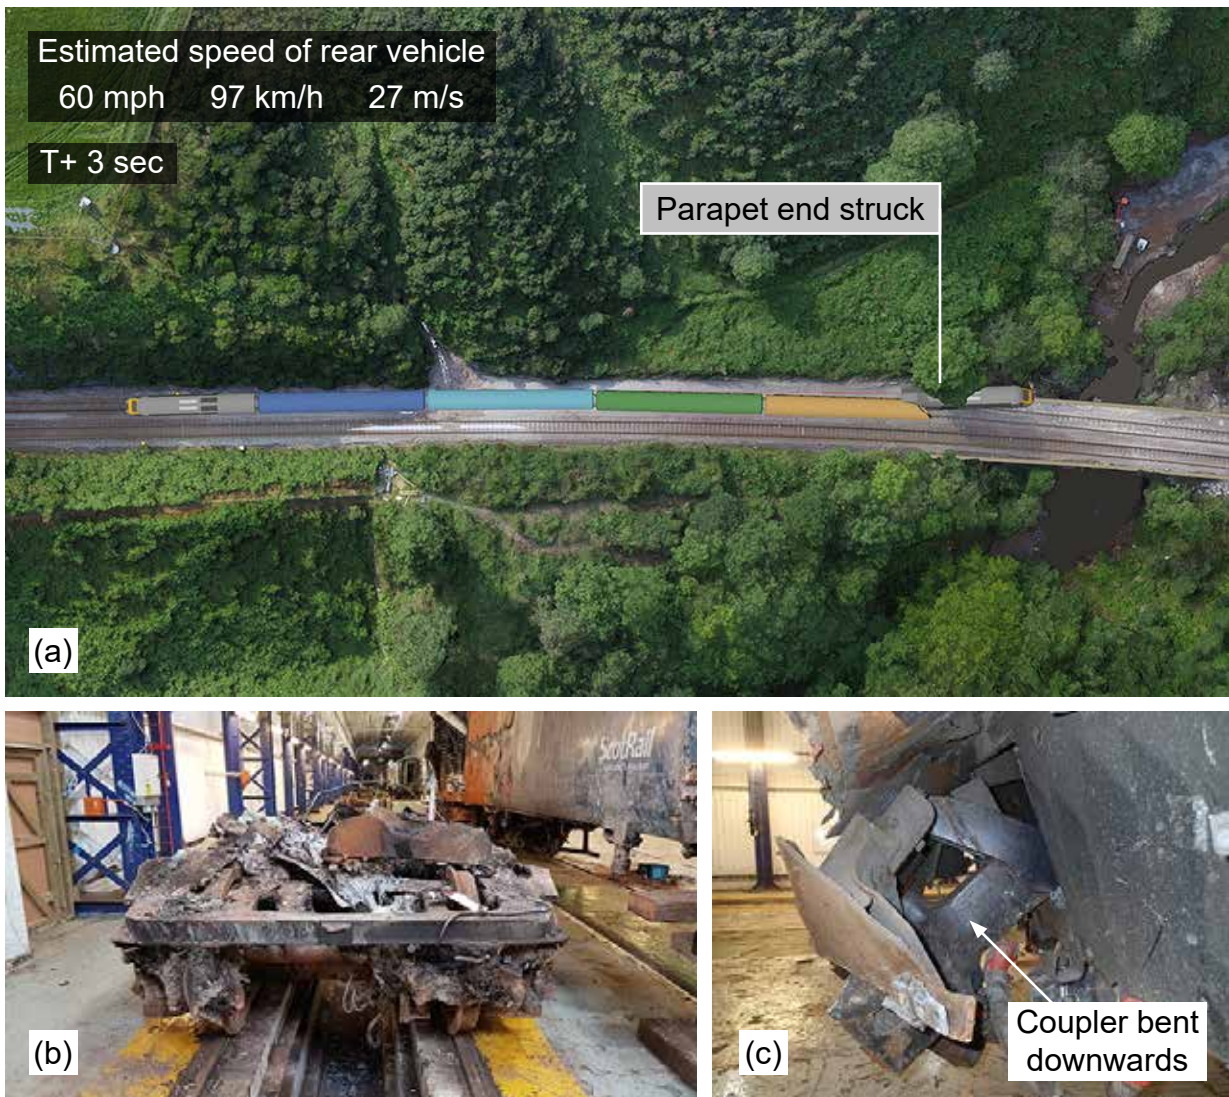
Figure E.4 (T+3 seconds):

- Leading power car strikes and demolishes left-hand bridge parapet, image (a).
- Sudden compressive force at the first interface and height difference between coach D (high) and power car (low) causes coach D to override the trailing right-hand side of the power car.
- Damage to leading bogie from impact with parapet, image (b).
- Damage to leading coupler of coach D - coupler bent downwards, image (c).

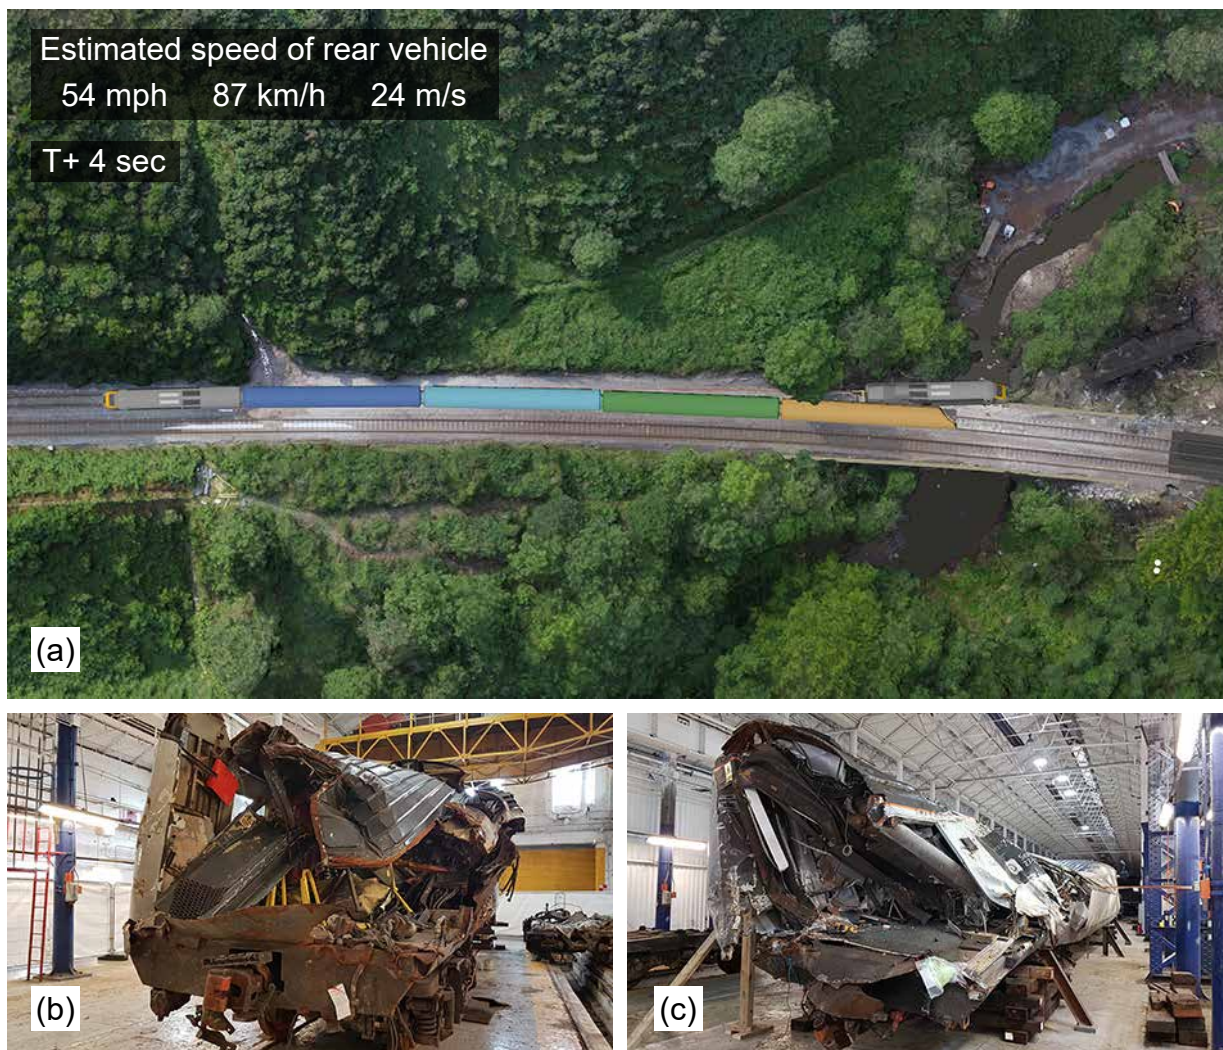
Figure E.5 (T+4 seconds):

- Overriding continues between leading power car and coach D, image (a).
- Rear of power car no longer restrained by coach D, image (b).
- Coach D lifts off from its leading bogie during overriding, which allows further interpenetration between the vehicles, image (c).
- Power car veers off the bridge.

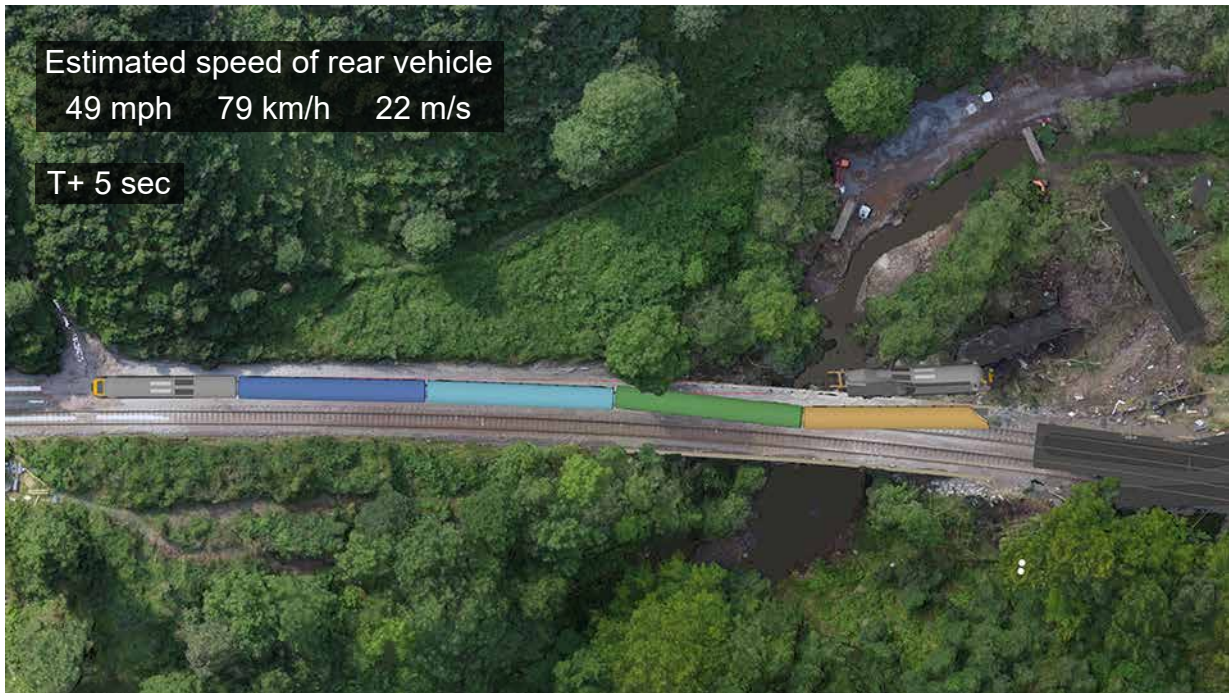
*Figure E.6 (T+5 seconds):*

- Leading power car starts to fall off the bridge.
- Leading end of coach D is pulled to the left during the override.
- Detached leading bogie from coach D follows power car off the bridge.
- Leading end of coach D, having lost its bogie, slides forward on its underframe equipment bay without its centre pivot digging into the ballast.

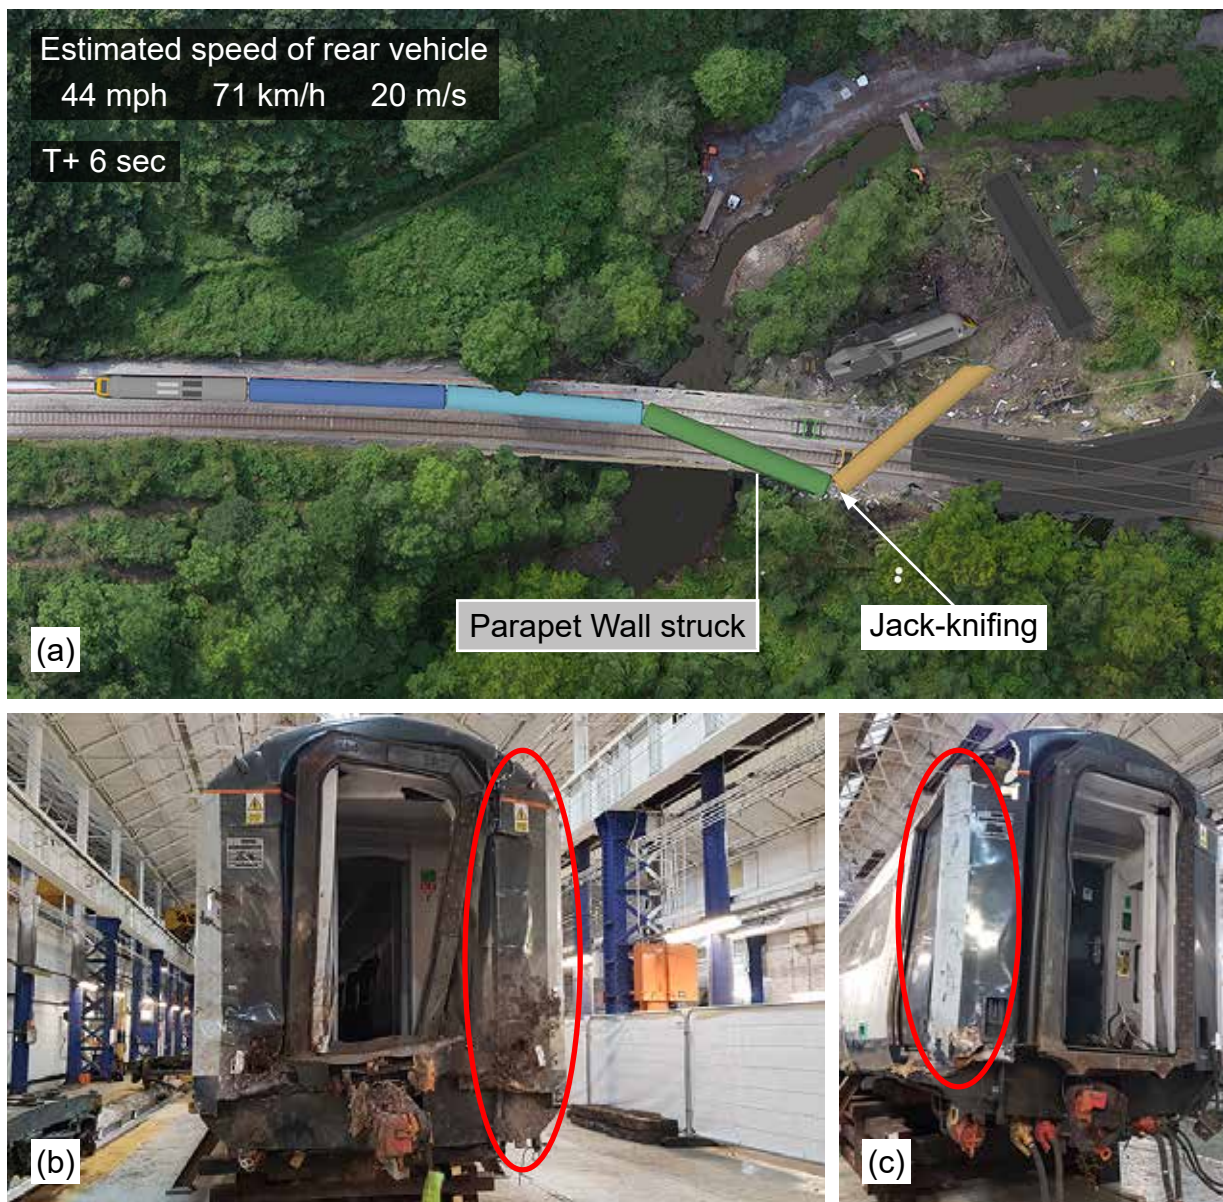
Figure E.7 (T+6 seconds):

- Leading power car impacts the embankment below the bridge, image (a).
- Leading end of coach D pitches down the embankment on the left, causing it to lift off its trailing bogie and slide on its underframe equipment.
- Lifting at the trailing end of coach D causes coach C to lift off its leading bogie.
- Jack-knifing develops at the interface between coaches C and D resulting in corner contact damage to coach C, image (b) and coach D, image (c).
- Jack-knifing pushes leading end of coach C to the right and into collision with the up-side bridge parapet.

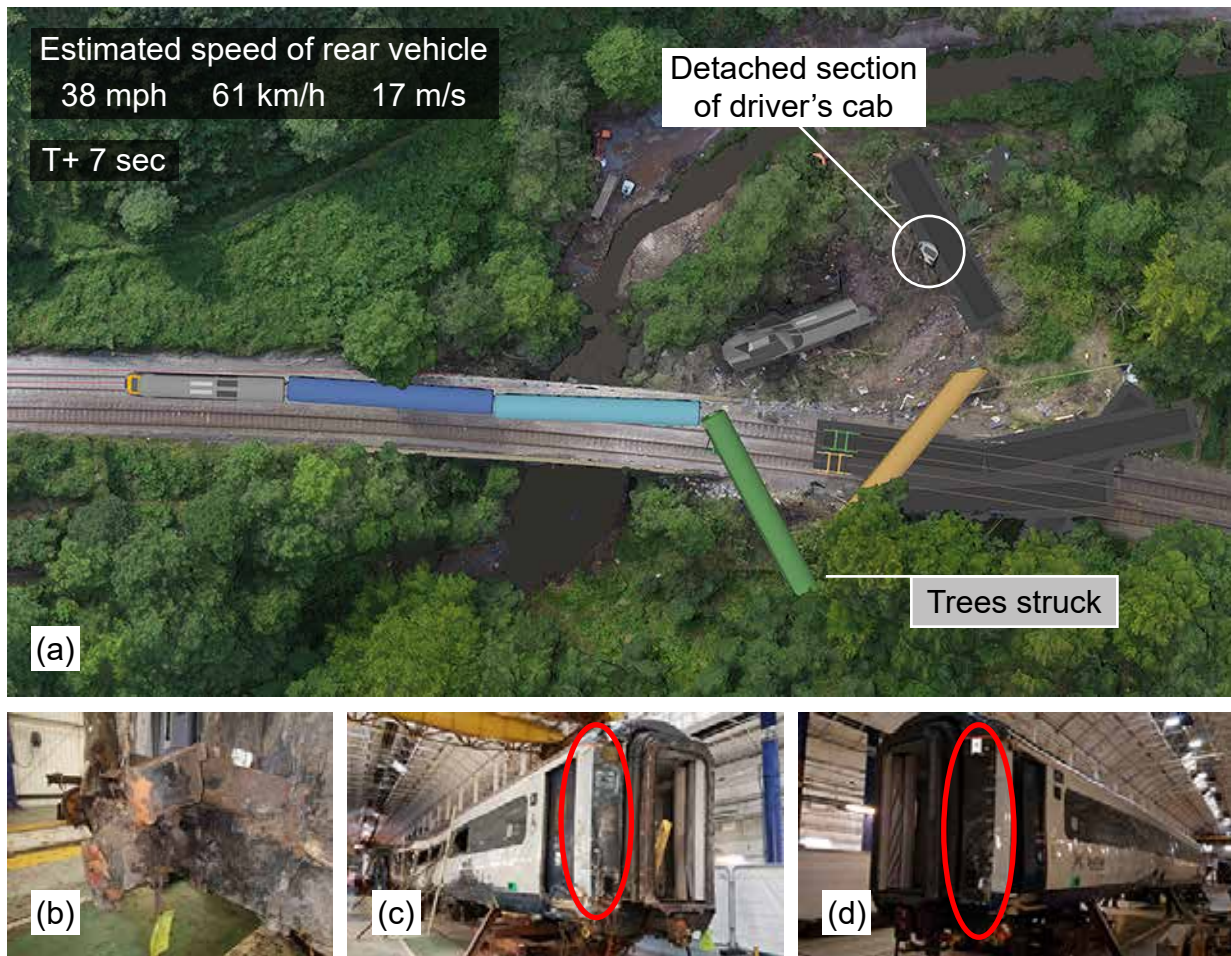
Figure E.8 (T+7 seconds):

- Driver's cab detaches and moves down the embankment slope, image (a).
- Coach C runs through trees while pitching down and impacts the earth bank on the up cress. Wood from trees in the up cress was found in the leading coupler of coach C, image (b), confirming its path.
- One passenger is ejected through the leading gangway of coach C.
- Jack-knifing occurs between coach C and coach B resulting in corner contact damage to coach B, image (c) and coach C, image (d).
- Coach D slides forward on its underframe, maintaining its rotated position.

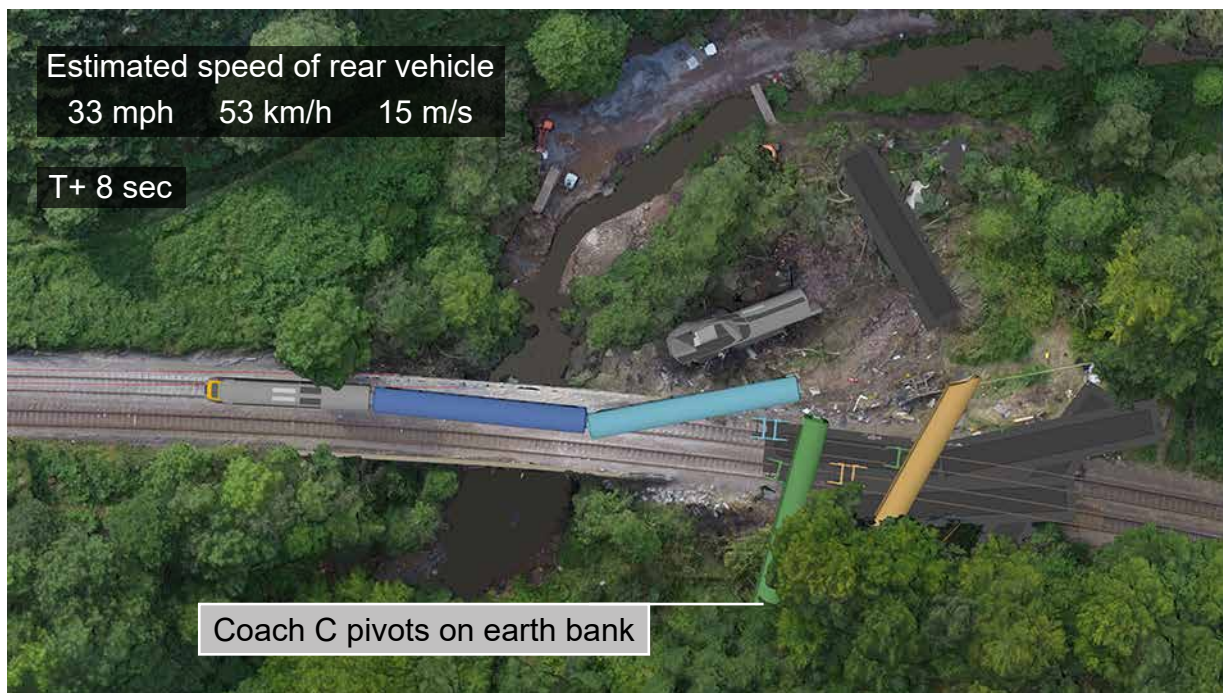
Figure E.9 (T+8 seconds):

- Coach C pivots about the earth bank in the up cess and is rotated round in a clockwise direction by coach B pushing it from behind.
- As coach C rotates, its trailing end pitches up, pushing the leading end of coach B off the track and lifting coach B off its leading bogie.
- Coach B starts to veer to the left and down the embankment.

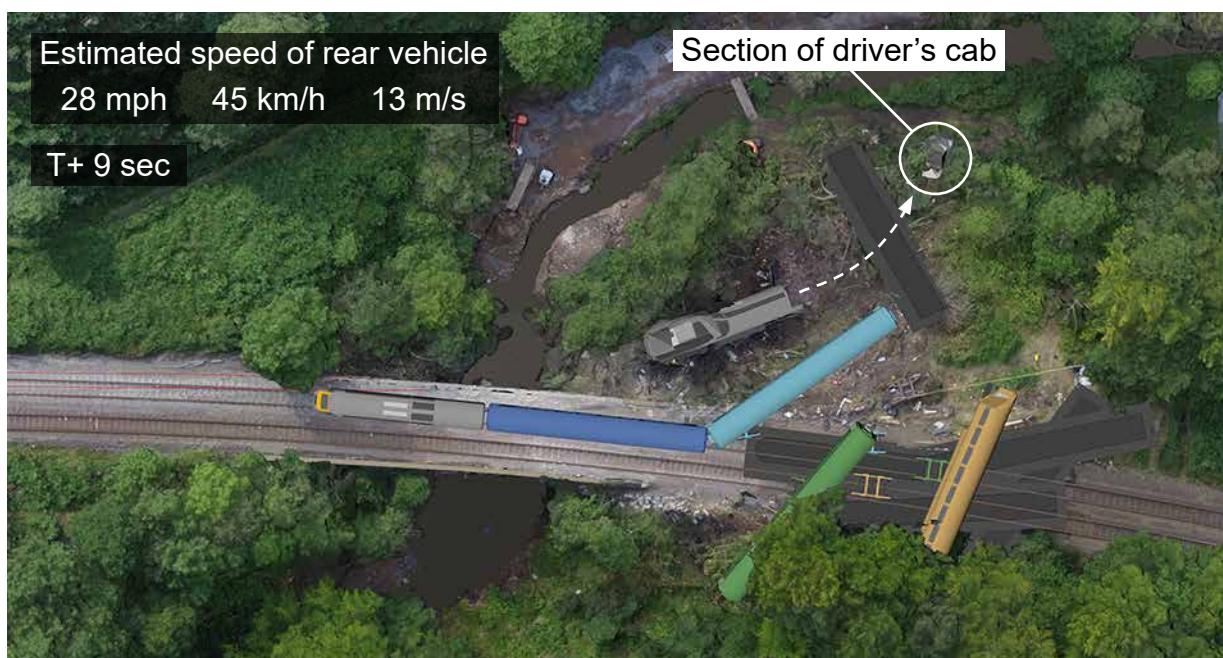
Figure E.10 (T+9 seconds):

- Driver's cab comes to rest at the bottom of the embankment.
- Coach B veers down the embankment, and rotates anticlockwise, being pushed from behind by coach A, and lifts off its trailing bogie.
- Coach C is still rotating clockwise under its own angular momentum.

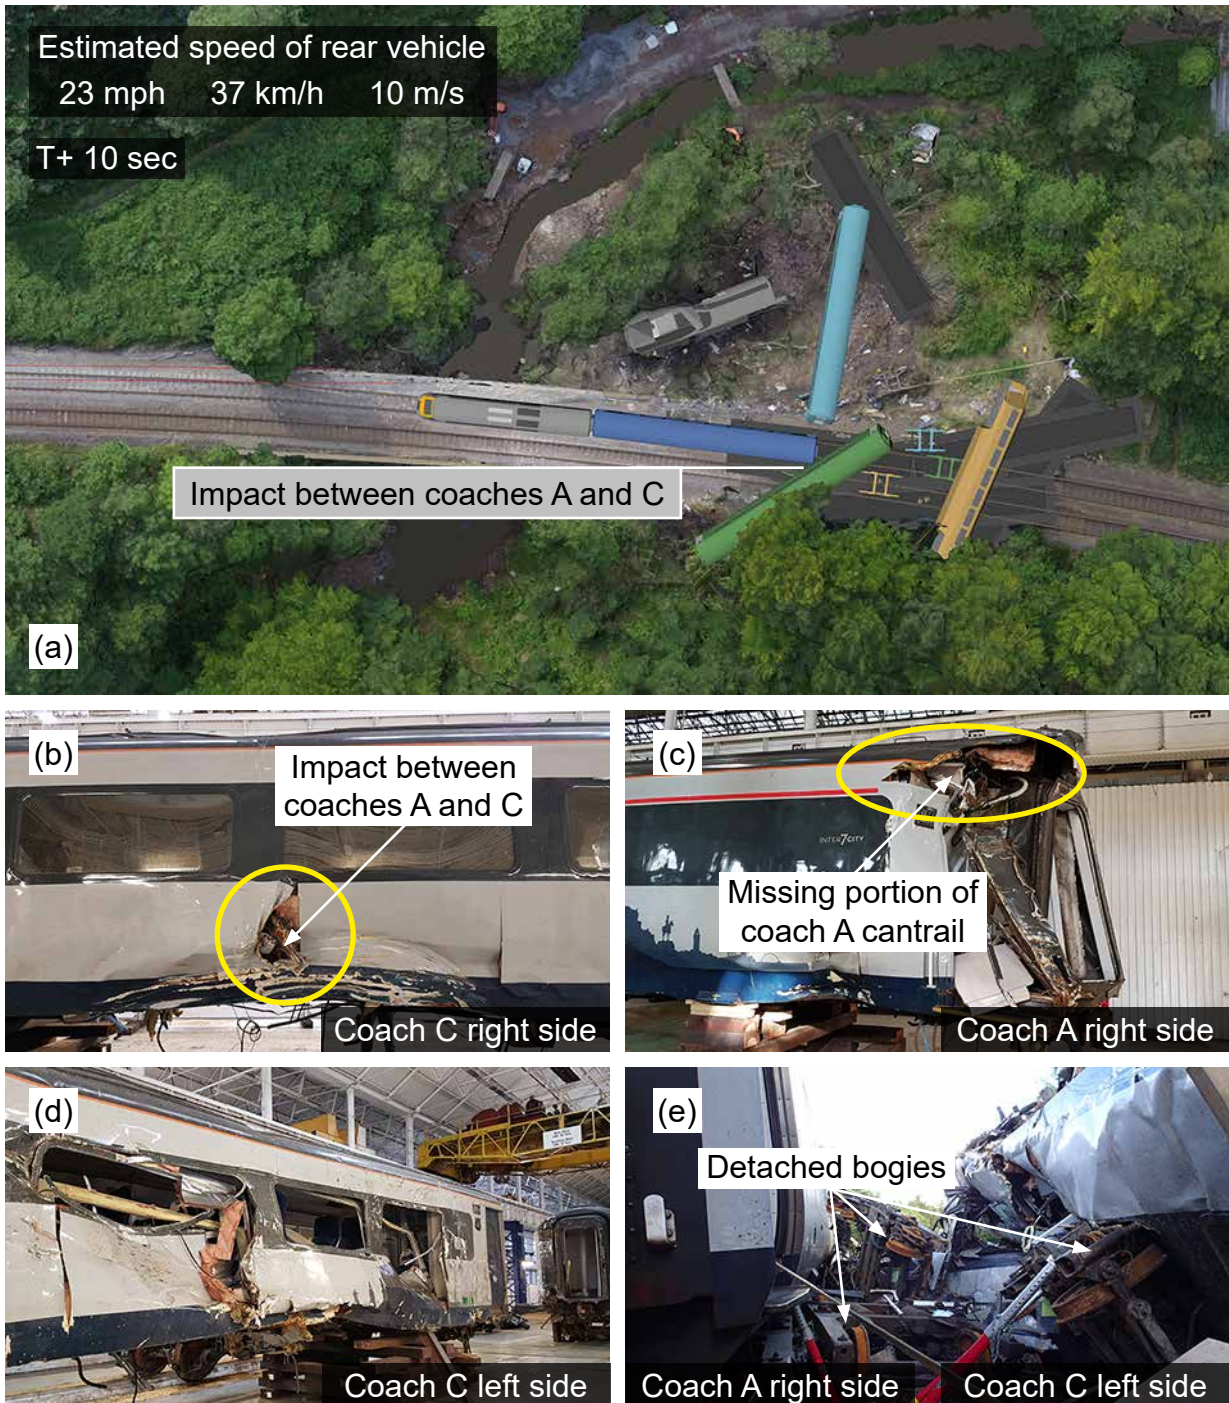
Figure E.11 (T+10 seconds):

- Coach A collides with coach C, penetrating coach C's bodyside, images (a) and (b) with a portion of its right-hand cantrail, image (c).
- Coach C is driven round clockwise by the impact with coach A and strikes detached bogies in its path, image (e). The trailing left-hand side suffers penetration damage, image (d).
- Meanwhile coach B continues to move towards its final rest position.
- Coach D is at a temporary rest position on its right side.

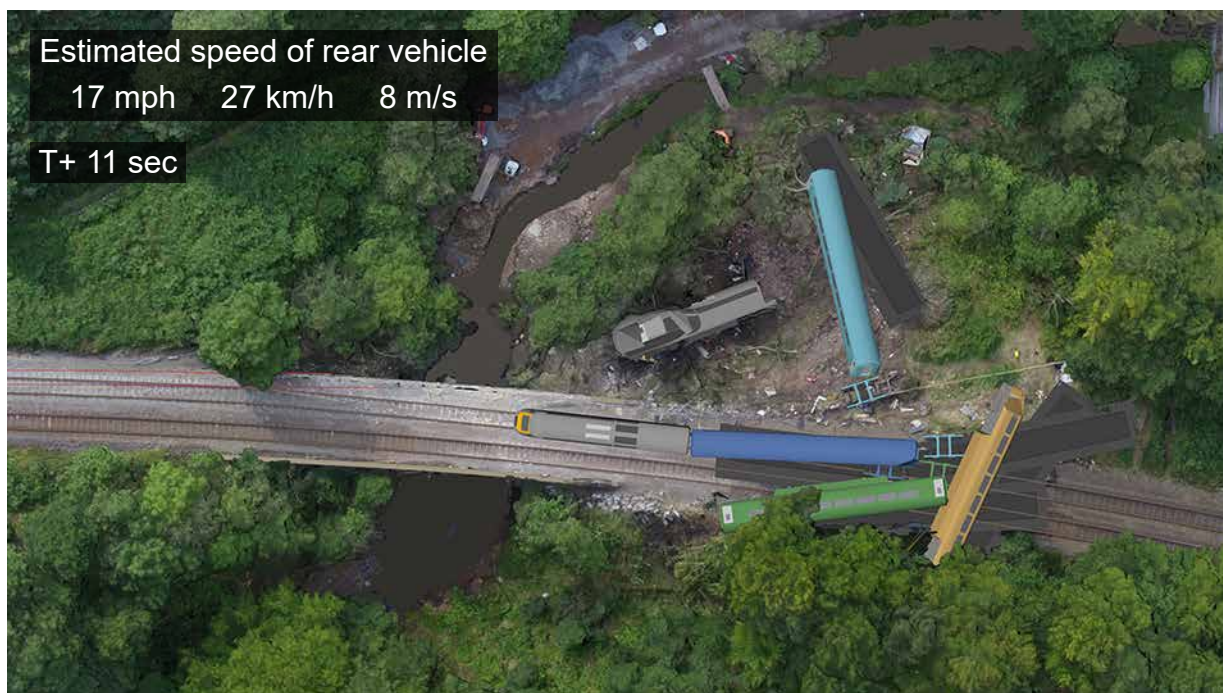
*Figure E.12 (T+11 seconds):*

- Coach A collides with detached bogies in its path and its leading end is lifted up off the leading bogie.
- Coach D is pushed further along the track by coach A and this contact starts to roll coach D over.
- Coach B continues to slip down the embankment.
- Coach C rotates further clockwise and is lifted and rolled by detached bogies onto the top of the trailing end of coach D.

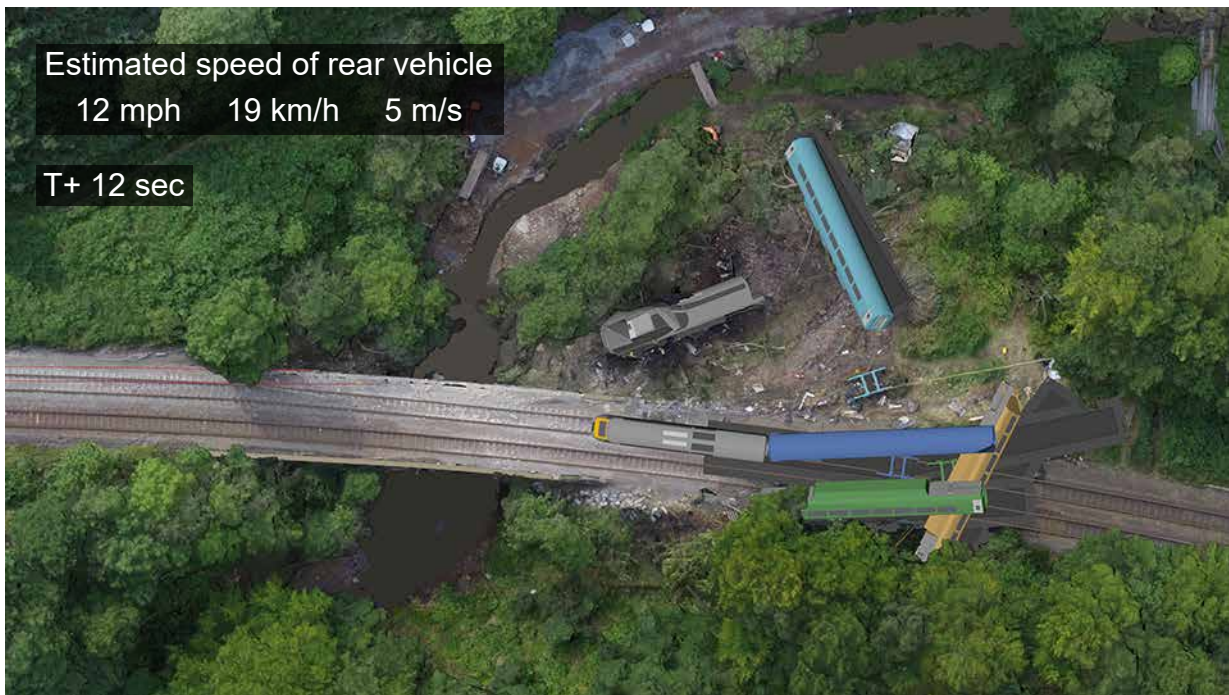
Figure E.13 (T+12 seconds):

- Coach A climbs over coach D, rolling it further onto its roof.
- Coach C rolls over onto its roof and moves to its final rest position on top of the trailing end of coach D.
- Coach B starts to roll over as its leading end approaches the bottom of the embankment.

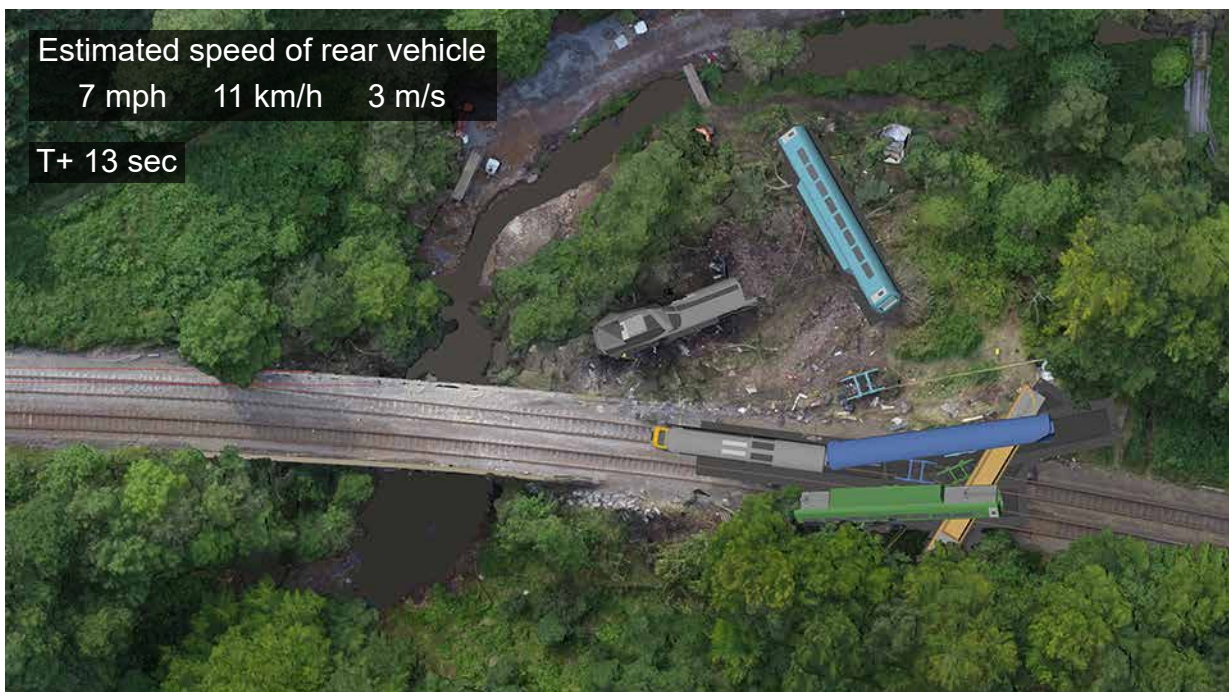
Figure E.14 (T+13 seconds):

- Coach A continues to climb over coach D.
- Coach B rolls over into its final rest position.

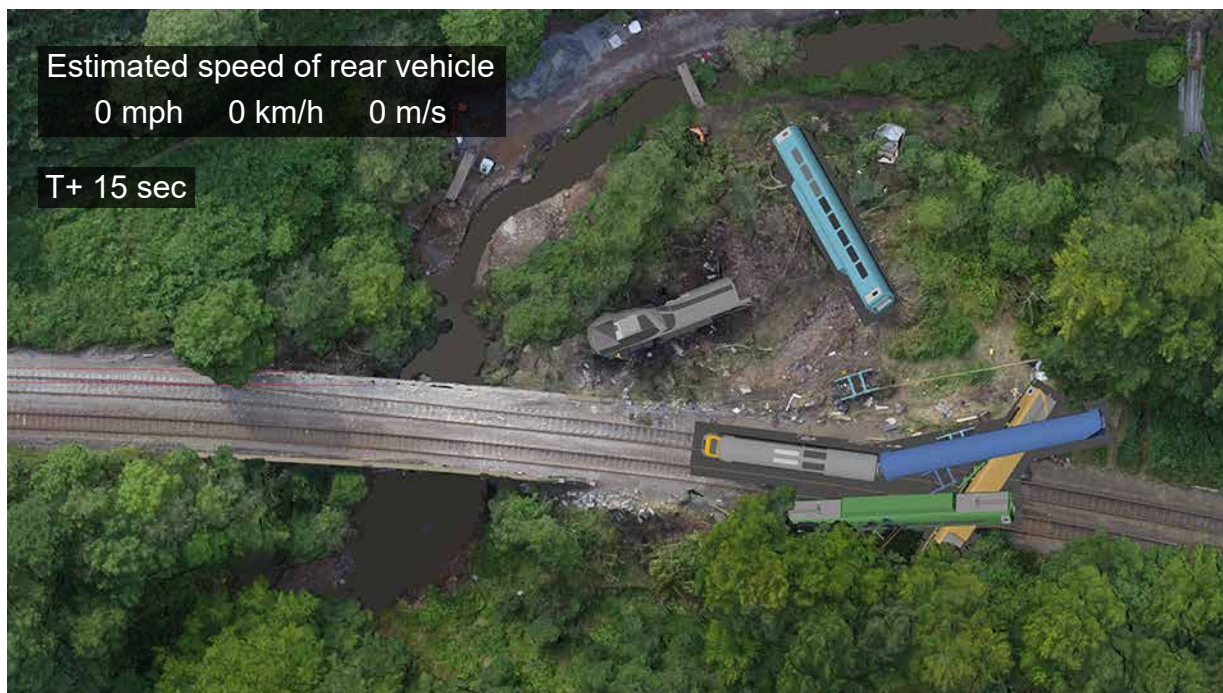
Figure E.15 (T+15 seconds and end of sequence):

- Rear power car has travelled approximately 240 metres during the accident.
