Rail Accident Investigation Branch

# Rail Accident Report

**Derailement of a passenger train at Carmont,  
Aberdeenshire  
12 August 2020**

Report 02/2022  
March 2022

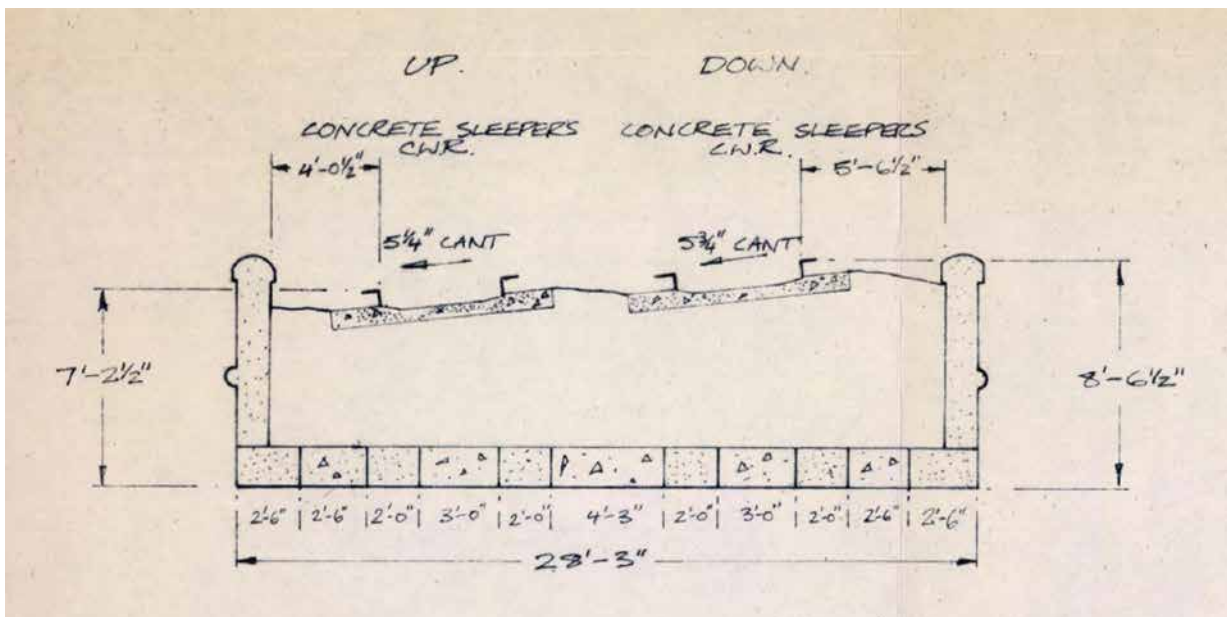
- F20 British Rail issued a structural assessment report for bridge 325 in December 1980. Photographs included in this report show that the reduced height sections of parapet had, by then, been infilled with concrete blocks to make each parapet a uniform height. Infilling the gaps allowed the ballast depth to be increased and a cross-section drawing within the report shows the top of the ballast at the same level as the underside of the coping (uppermost) stones on the down-side parapet (figure F.3). The ballast remained at about this level until the accident. A post and wire fence was installed as parapet edge protection for staff working on the railway.

Figure F.3: Drawing showing level of the tracks relative to the parapets (1980)

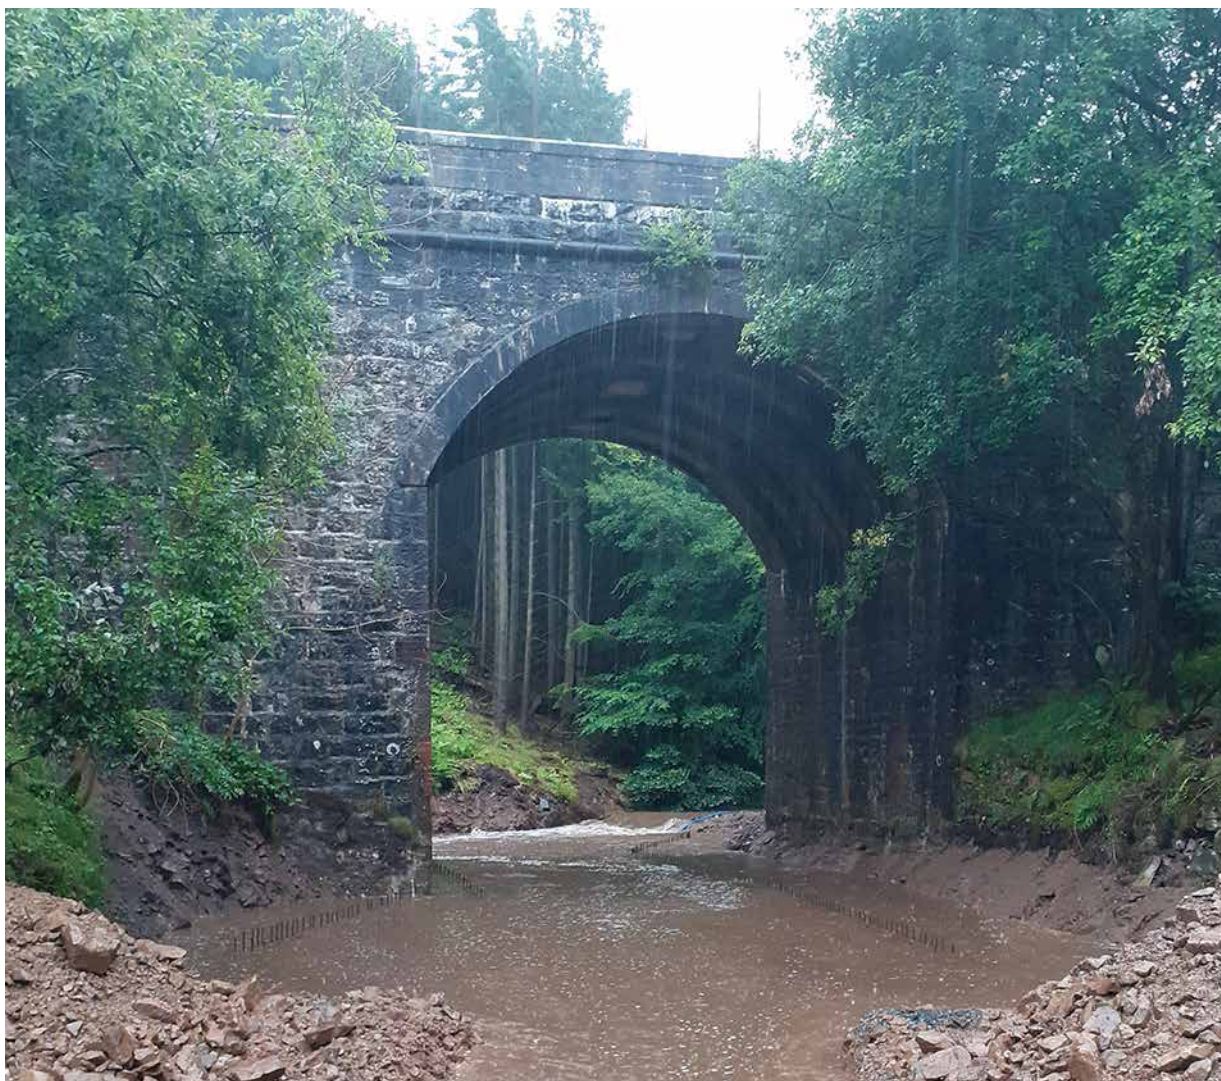
- F24 The depth of the ballast present before the accident meant that it applied an outward force on almost the full height of the down-side parapet wall and for a large proportion of the up-side parapet wall. It is possible this force contributed to the formation of longitudinal fractures between the arch and the spandrel walls (figure F.4). There is no evidence that these fractures influenced the behaviour of the parapets during the accident.

Figure F.4: Down-side elevation of bridge 325 at 08:19 hrs on 12 August 2020, shortly before the accident (Story Contracting)

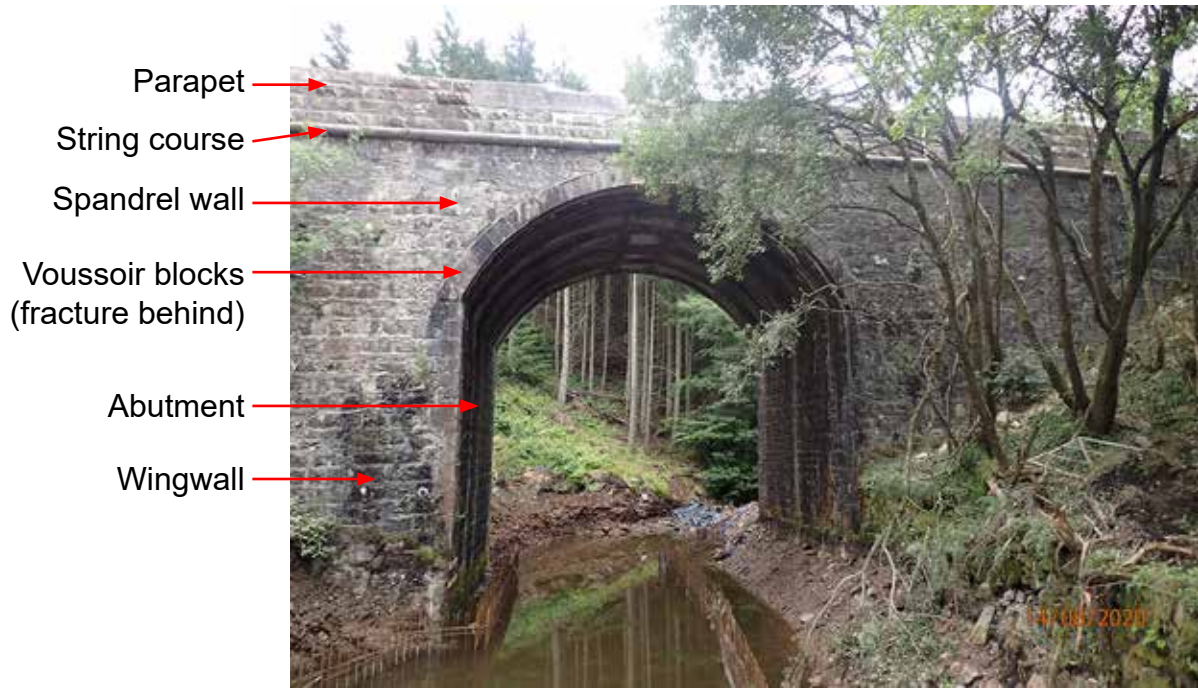
Figure F.7: Down-side elevation of bridge 325 on 14 August 2020

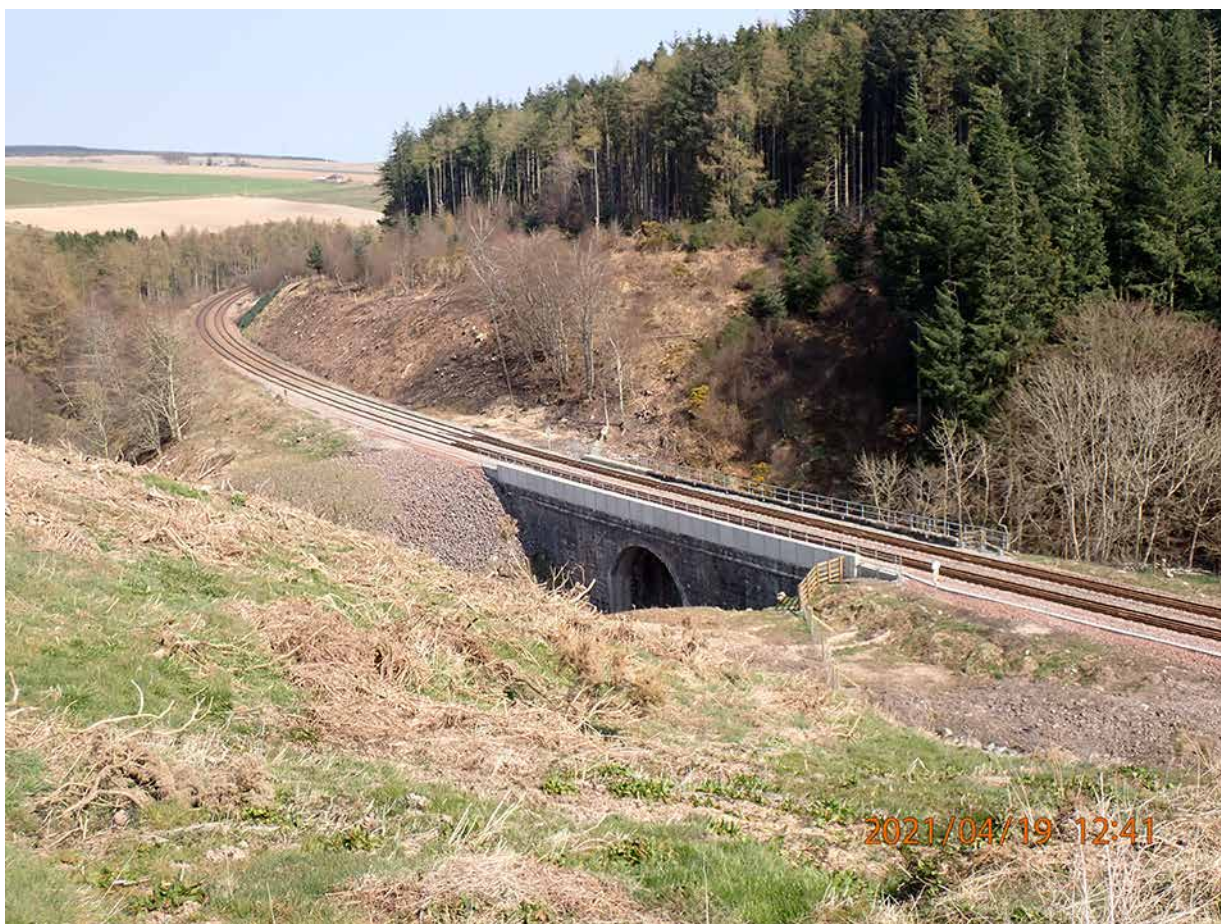
Figure F.9: Bridge 325 in April 2021 following the replacement of the down-side parapet and track

- Grouted stitching bars were installed to each stone (voussoir) in the arch ring embedded 2 metres into the arch barrel on both the up-side and down-side. Network Rail has confirmed that these works addressed existing defects within the structure (longitudinal separation fracture between spandrel (voussoir) and barrel), and were considered integral to reinstating the full integrity of the structure due to the potential impact damage suffered during the accident.

- Grouting of a vertical hairline fracture to the high mileage (north) abutment.

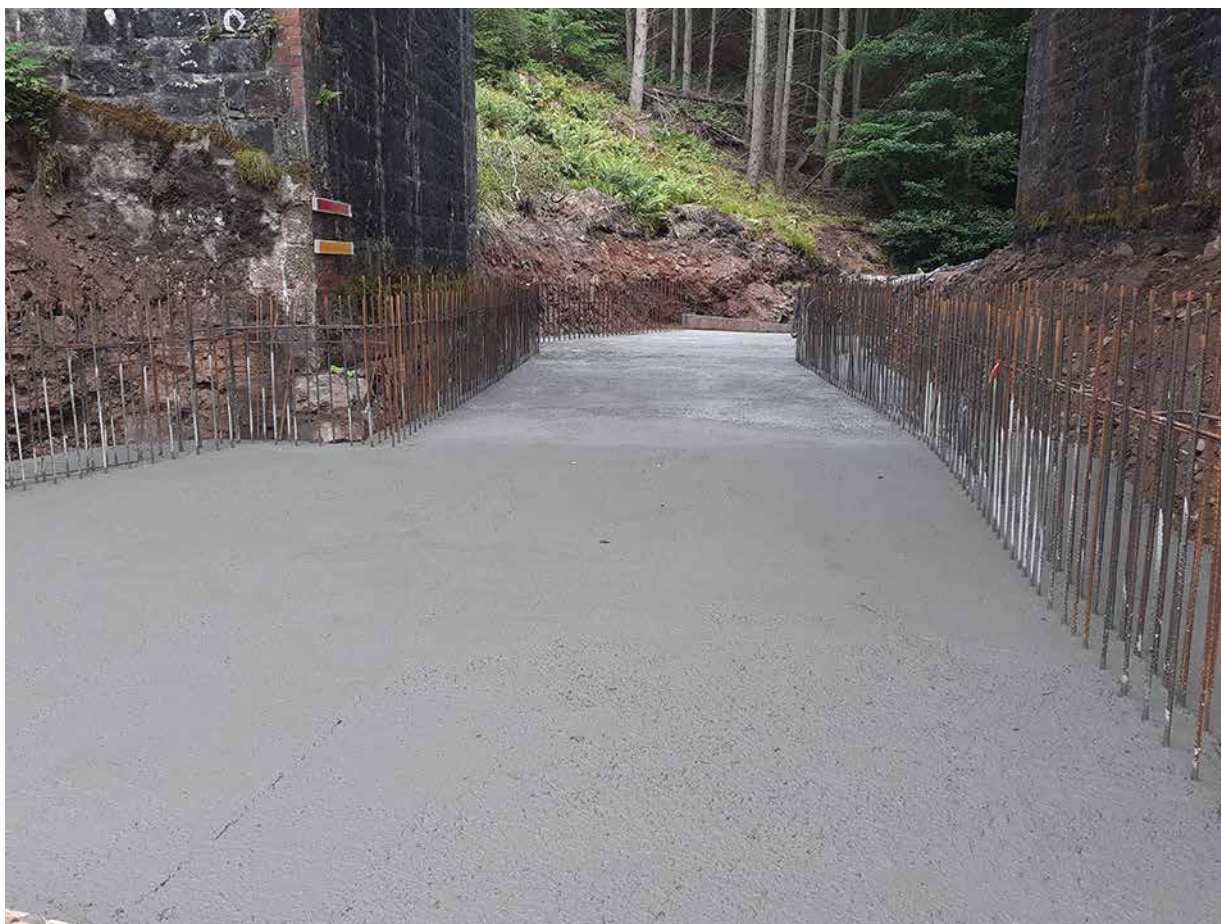
F29 At the base of bridge 325, scour protection works were in progress at the time of the accident to prevent the river eroding away the bridge foundations. The northern abutment had been identified as vulnerable during a scour assessment undertaken on behalf of Network Rail in September 2016. Scour risk meant that the structure was monitored when river levels were high, but this was not the situation on the morning of 12 August 2020.

*Figure F.10: Scour protection works at bridge 325 on 11 August 2020 (Story Contracting)*

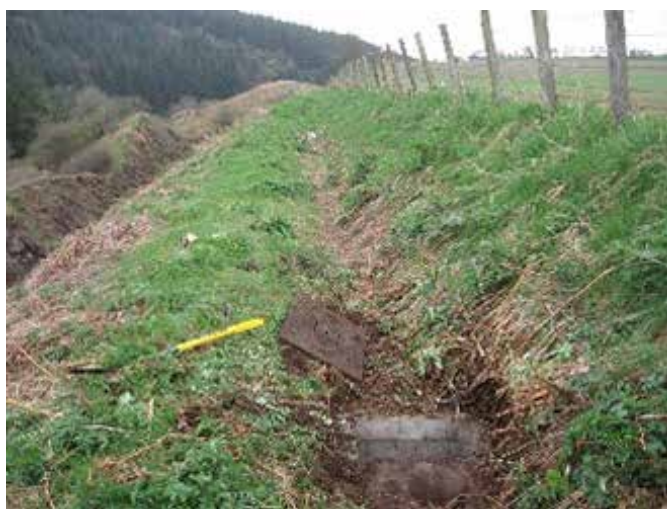
*Figure G.1: Pre-2010 crest drain catchpit between CP10 and CP16 showing drain close to the cutting crest in 2010 (Carillion)*

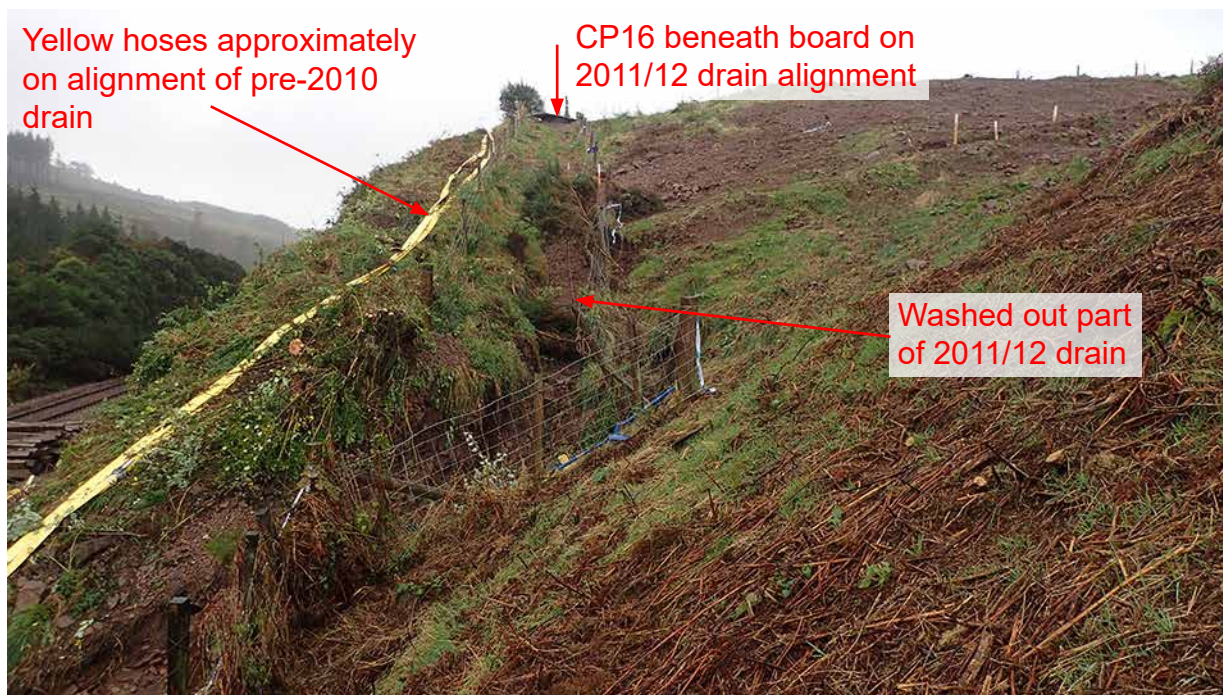
Figure G.2: View from near CP18 towards CP16 showing alignment of the pre-2010 crest drain and the 2011/12 drain after post-accident vegetation clearance

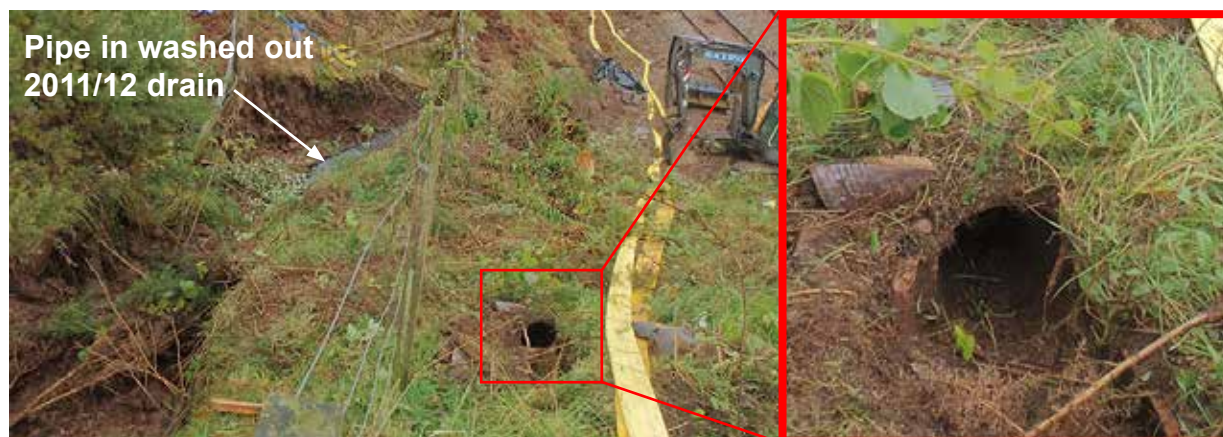
Figure G.3: Break in pre-2010 crest drain near top of washed out section of 2011/12 drain looking downslope with railway visible in top right-hand corner of image

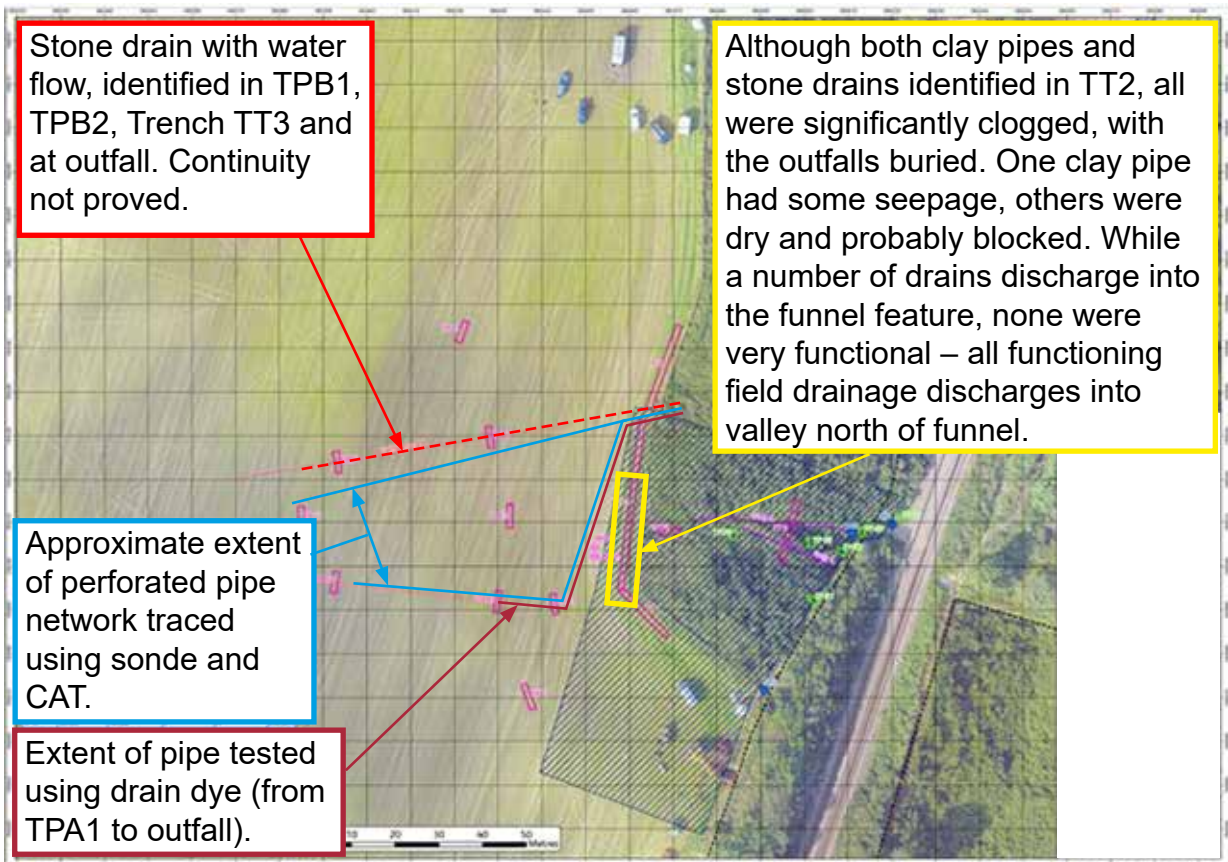
Figure G.5: Field drain survey findings (edited version of Network Rail drawing)

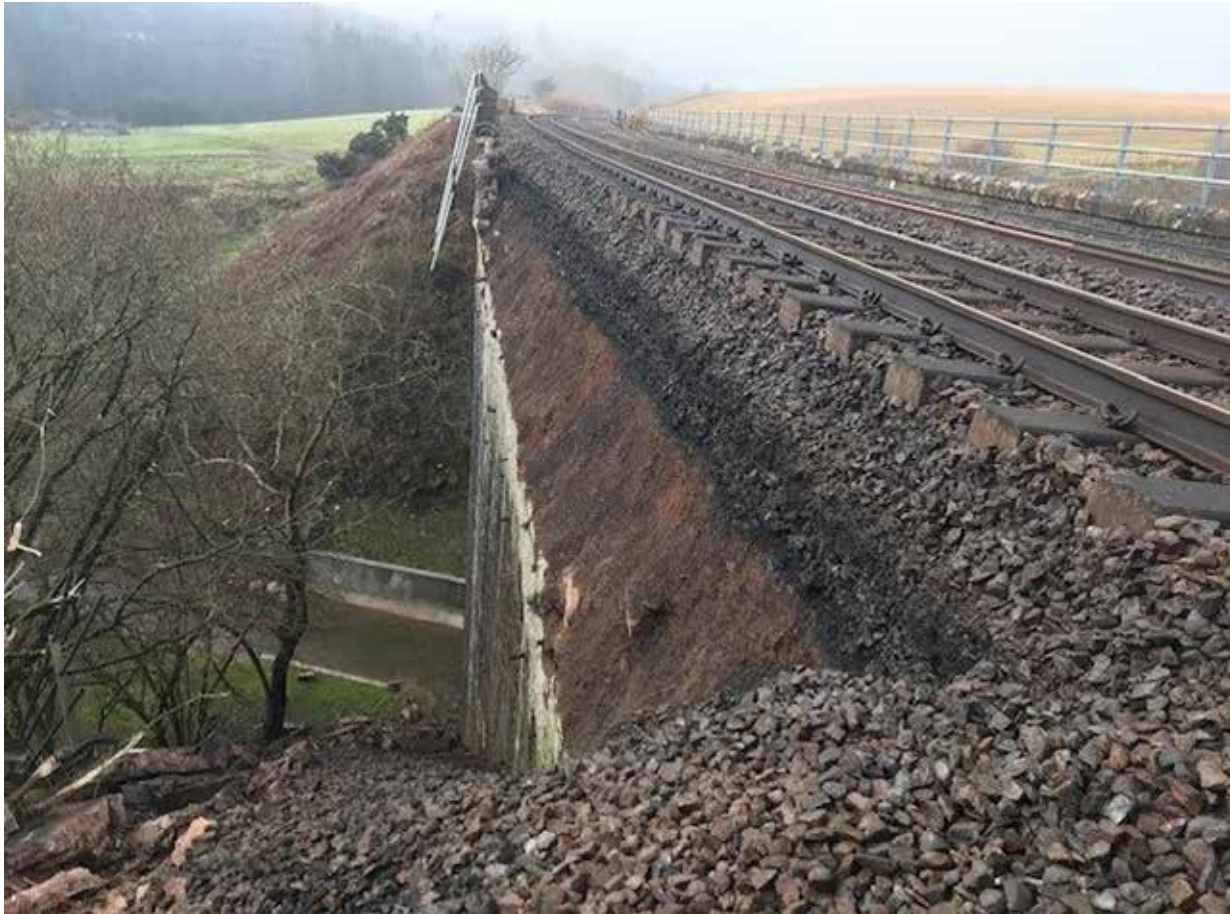
Figure M.2: Up line on bridge 328 looking south on 15 January 2021 (Network Rail)

- M5 An investigation undertaken by Network Rail found that the parapet had become pushed outwards by deep ballast on the bridge. Additional ballast had been placed as part of a track upgrade undertaken between 1980 and 1993. During this project, jointed rail was changed to continuous welded rail. The depth of the ballast was increased to support the stresses and forces generated by the rail being welded together and stressed and to allow train speeds to be increased. There was no evidence that the parapet wall had been designed to carry forces from the ballast and its failure was exacerbated by the presence of existing defects in the parapet and wingwall.

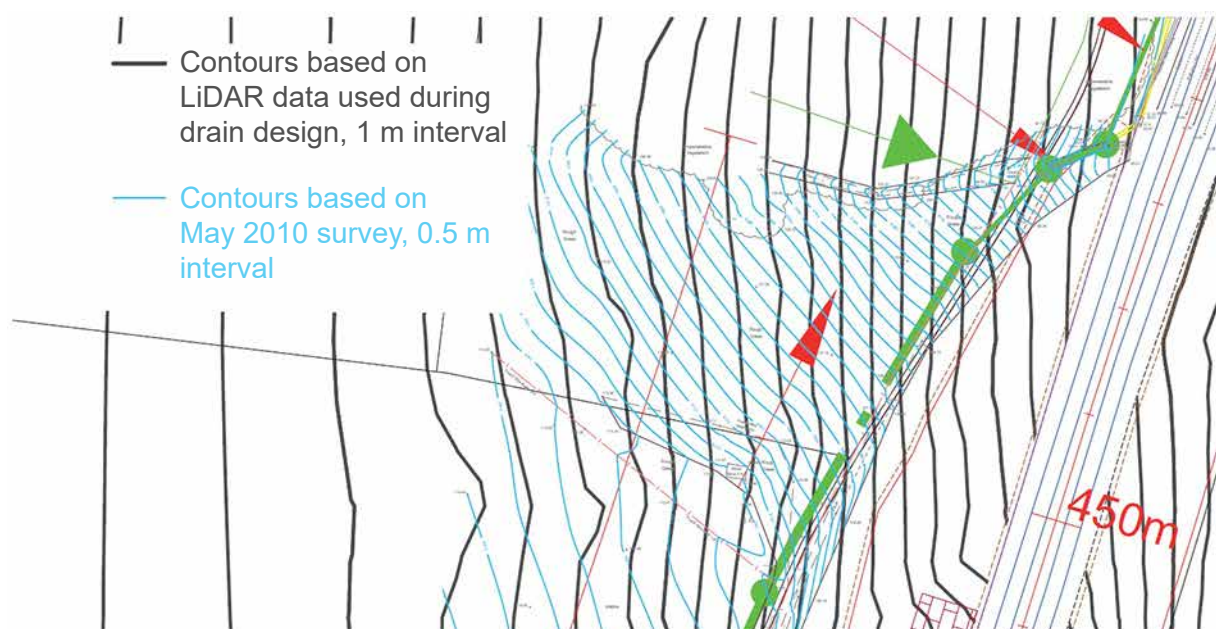
- N3 The LiDAR data used by Arup lacked the accuracy needed to show the funnel feature, but this was shown on additional survey data which was provided to Arup in May 2010 (paragraph 95 and figure 33). The two sets of data are compared on figure N.1.

Figure N.1: Funnel area contours compared

- N4 Some unwanted material excavated during construction of the 2011/12 drain was placed on the southern face of the funnel feature, so it is shown on the post-accident LiDAR survey, but not on the May 2010 survey. There is no evidence suggesting that the placement of this material affected the accident.
- N5 Network Rail standards applicable in 2010 did not specify the method to be used to calculate the amount of water reaching each part of the 2011/12 drain. Arup used the Institute of Hydrology Report 124 (IH124) method. AECOM confirmed that the Arup calculations were in accordance with this.
